WILSONS RIVER REACH AUDIT AND PLANNING: ELTHAM TO BOATHARBOUR

PART B: REACH SCALE ASSESSMENT OF CONDITION AND
REACH PRIORITISATION

MARCH 2023

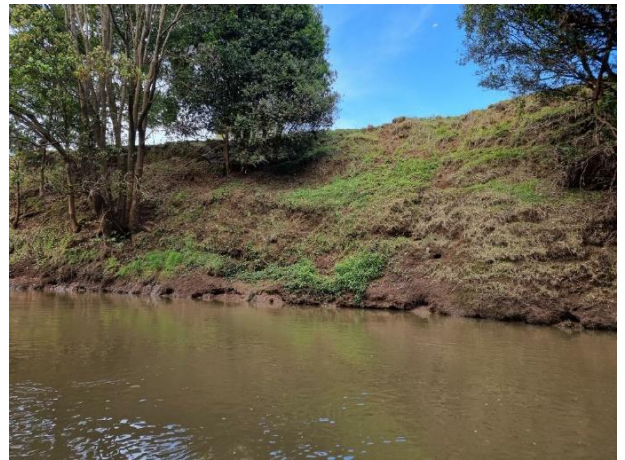
This picture shows bank toe cracking and slumping. This is evidence of incision.

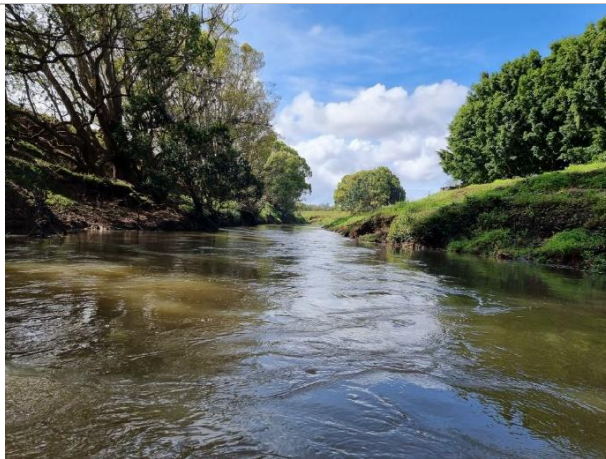
As seen above, potential head cut or construction is seen, with an increase in velocity comparatively.

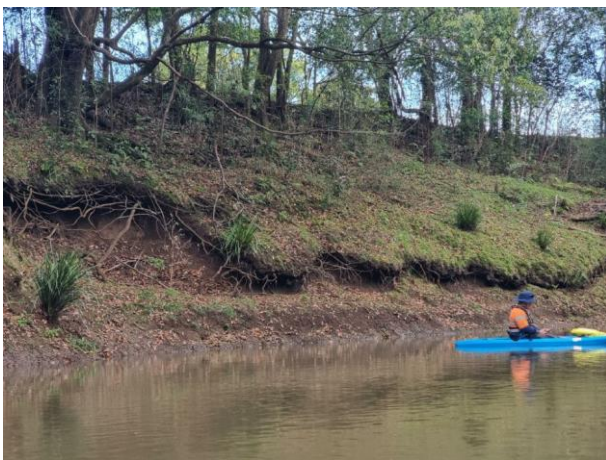
This photo illustrates bank cracking, toe slump, and evidence of incision was observed in the field.

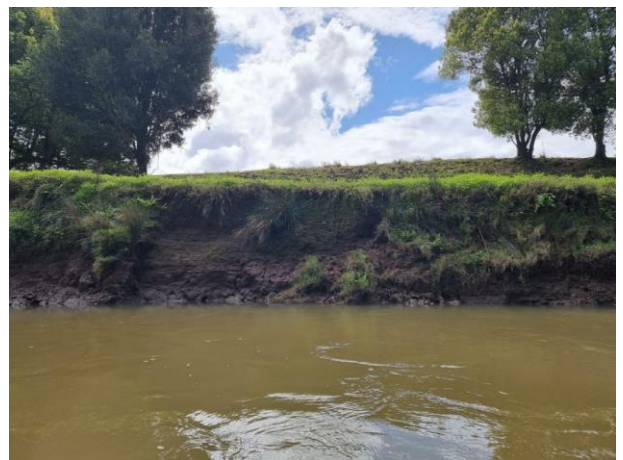
Scour of bench feature is seen here. Potential shrink-swell from clayey plastic soils, which can reduce bank stability, especially if intense grazing exists.

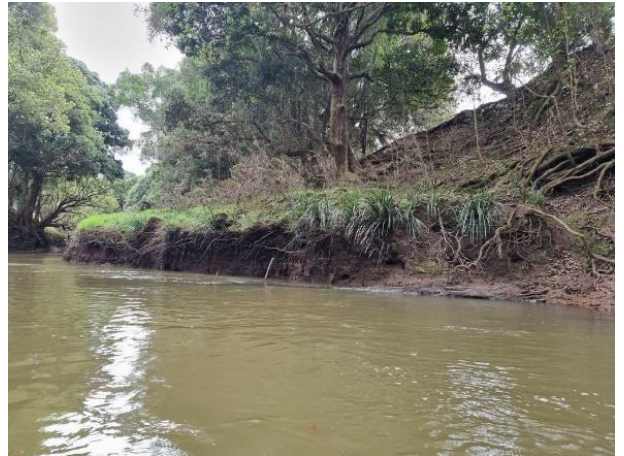
Bank scour and failure is seen here.

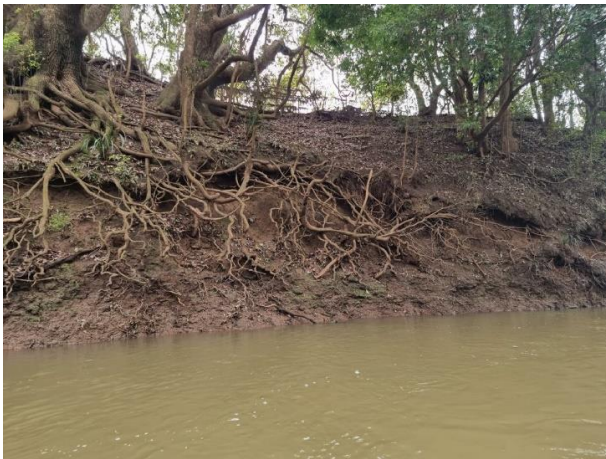
Bank scour and failure is seen here. Large tree root exposed, reducing bank stability.

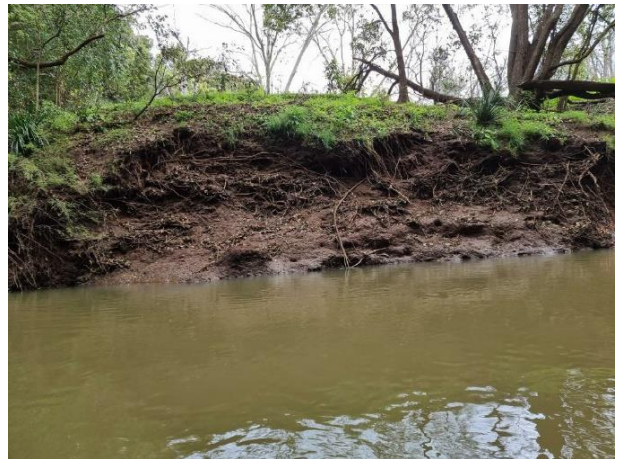
Bank scour and collapse is seen here.

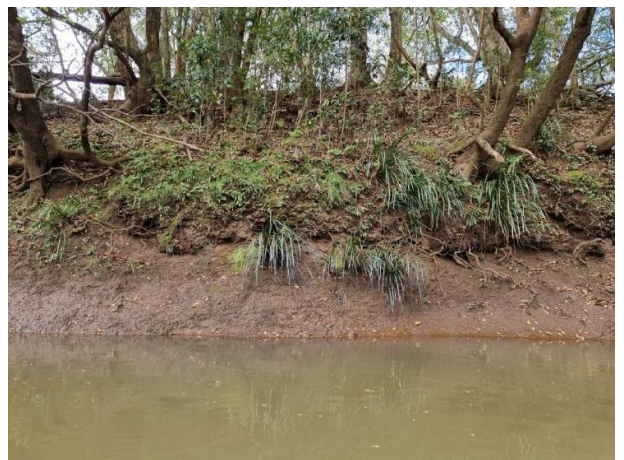
This photo illustrates bank cracking and undercutting.

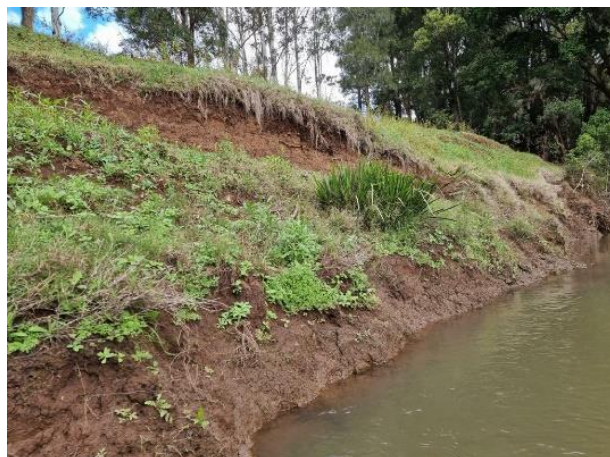
Consistent bank failures seen across these reaches.

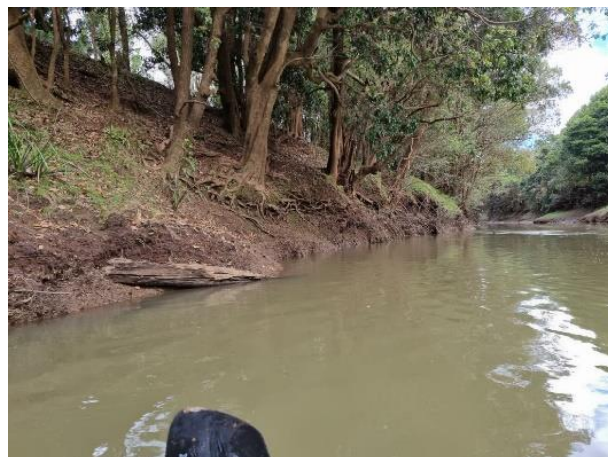
This photo shows active scour processes on left bank.

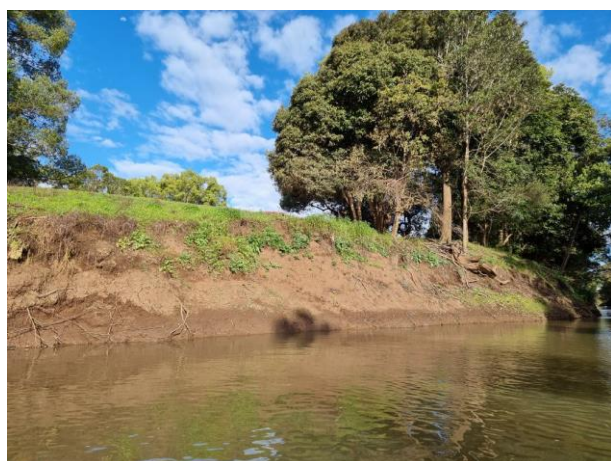
Historical bank failure, with active bank scour and decreased amounts of large trees on riparian zone.

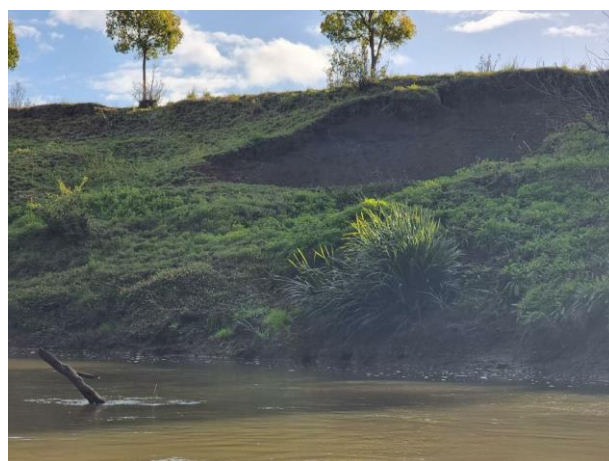
Bank collapse, with active toe erosion and decreased amounts of large trees on riparian zone.

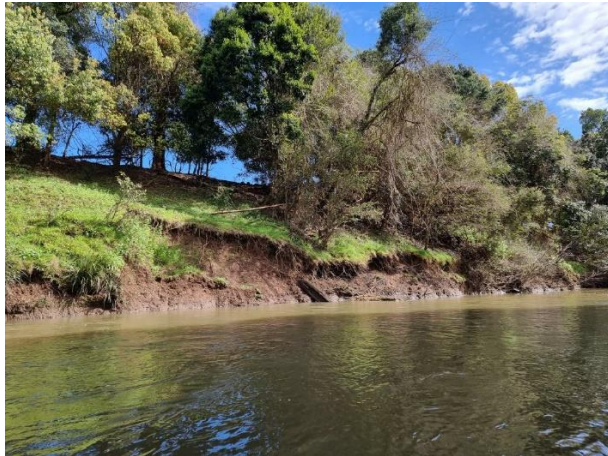
Reduced riparian vegetation and bank failures is seen here. Potential bedrock-controlled riverbed.

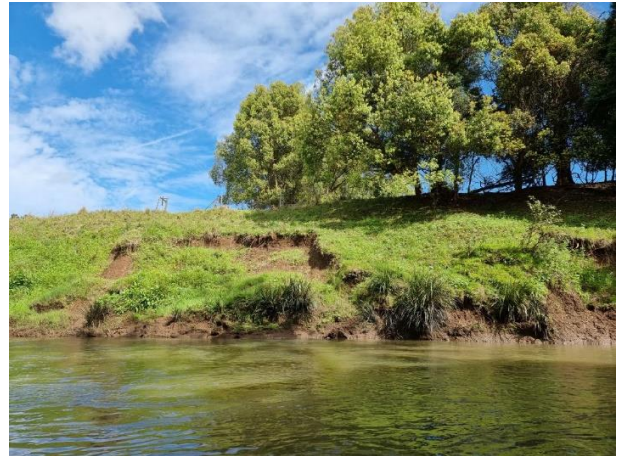
Reduced riparian vegetation and bank failures is seen here. Potential bedrock-controlled riverbed.

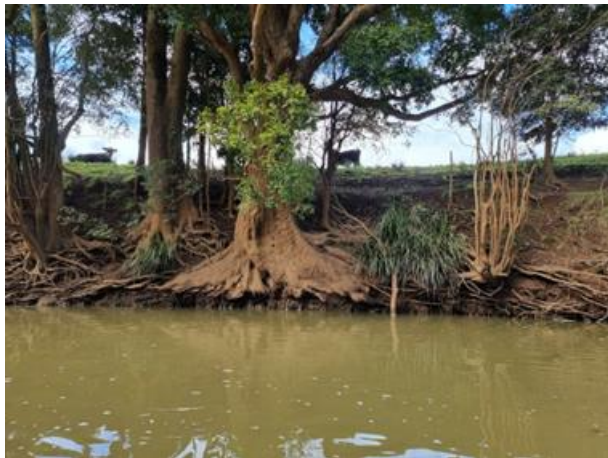
Undercut banks is seen here.

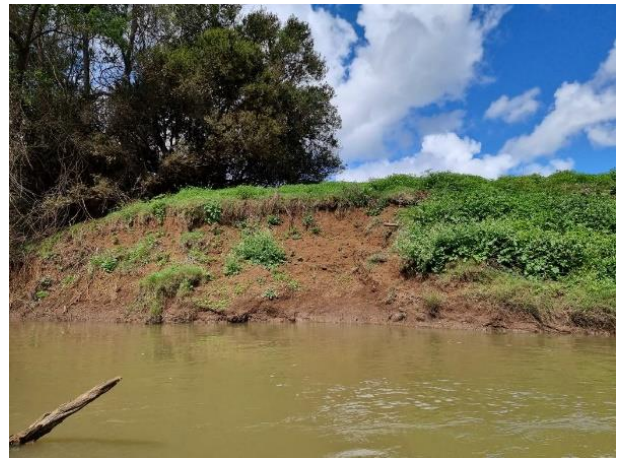
This photo shows bank failures associated with flow from the tributary channel joining.

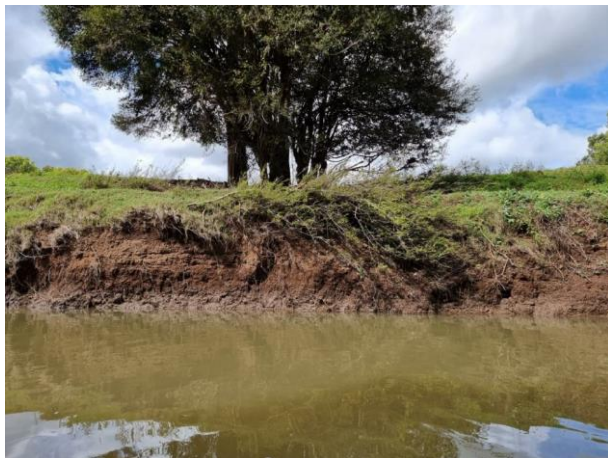
Reduced riparian vegetation and bank slumping is seen here.

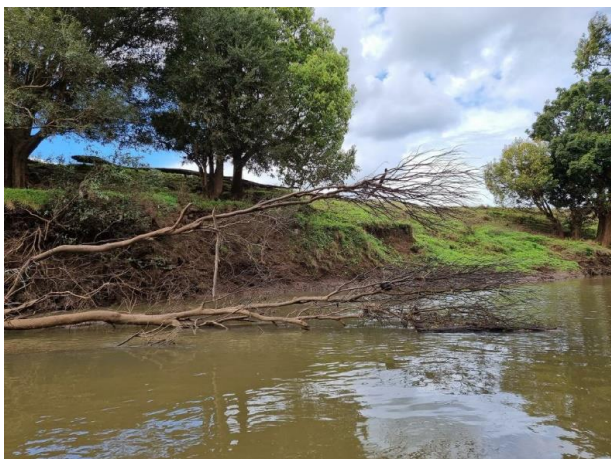
<p>Reduced riparian vegetation and bank failures is seen here. Potential livestock trail.</p>	<p>Reduced riparian vegetation and bank failures is seen here.</p>

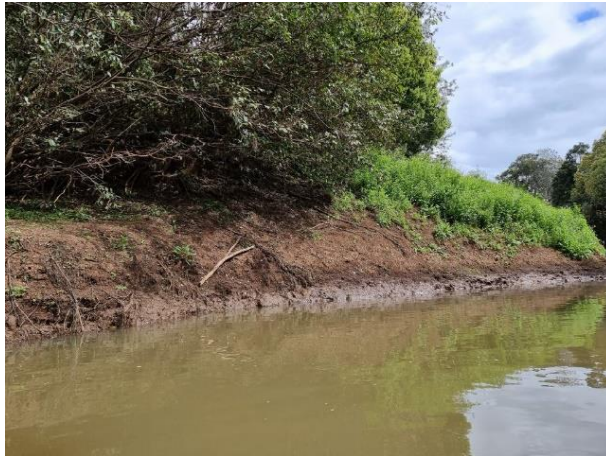
This photo shows toe and bank scour.

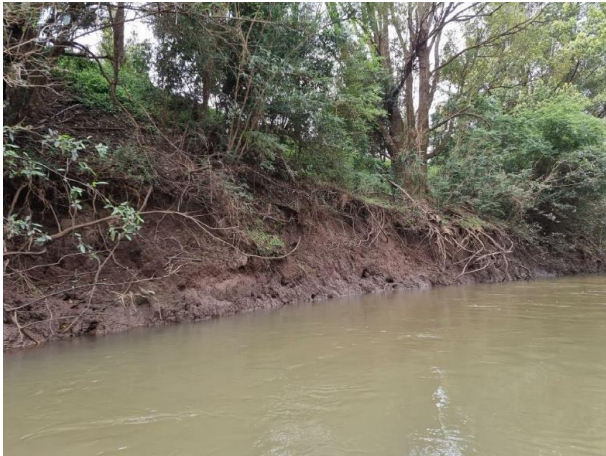
Toe failure and scour is seen here.

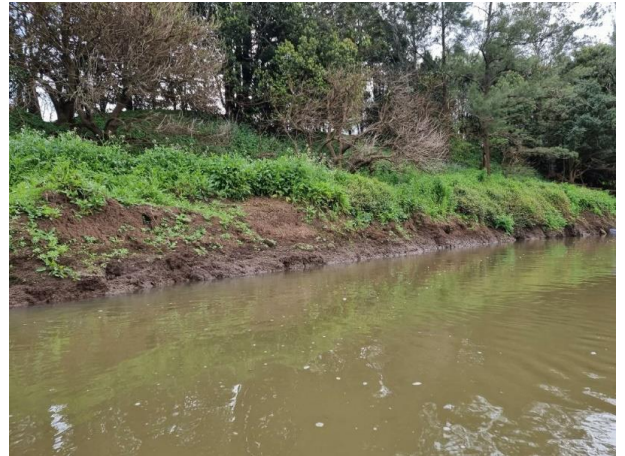
Toe failure and scour is seen here.

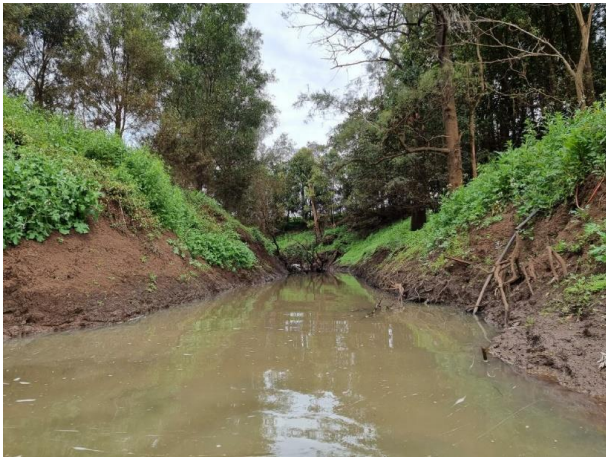
Headward eroding tributary with toe scour is seen here.

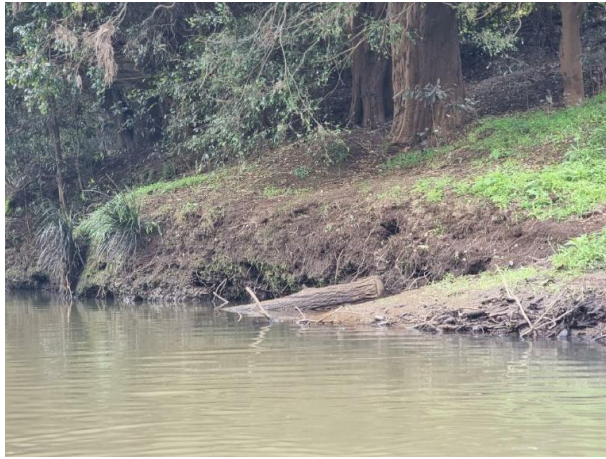
Reduced riparian vegetation and bank scour and failures is seen here.

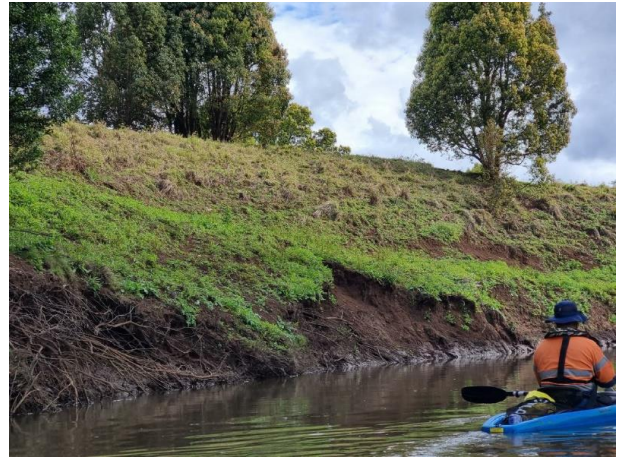
Reduced riparian vegetation and bank scour and failures is seen here.

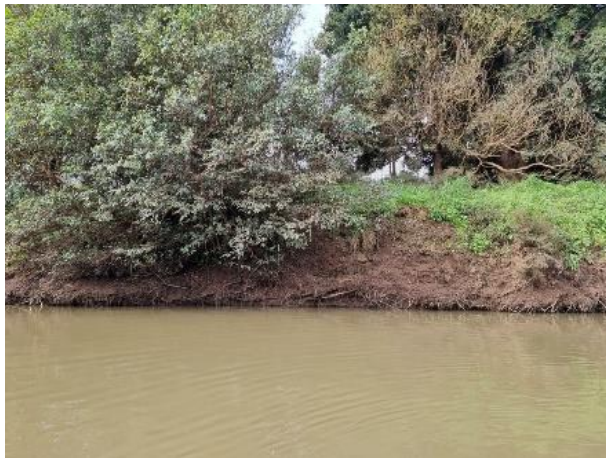
Reduced riparian vegetation and bank scour is seen here.

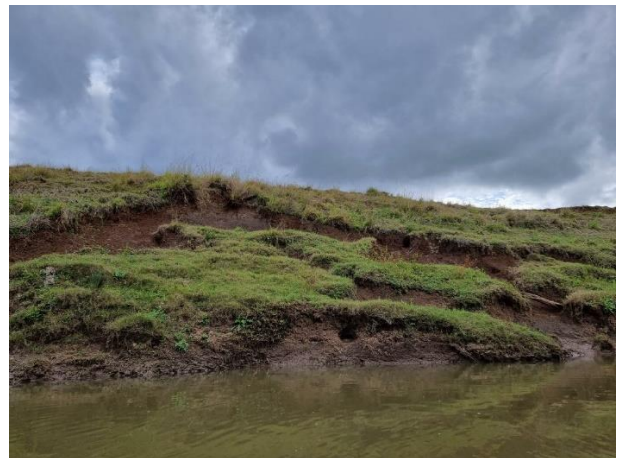
Consistent bank failures throughout the bend are seen here.

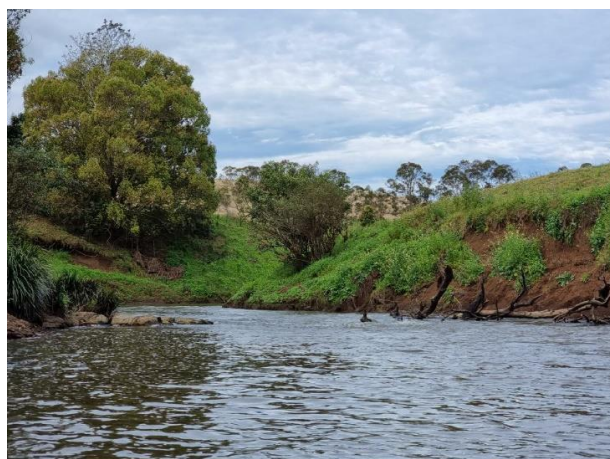
This photo shows bedrock step. Part of bank exposed, increased ground cover comparatively.

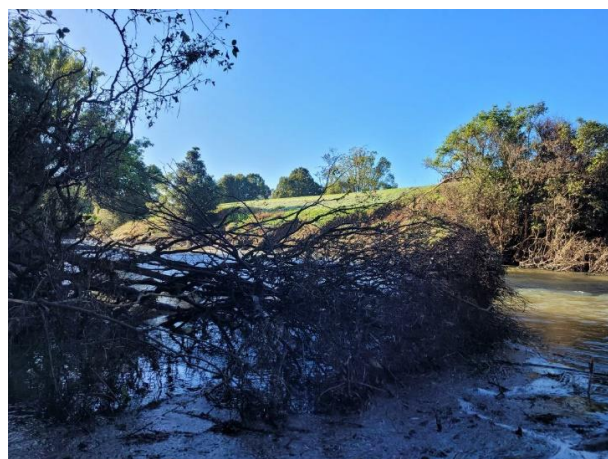
Bank scour and failure is seen here.
Water quality measurement point.

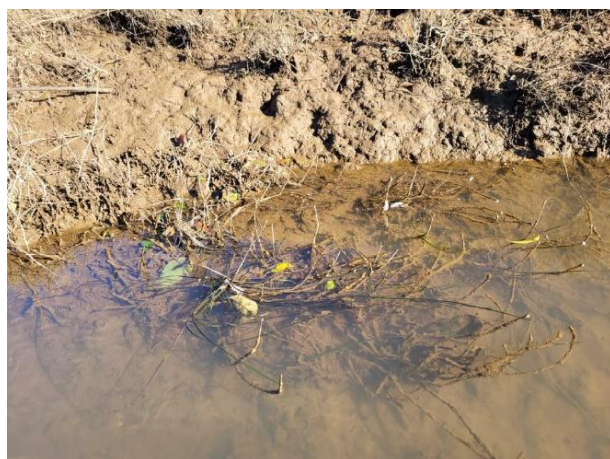
Exposed bank is seen here.

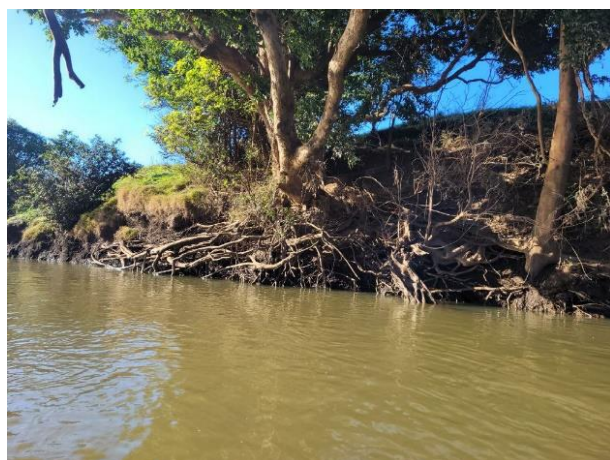
Bank scour and failure is seen here.

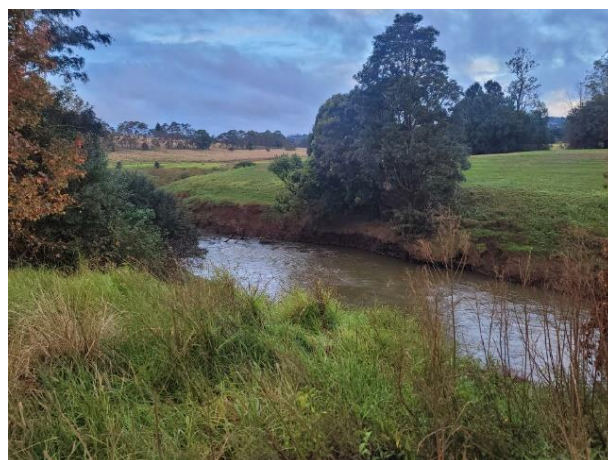
Reduced riparian vegetation and toe scour is seen here.

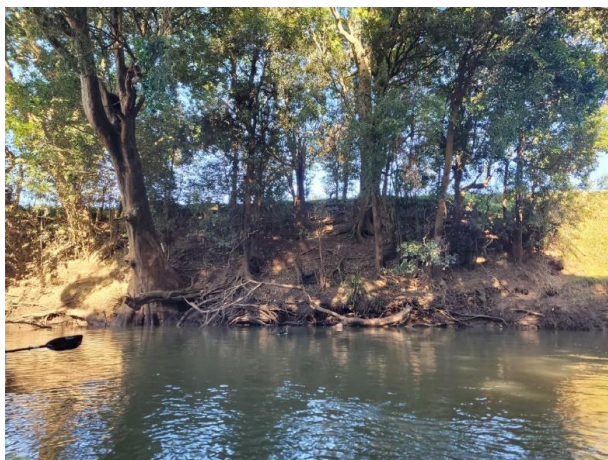
This photo shows bank scour and failure. Large tree roots have been exposed and reduce bank stability.

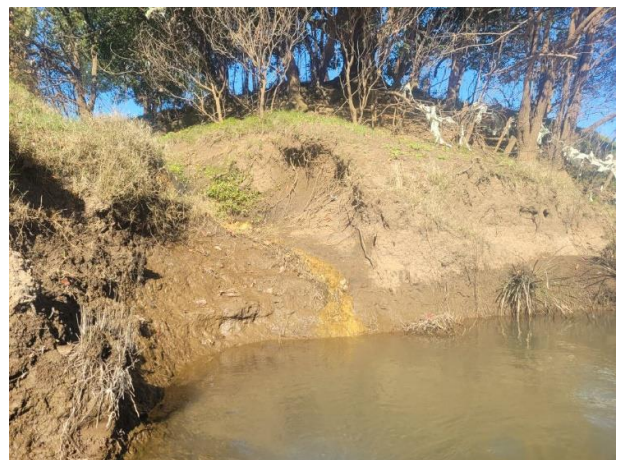
Evidence of livestock trail is seen here. Potentially sediment point source.

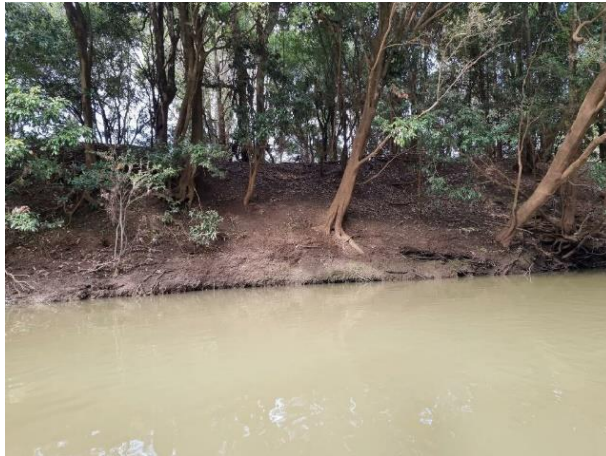
Bank scour is seen here, with potential bank undercutting.

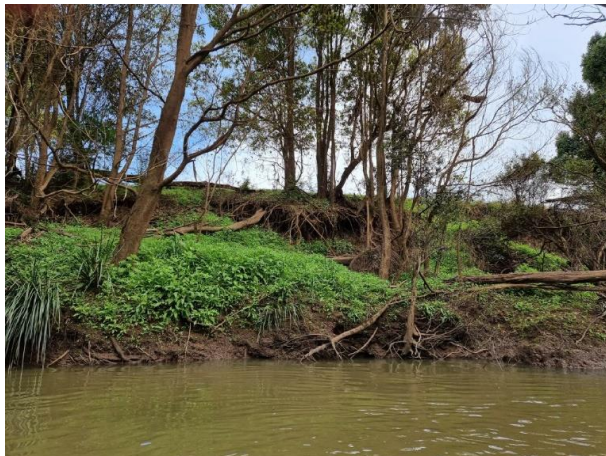
This photo illustrates bank failures and exposed large tree roots.

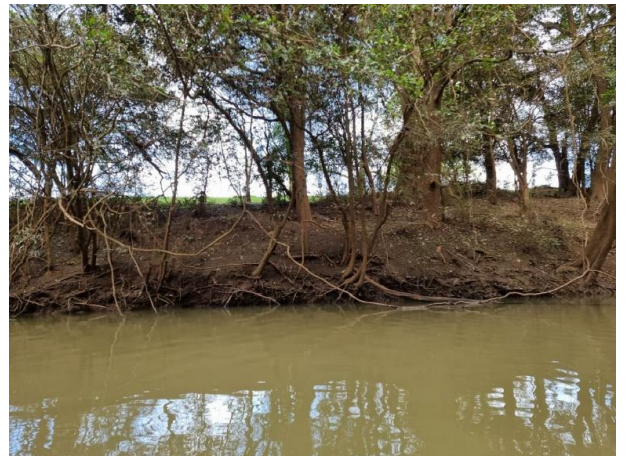
This photo illustrates bank failures and exposed large tree roots, with potential for bank undercutting.

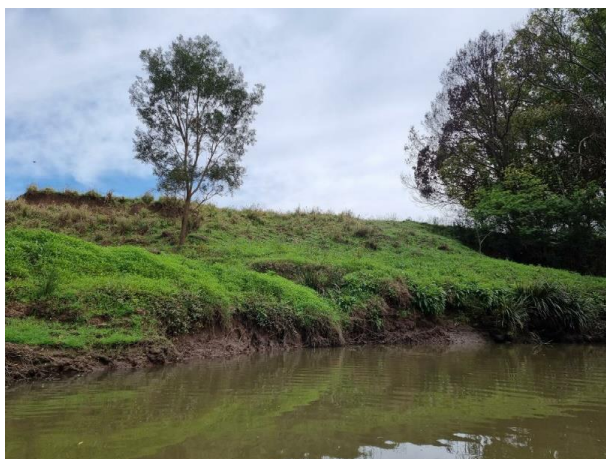
Reduced riparian vegetation and bank slumping is seen here.

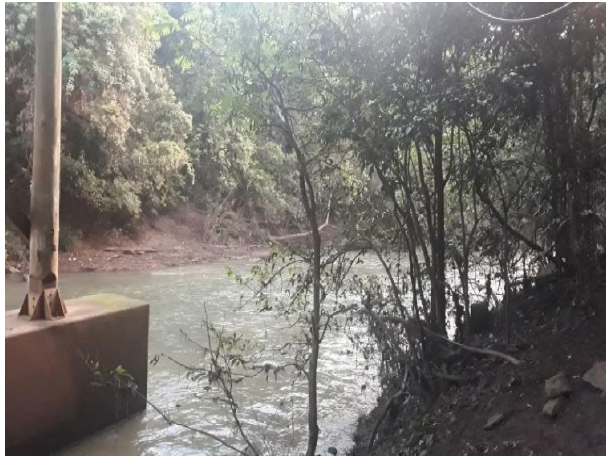
Bridge pier is seen here. Changes to velocities and consequential changes to depositional patterns. Some bank failure seen, as water is pushed around pier.

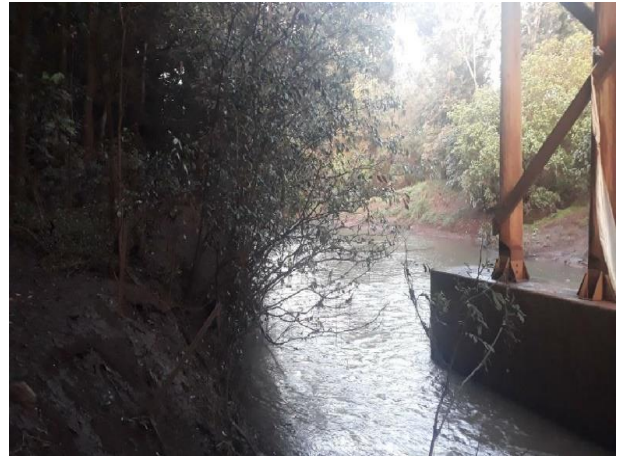
Bridge pier is seen here. Changes to velocities and consequential changes to depositional patterns. Some bank failure seen, as water is pushed around pier.

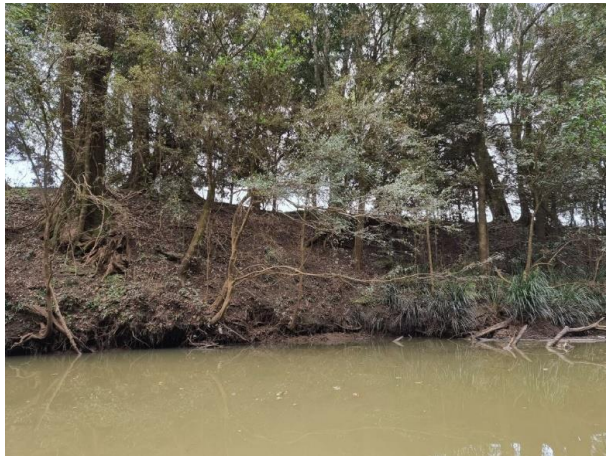
Some overhanging vegetation is seen on fringing zone, with undercut banks.

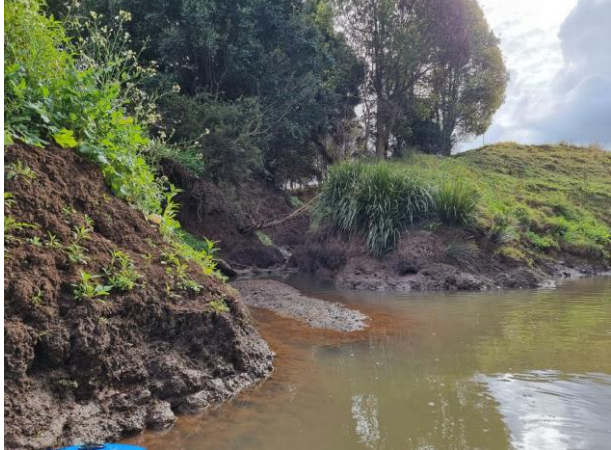
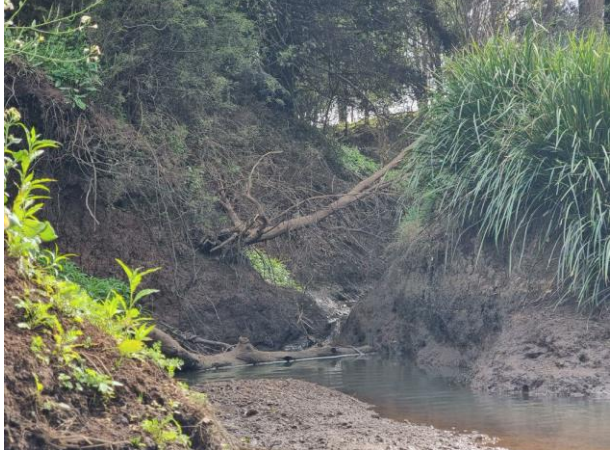
<p>14 - Reach 12, headward eroding trib with toe scour. Severity - High</p>	<p>14</p>

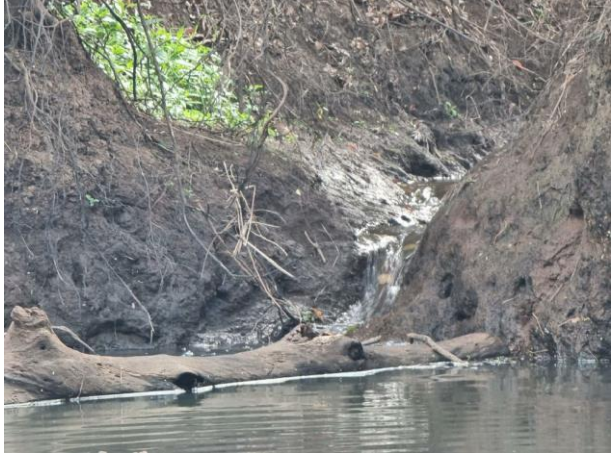
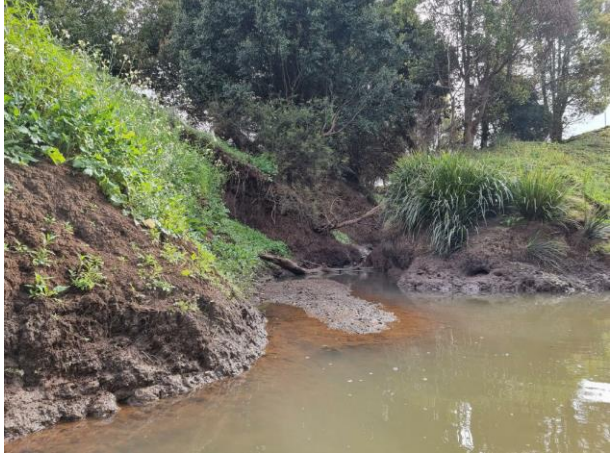
<p>15 - Reach 13, headward eroding trib with bank failures, large sediment input. Severity – High</p>	<p>15</p>
