WATER QUALITY REPORT

Mid Richmond River – Annual Progress Report, January 2023
Prepared by Southern Cross University

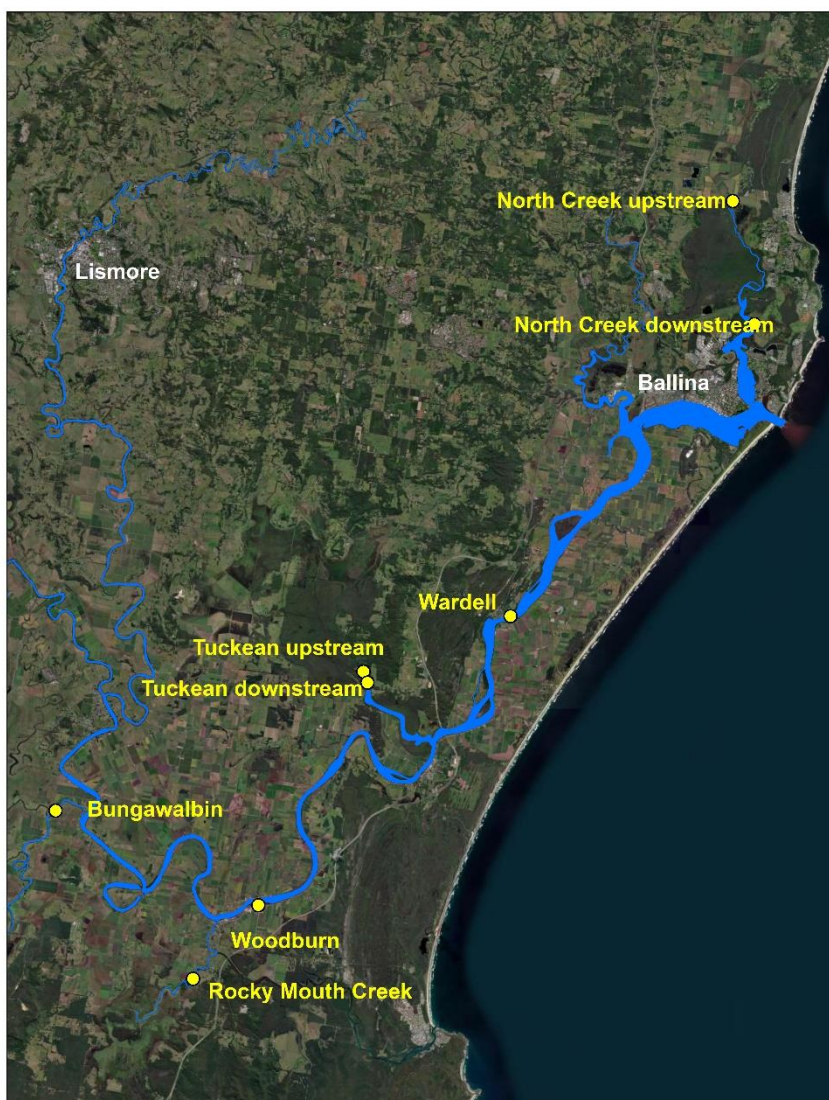
Figure 1 Location of the eight water quality loggers (yellow text).

The water quality loggers are located at eight sites throughout the lower Richmond River and its key tributaries as shown in Figure 1.

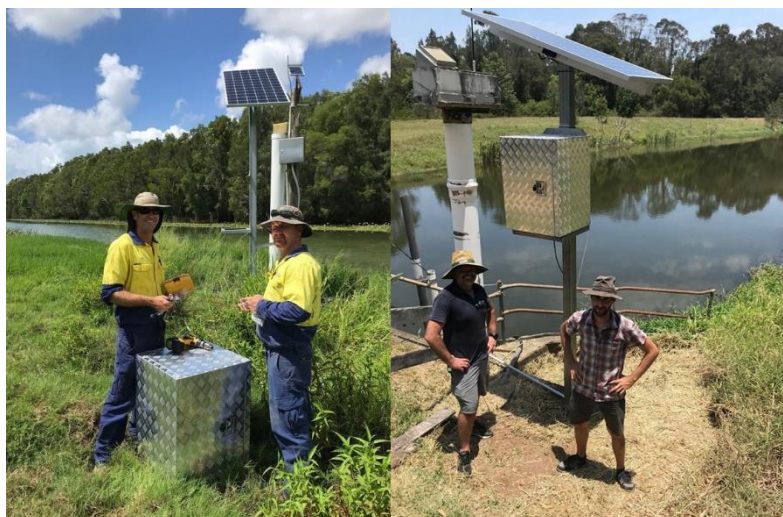
Figure 2 Rous County Council Flood Mitigation Operators installing a logger housing at the Tuckean Upstream site (left) and SCU staff at the Rocky Mouth Creek site following logger installation (right).

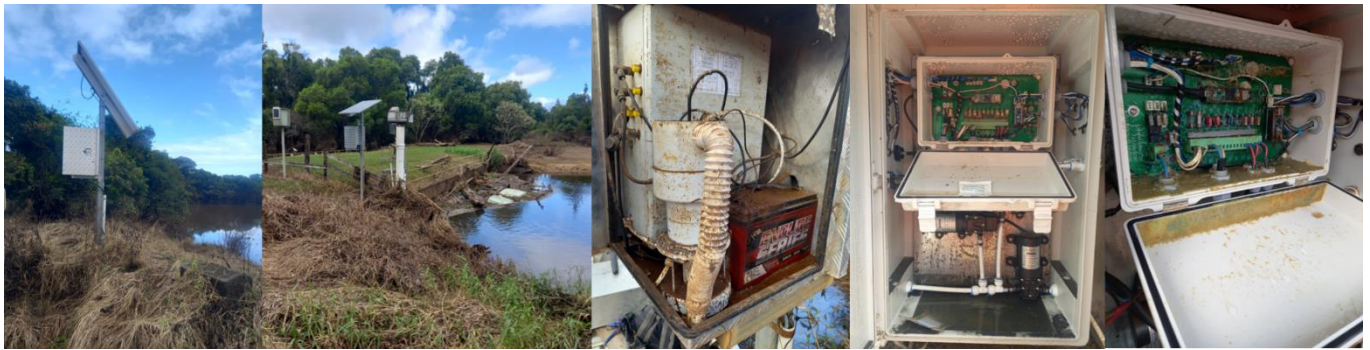
Figure 3 Photos of flood damaged loggers

Unfortunately, loggers at four of the monitoring sites were damaged beyond repair following the record flood in March 2022: Rocky Mouth Creek, Woodburn, Tuckean Upstream and Tuckean Downstream. A variety of temporary loggers sourced from DPE, SCU and RCC were deployed at some of these sites when the loggers were available for use. Considerable time and money were required to deploy and maintain the temporary loggers including the purchasing of new materials for temporary installations and more frequent visits due to calibration requirements. The loggers were deployed for much of 2022 to capture the flood recovery with the data collected from the temporary loggers incorporated in Section 7.

After a lengthy insurance claim, replacement loggers plan to be installed mid-2023 by SCU. The new loggers feature an improved design that aims to improve serviceability and reduce maintenance time. Given this considerable investment, a longer-term plan for the continuation of the initiative is recommended as funding for the collaborative project ends in early 2025.

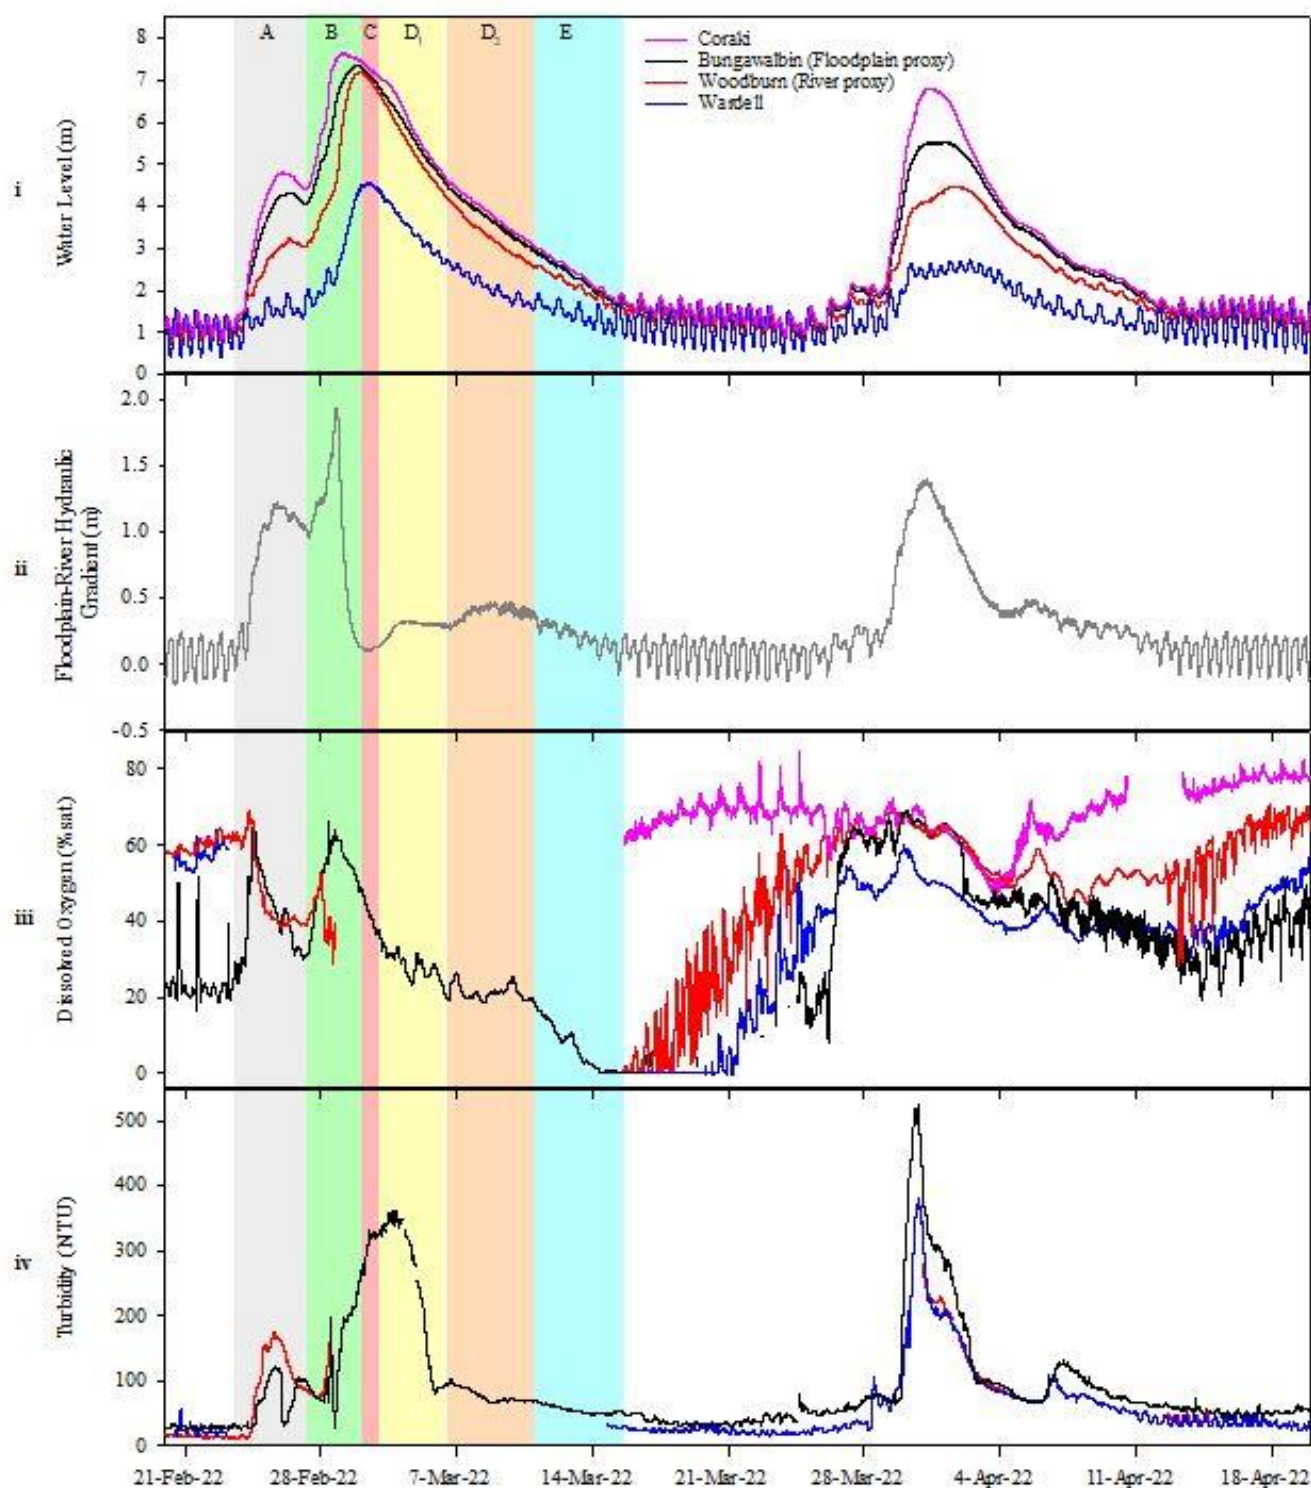
Figure 6 **i** Water level data; **ii** Floodplain-River Hydraulic Gradient; **iii** Dissolved Oxygen; **iv** Turbidity. **A** Pre-flood; **B** Rising stage; **C** Flood peak; **D₁** Stage 1 of floodplain drainage; **D₂** Stage 2 of floodplain drainage; **E** Backswamps drain.

Figure 6 presents water level, DO and turbidity data from the Bungawalbin, Woodburn and Wardell loggers as well as data from Coraki. The floodplain-river hydraulic gradient is also presented - this is the difference in elevation in m AHD between the water levels on the floodplain and in the river (calculated as the difference between Bungawalbin and Woodburn water levels).

For this event, there appeared to be a sequence of distinct phases linked to the timing of water level changes across the floodplain and in the river (i.e. the floodplain-river hydraulic gradient) that lead to the large hypoxic blackwater event that resulted in mass fish mortality. The key phases were:

- During the moderate flood that occurred on the 25th February, low-lying areas of the floodplain (i.e. backswamps below 2 m AHD) became inundated prior to the major flood event (refer phase “A” in Figure 6).

- Following the flood peak (refer phase “C” in Figure 6) the first phase of floodplain drainage occurred (refer phase “D₁” in Figure 6). During this initial decanting, blackwater discharges over the natural levees.

- The final stage of floodplain drainage occurred when water levels at Woodburn dropped below ~2.5 m AHD (refer phase “E” in Figure 6). Blackwater from the low-lying backswamps, which were inundated for up to 15 days, drain to the main river channel

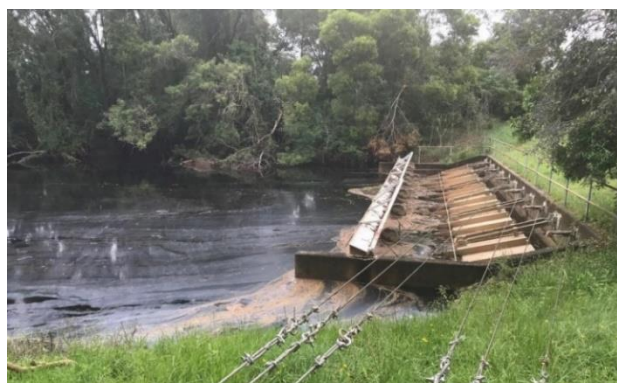
Figure 8 Blackwater discharging from Rocky Mouth Creek after flooding in 2020. Source: RCC.

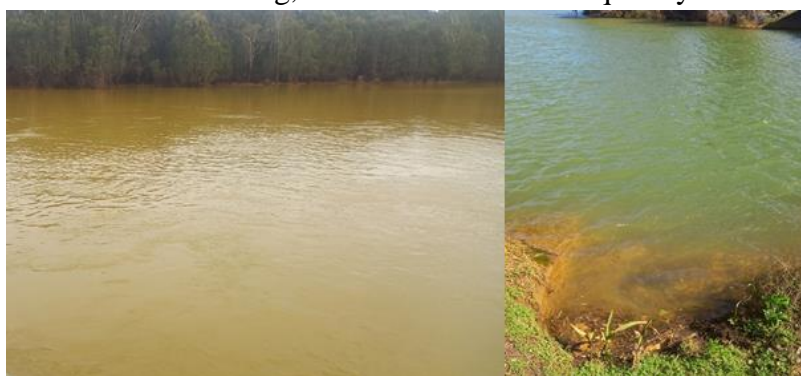
Figure 9 Acid discharges from Tuckean Downstream at Baggotville Barrage. Left: Iron stained water, pH ~3.2, 5/8/22. Right: Shifting to blue-green water due to high levels of aluminum, pH ~3.5, 17/8/22.

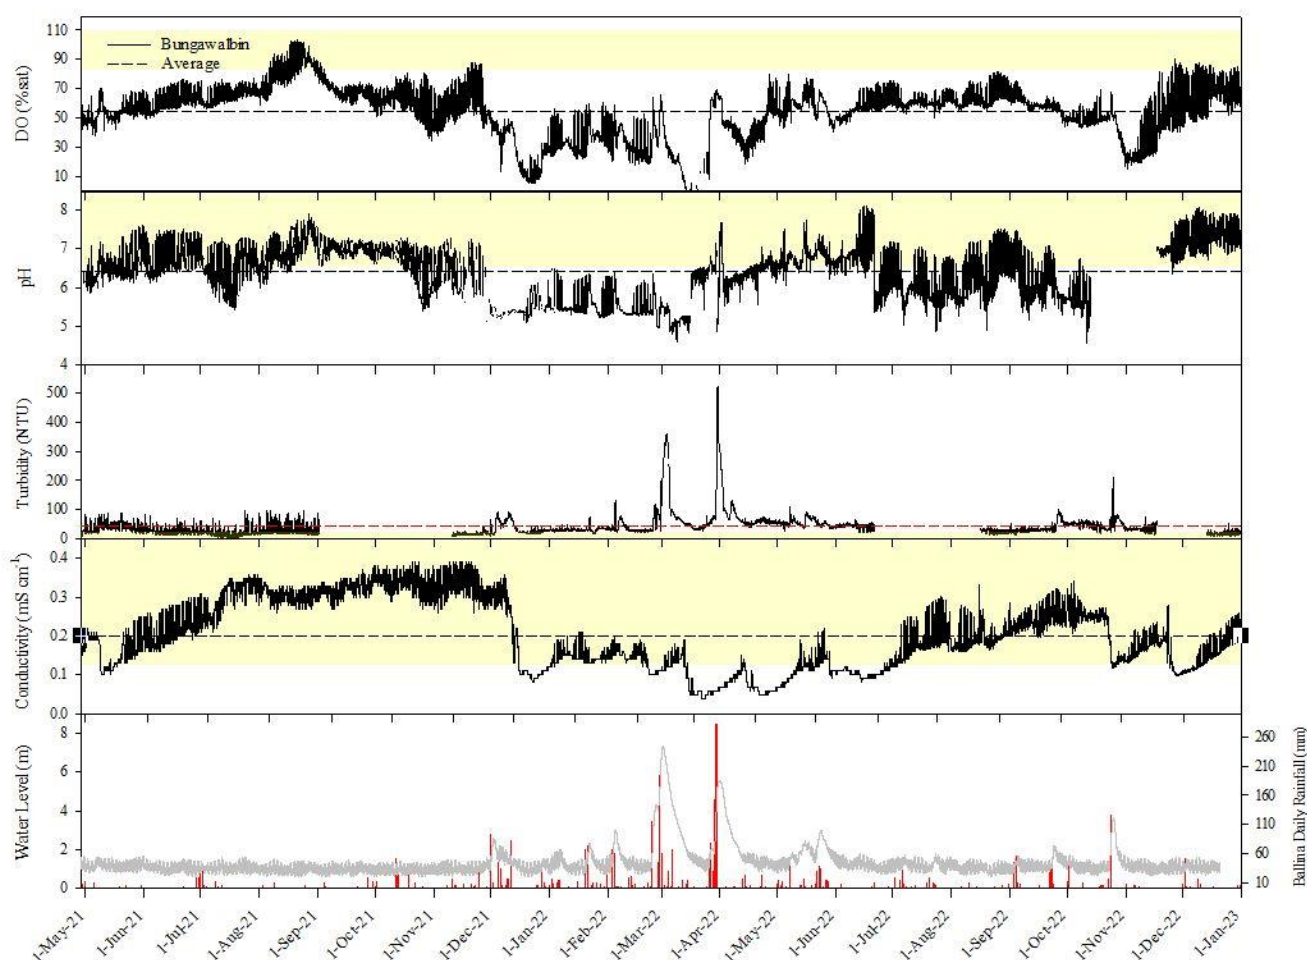
Figure 11 DO, pH, turbidity and conductivity at Bungawalbin. Yellow shaded area represents the ANZECC guideline range for slightly disturbed Lowland Rivers in south-east Australia.

Timeseries data is presented in Figure 11.

- Water quality measured by the logger is influenced from waters discharging from the floodplain (lower in DO and pH) and better-quality upstream water (higher in DO and pH) transiting downstream and shunting up into Bungawalbin Creek during the flood tides

- DO has averaged 55 %sat which is driven by low DO following rainfall
 - Water discharging from the catchment was largely hypoxic (DO < 30 % sat) during the wet summer/autumn (December 2021 through to May 2022) and then again following the onset of wet conditions in October 2022

- ⇒ The spikes in DO is the upstream water
 - Anoxic waters occurred following the March 2022 flood and were <10%sat during December 2021
 - During dry periods DO can reach ANZECC Guideline values e.g. August 2021

- pH has averaged 6.4
 - Acidic floodplain discharges of 4.5 to 5.5 occur during wet periods and continue in the weeks to months after as soils drain
 - During dry periods pH can approach ANZECC Guideline values e.g. winter and spring in 2021

- ⇒ Rainfall after these periods flushes acid from floodplain soils e.g. July and October 2021
- Turbidity is generally outside of ANZECC guideline values during rain events and immediately after

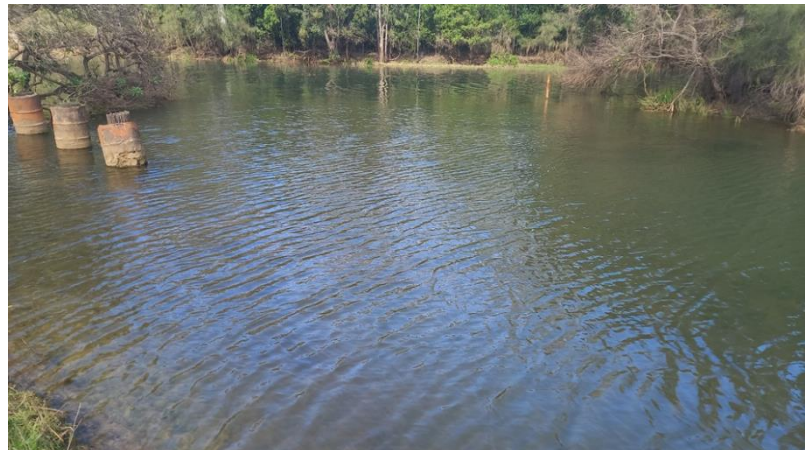
Figure 12 Blue-green water at Rocky Mouth Creek, pH ~ 3.6, DO ~90 %sat on the 17/8/22.

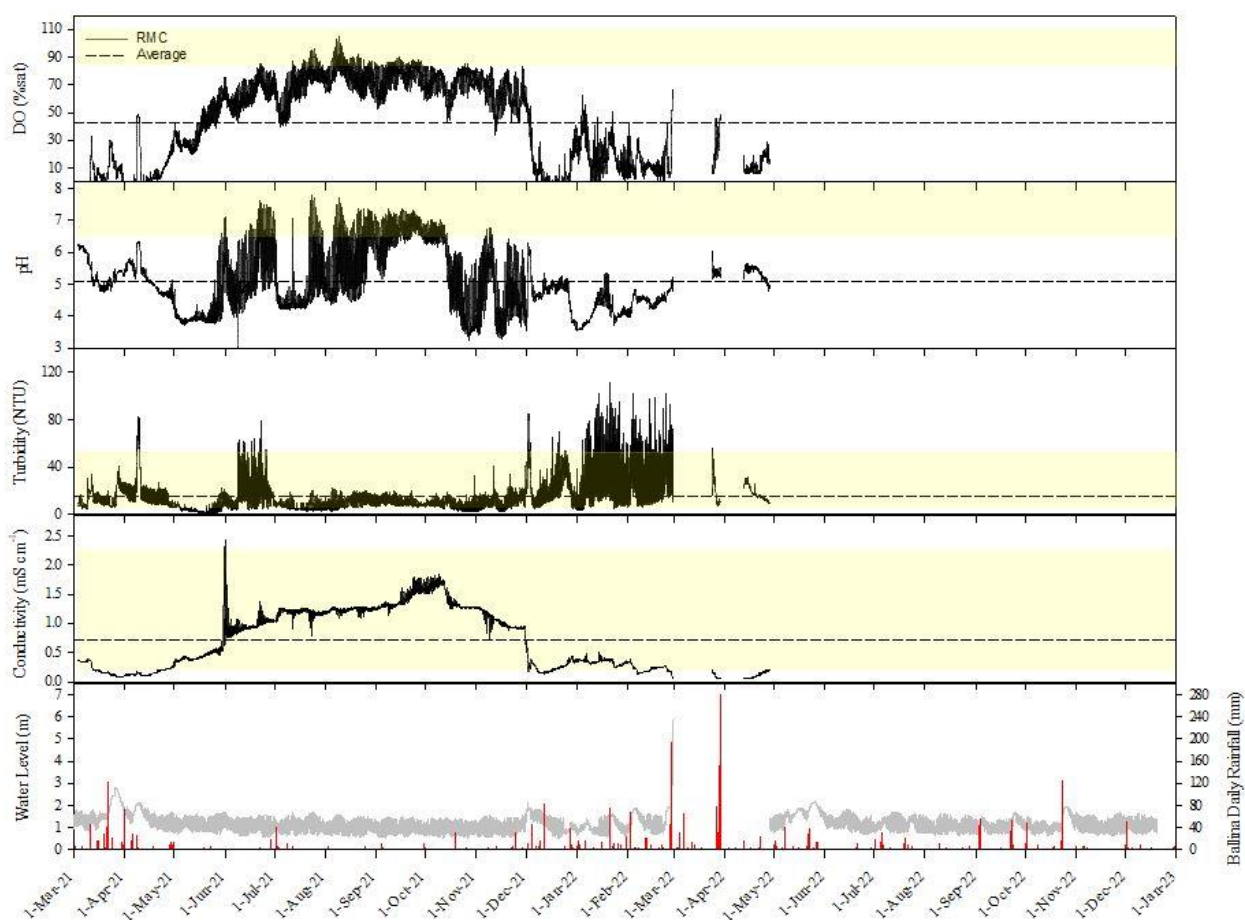
Figure 13 EC, DO, pH, turbidity and water temperature at Rocky Mouth Creek. Yellow shaded area represents the ANZECC guideline range for slightly disturbed Lowland Rivers in south-east Australia.

Timeseries data is presented in Figure 13.

- DO and pH averaged 43% sat and 5.1, respectively
 - Anoxic waters routinely discharge following rain e.g. March through May 2021, and December 21 through to May 2022
 - pH routinely drops to <4
 - ⇒ Figure 12 shows blue-green water that routinely occurs at Rocky Mouth Creek and driven by high levels of aluminium that causes particles in the water to clump together and fall to the bottom creating the clear, blue-green water
- DO and pH can approach ANZECC Guidelines but only during extended dry periods when tidal waters intrude
 - This occurred only 3% of the time for DO and 15% of the time for pH
- Turbidity is only outside of ANZECC guideline values during rain events and immediately after

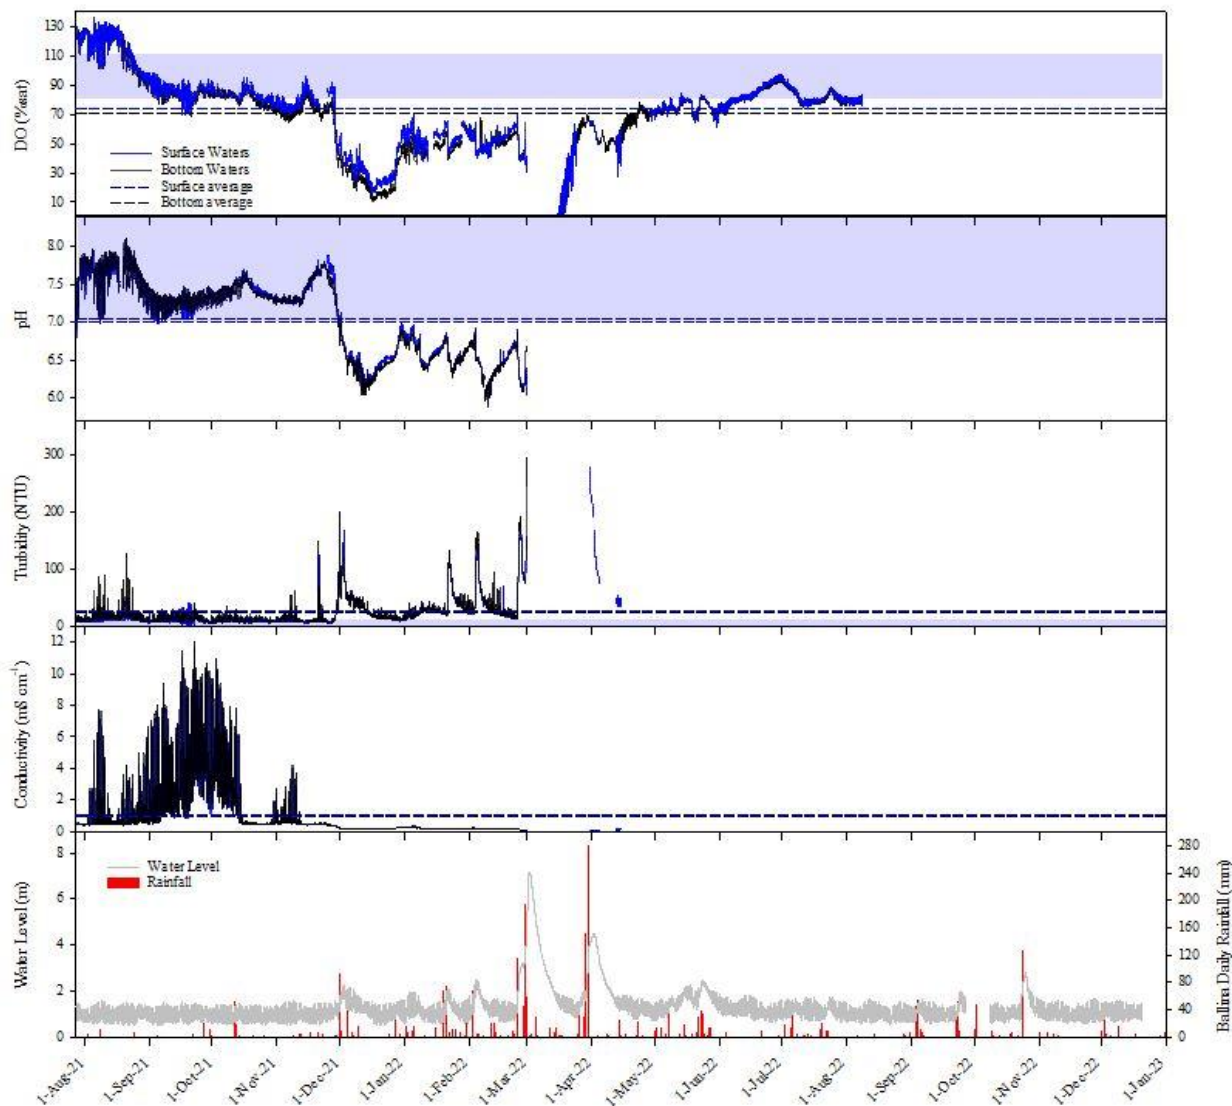
Figure 14 EC, DO, pH and Turbidity at Woodburn. Blue shaded area represents the ANZECC guideline range for slightly disturbed Estuaries in south-east Australia.

Timeseries data is presented in Figure 14 and Figure 15.

- Floodplain discharges heavily influence water quality during wet periods
 - Fresh water dominated the water column from mid-November onwards when La Nina re-established

- ⇒ Hypoxic waters (DO < 30%sat) occurred in December 2021
 - ⇒ Anoxic blackwater event in March 2022 and pH levels dropped considerably towards the end of November 2021 and remained below ANZECC guidelines until June 2022

- ⇒ pH ranged from 5.9 to 7.0 during this time
- Brackish tidal water dominated the water column during the dry period (August through October 2021)
 - DO was within ANZECC guidelines during this time except the first few weeks of August when waters were super-saturated (>110 %sat) in DO suggesting high primary productivity at that time

- pH was also within ANZECC guidelines during this period
 - Rainfall in October resulted in a fresh water column for a few weeks but DO and pH still remained within ANZECC

- Turbidity driven by tidal activity with values generally outside of the guidelines
- Turbidity levels spiked immediately with the onset of rain in December and late January

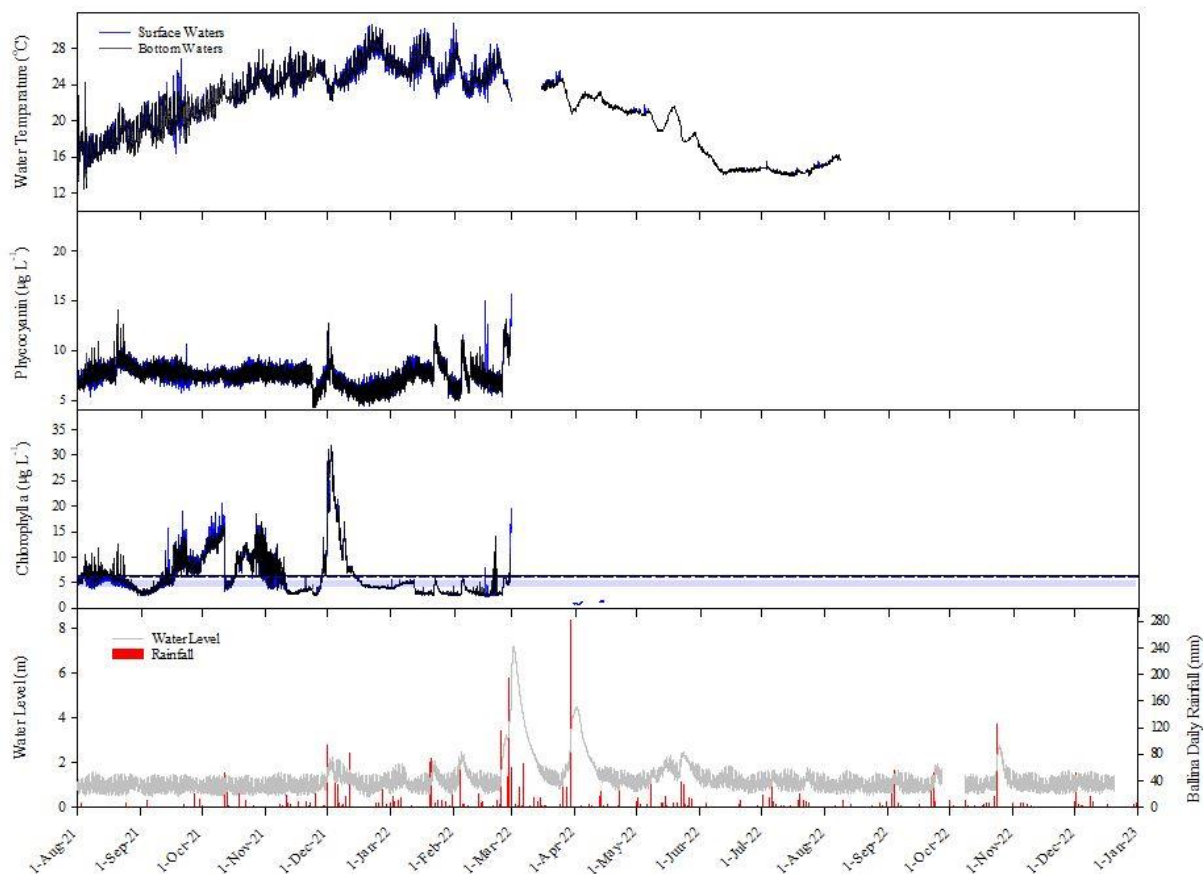
Figure 15 Water temperature, Phycocyanin, and Chlorophyll a at Woodburn. Blue shaded area represents the ANZECC guideline range for slightly disturbed Estuaries in south-east Australia.

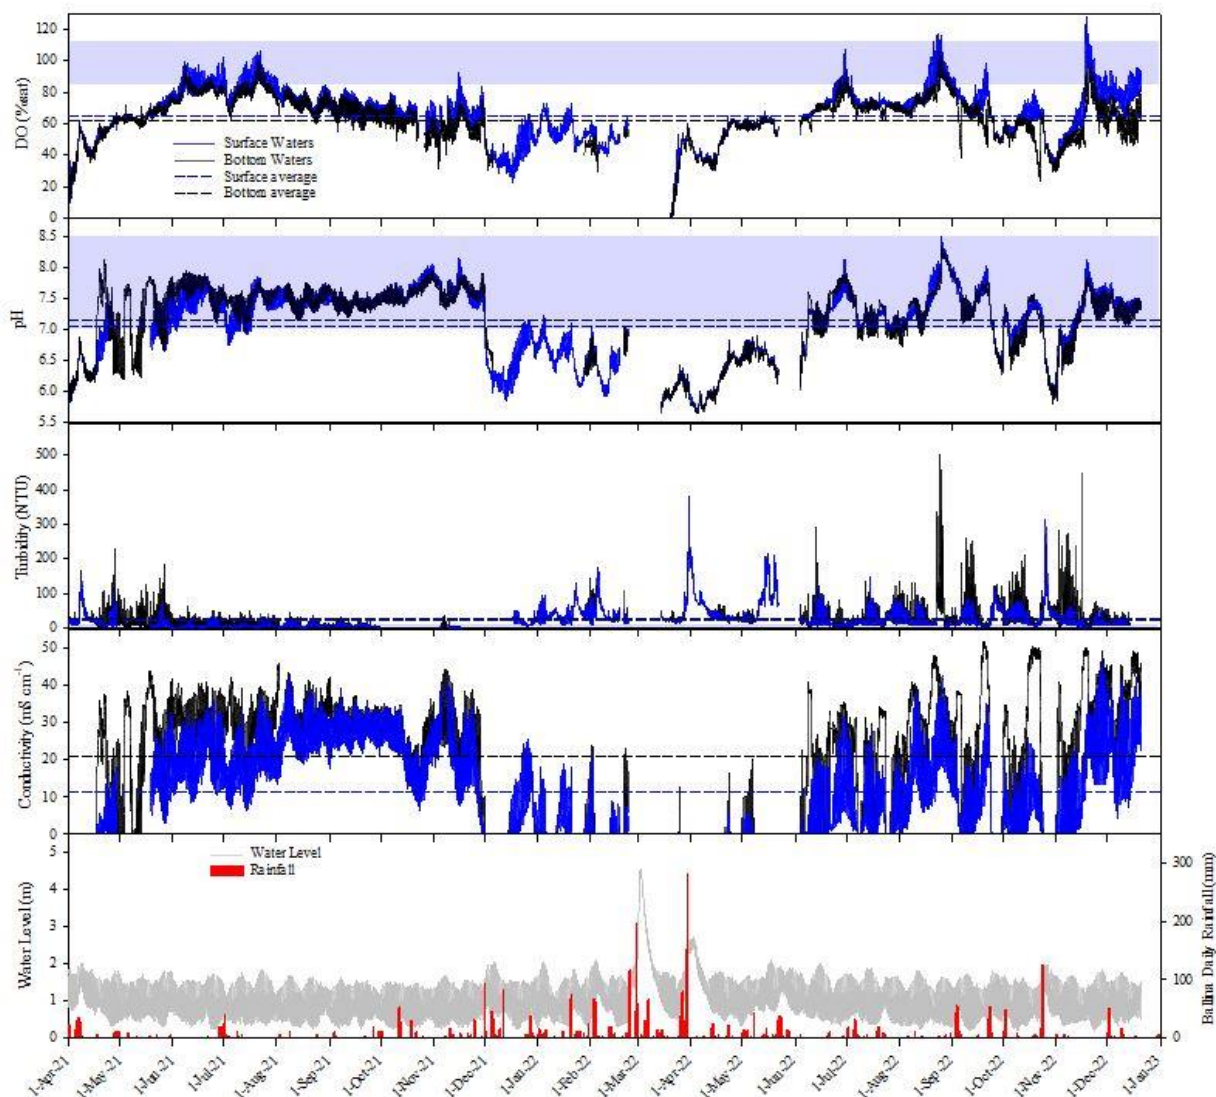
Figure 17 EC, DO, pH and Turbidity at Wardell. Blue shaded area represents the ANZECC guideline range for slightly disturbed Estuaries in south-east Australia.

The timeseries data is presented in Figure 17 and Figure 18.

- Floodplain discharges heavily influence water quality during wet periods
 - The river is routinely flushed fresh during the wet periods
 - ⇒ DO and pH drop considerably as the poor water upstream discharges from the system

- ➔ DO dropped to ~10 % sat in April and December 2021 and 30% in October and November 2022
 - ➔ Anoxic during the major blackwater event
 - ➔ pH of ~ 5.6 occurred following floods in March and October 2022

- During the dry period DO and pH are relatively stable (e.g. June through November)
 - pH is generally within ANZECC guidelines during this time
 - The ~ 15% of the time DO is within ANZECC guidelines occurs during dry periods

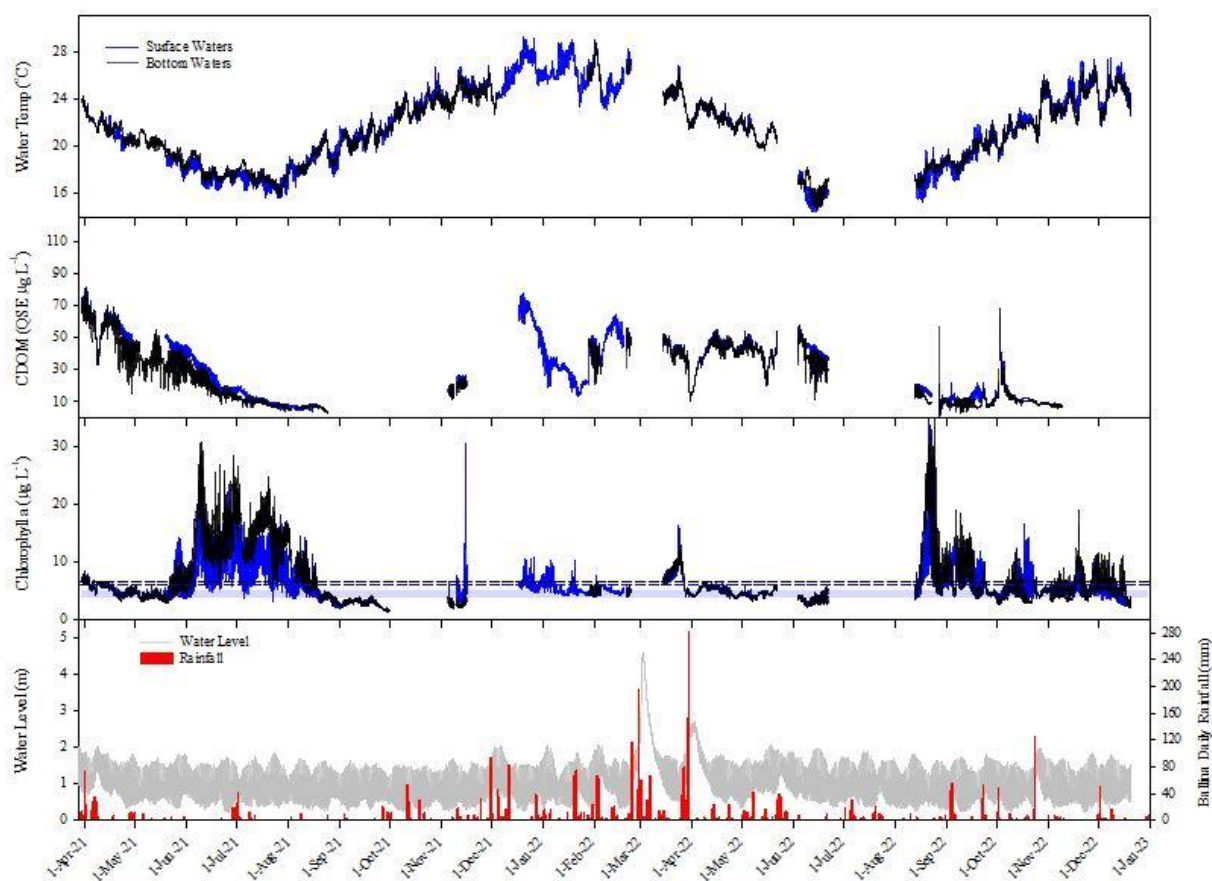
Figure 18 Water temperature, CDOM, and Chlorophyll a at Wardell. Blue shaded area represents the ANZECC guideline range for slightly disturbed Estuaries in south-east Australia.

- Stratification of surface and bottom waters can display a spring-neap tidal trend with stratification becoming more pronounced during neap tides – this trend was most prevalent during the dry period (May to September)

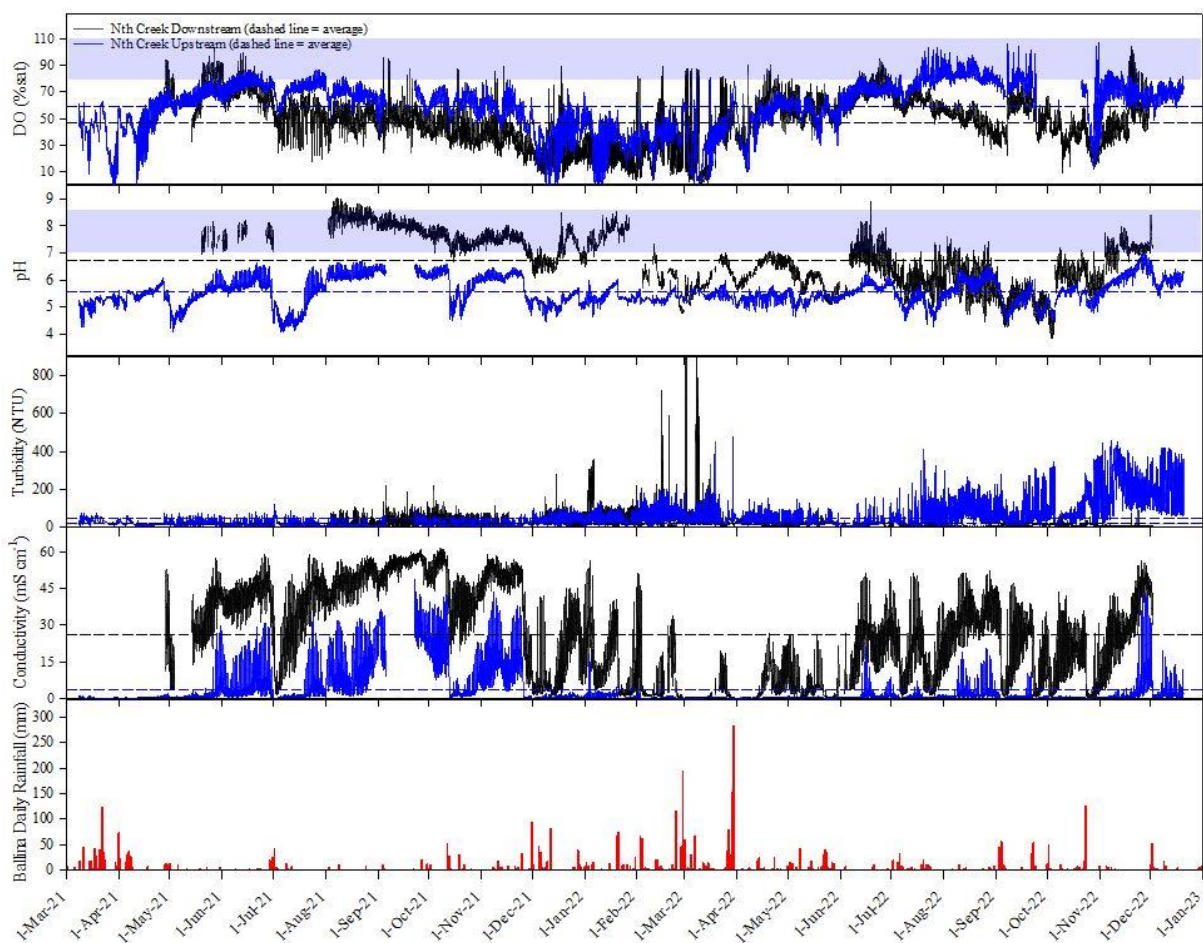
Figure 19 EC, DO, pH, turbidity and water temperature at the North Creek sites. Blue shaded area represents the ANZECC guideline range for slightly disturbed Estuaries in south-east Australia.

- Downstream site is buffered by marine waters, thus within ANZECC guideline ~40% of the time
 - ⇒ pH dropped to 3.8 in October 2022 which is lower than the lowest value observed at the Upstream site (4.1)
