# EMIGRANT CREEK DAM

## DAM TECHNOLOGY...

## Technical Specifications

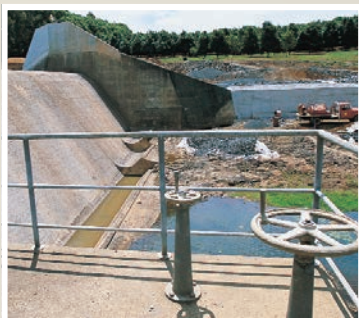
This shape is so that when there has been so much rain that the water level in the dam is higher than the crest level of the spillway, it will flow smoothly over the spillway. This reduces the chances of a flood washing the dam away or damaging land on either side of the dam. The land

The embankment that forms the majority of the dam wall consists mainly of rock and soil. The spillway, which provides for controlled release of water from the dam, consists mainly of concrete and steel. Together, the dam wall and spillway is made of about 6,000 tonnes of rock, soil, concrete and steel. (That's over 1000 concrete trucks full!) The spillway is shaped with a vertical wall on the 'full' side of the dam and a 68 degree slope on the 'downstream' side. The shape of the top of the spillway is a pointed curve called an 'ogee'.

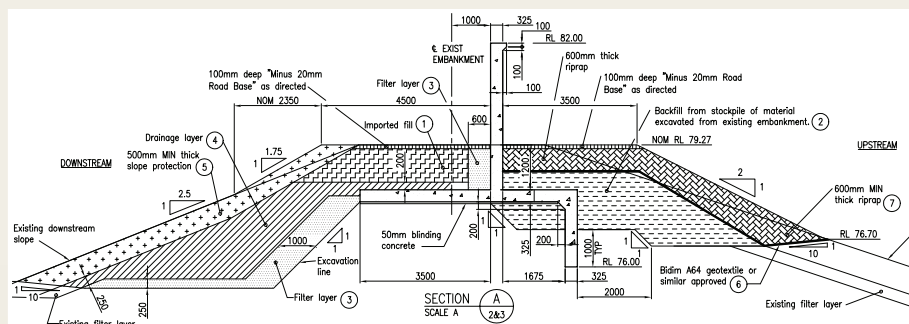
### Emigrant Creek Dam Cross-section of Upgrade Embankment

The **embankments** on either side of the spillway were raised, so that water would flow over the spillway rather than over or around the dam wall embankments.

This was achieved by constructing concrete side walls to increase the depth of flow over the spillway before the embankments are overtopped. The dam and spillway are now capable of passing the floodwaters that would occur during the level of the 'Probable Maximum Flood'. This work was completed in 2001.

**Reinforcing** the spillway with vertical steel rods that are drilled through the concrete. There are 48 rods, placed less than a metre apart. Each rod is 7 metres long, and reaches from the top of the wall into the concrete.

**Anchoring** the spillway to the 'bedrock' that lies approximately 30 metres below the creek bed. This was done by drilling 18 steel rods through the dam wall, between the floor of the gallery and into the bedrock below the dam wall. This makes the length of each anchoring rod about 50 metres.

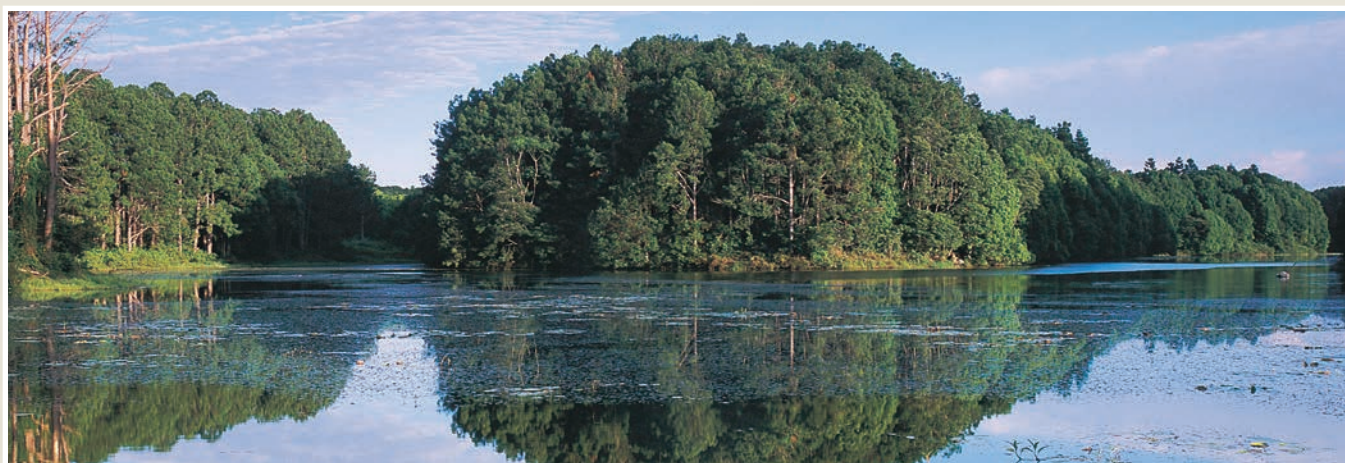
Water is released through the dam for environmental flow purposes via a 375 mm **scour valve**. The rate at which this scour valve releases water downstream is dependent upon how far the valve is opened. The outflow has been calibrated so that Rous County Council knows how much water is being released downstream based on how far the valve is opened – this release is adjusted manually.

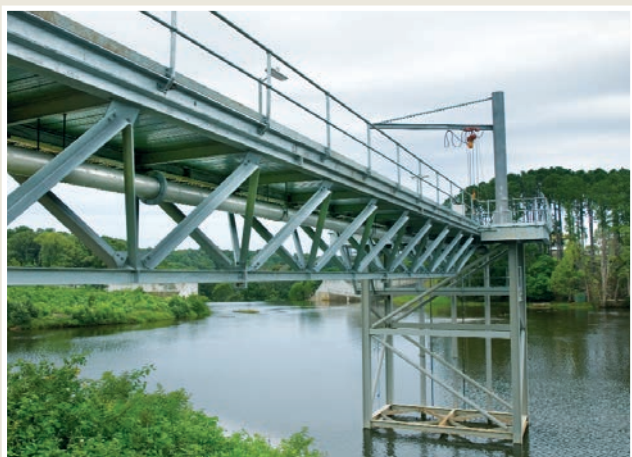
The raw water intake structure on the western side of the dam.

The location of the raw water intake and pump station is on a jetty-like structure extending out into the water from the treatment plant site which is on the peninsula on the western side of Emigrant Creek Dam. The raw water pump station includes provision for pumping water at two different levels of the dam. Water is pumped at sufficient flow rates that allow the membrane filtration plant to produce a net throughput of 7.5ML/day and 25% less in the winter months.
