Richmond Ecohealth Project 2014

Assessment of River and Estuarine Condition

Final Technical Report

June 2015

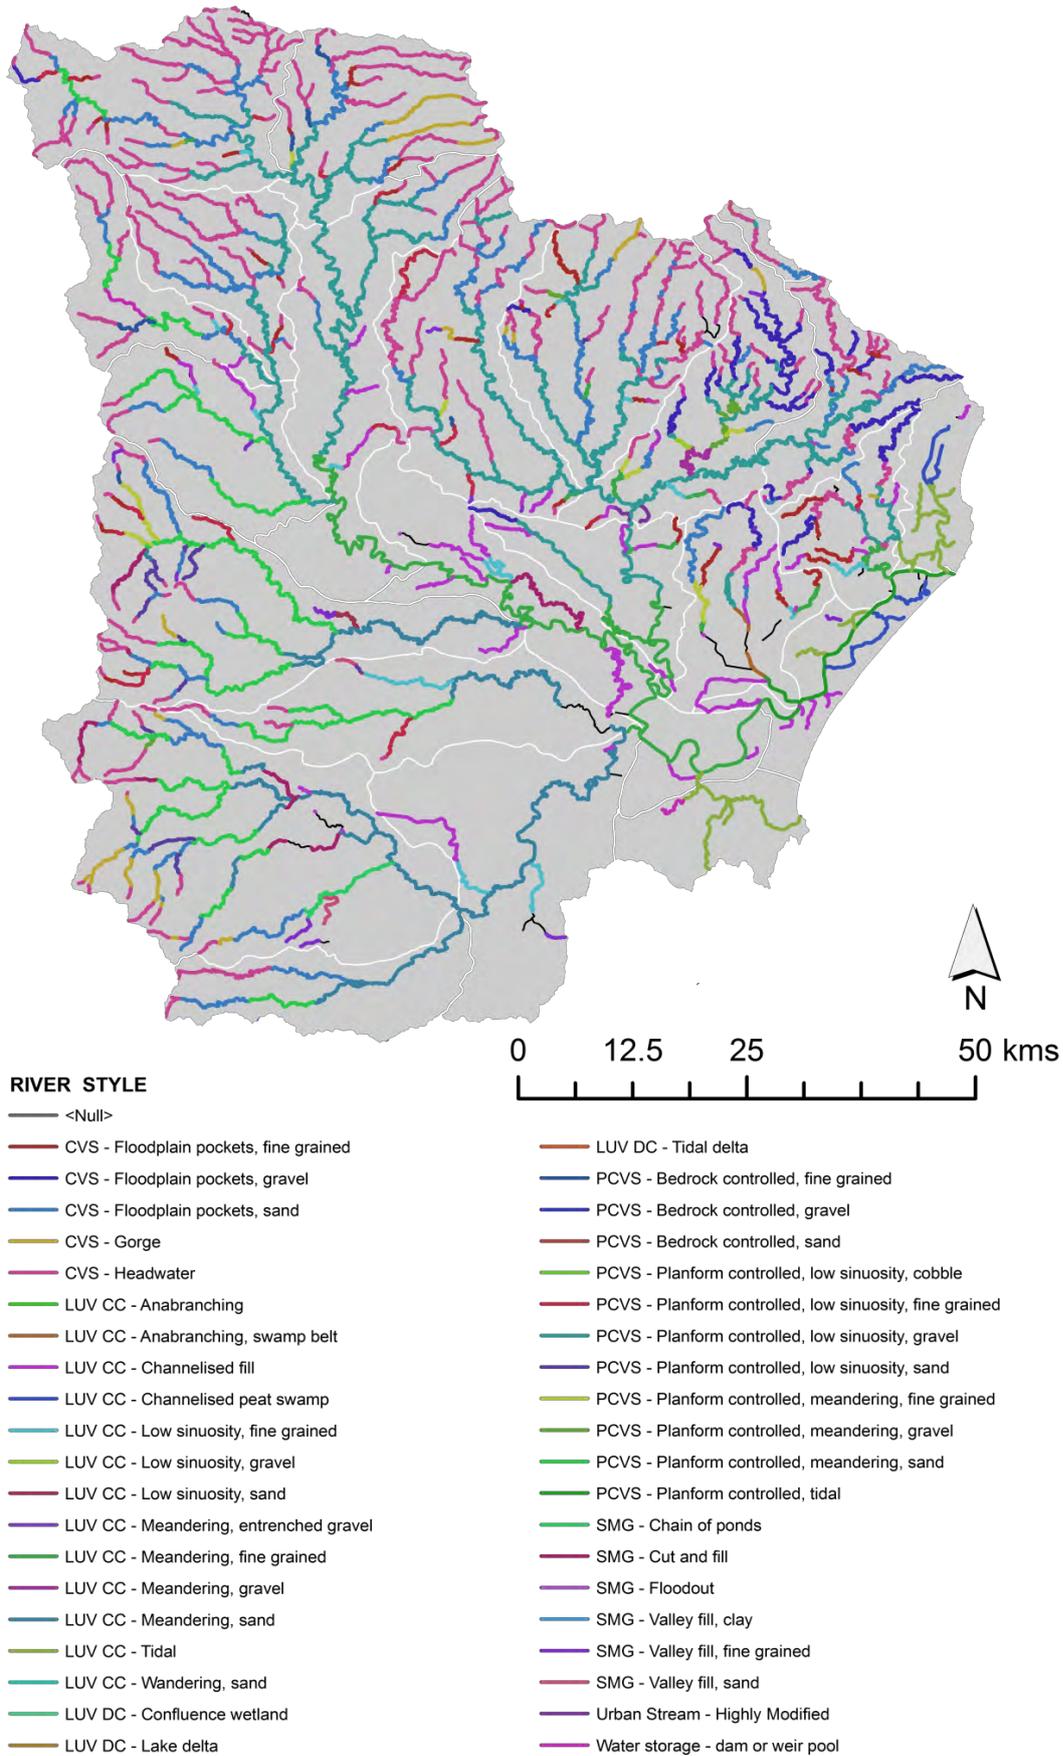
Figure 2.5 River Styles of the Richmond catchment.

Confined valley settings (CVS) account for 42% of the total stream length in the Richmond Catchment, followed by partly confined valley setting (PCVS, 32%), laterally unconfined valley setting – continuous channel (LUV CC, 23%) and swampy meadow group (SMG, 3%). Approximately 1% of the catchment's stream channels have not been classified (Figure 2.5). Of the total stream length, 18% are considered to be in good condition, 59% in moderate condition and 23% in poor condition. The stream channels in good condition are dominated by headwaters (67%) and meandering sand-bed channels (10%), while the stream channels in poor condition predominantly comprise planform controlled, meandering sand-bed channels (25%) and channelized fill (19%). The majority of the upper reaches of the Richmond main stream is planform controlled, low sinuosity gravel-bed, while the lower reaches and estuary comprise laterally unconfined, meandering, fine-grained channels (Figure 2.5).

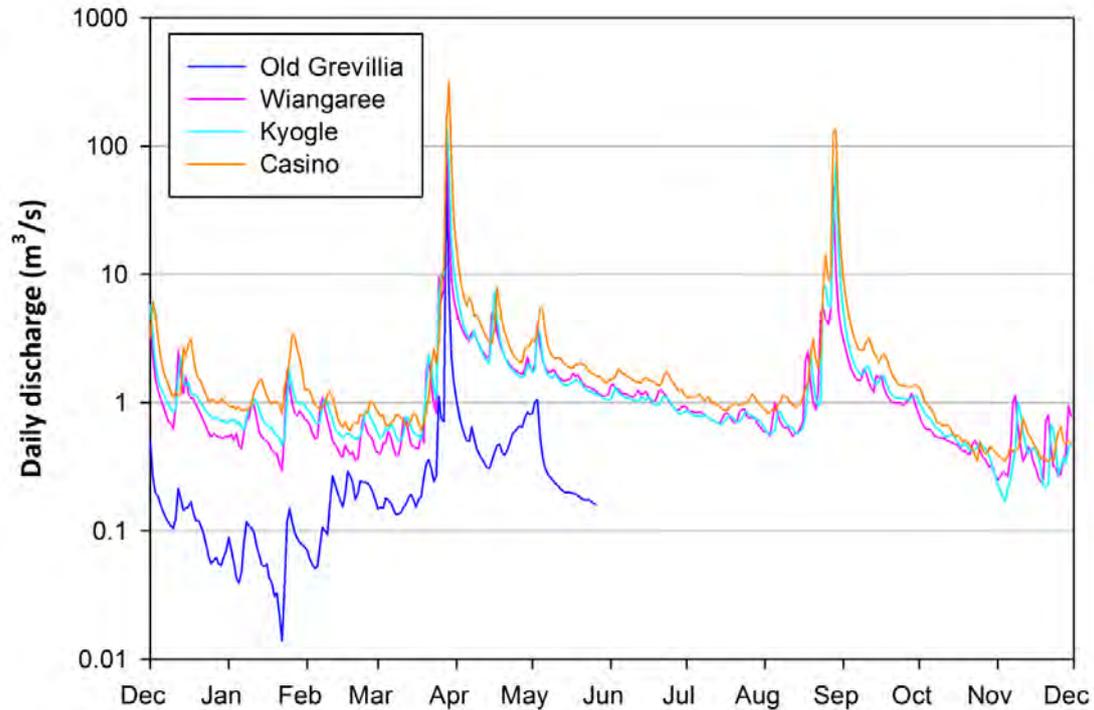
Figure 2.7 Daily discharge (m^3/s) in the Richmond River longitudinally downstream from Old Grevillia (gauge 203056), Wiangaree (gauge 203005), Kyogle (gauge 203900) to Casino (gauge 203004) from 1 December 2013 to 30 November 2014 (data from NSW Office of Water).

Daily discharge at Old Grevillia, Wiangaree, Kyogle, and Casino reflected the variable rainfall for the Richmond Catchment (Figure 2.7). The highest mean monthly discharge of 1676.7ML/d ($19.4 \text{ m}^3/\text{s}$) was recorded at Casino in March; this was only half the long term average for March (Figure 2.8). The lowest mean monthly discharge of 39.7ML/d ($0.46 \text{ m}^3/\text{s}$) for Casino was recorded in November. Discharge data for the upper Richmond at Old Grevillia is not available for dates after the 26th of May 2014. However, the highest mean monthly discharge for the first 6 months of sampling was 240.5ML/d ($2.78 \text{ m}^3/\text{s}$) recorded in March, with the lowest discharge of 6ML/d ($0.069 \text{ m}^3/\text{s}$) in January. The highest mean monthly discharges for The Richmond River at Wiangaree and Kyogle were 696.8ML/d ($8.06 \text{ m}^3/\text{s}$) and 834.1ML/d ($9.65 \text{ m}^3/\text{s}$) respectively, both recorded in March. The lowest mean monthly discharge for Wiangaree and Kyogle was 39.2ML/d ($0.454 \text{ m}^3/\text{s}$) and 34.2ML/d ($0.396 \text{ m}^3/\text{s}$) respectively, both recorded in November. These rainfall and discharge data demonstrate the below-average rainfall and resulting reduction in discharge throughout the sampling period. There were two significant peaks in both rainfall and discharge in March and August 2014 (Figure 2.9).

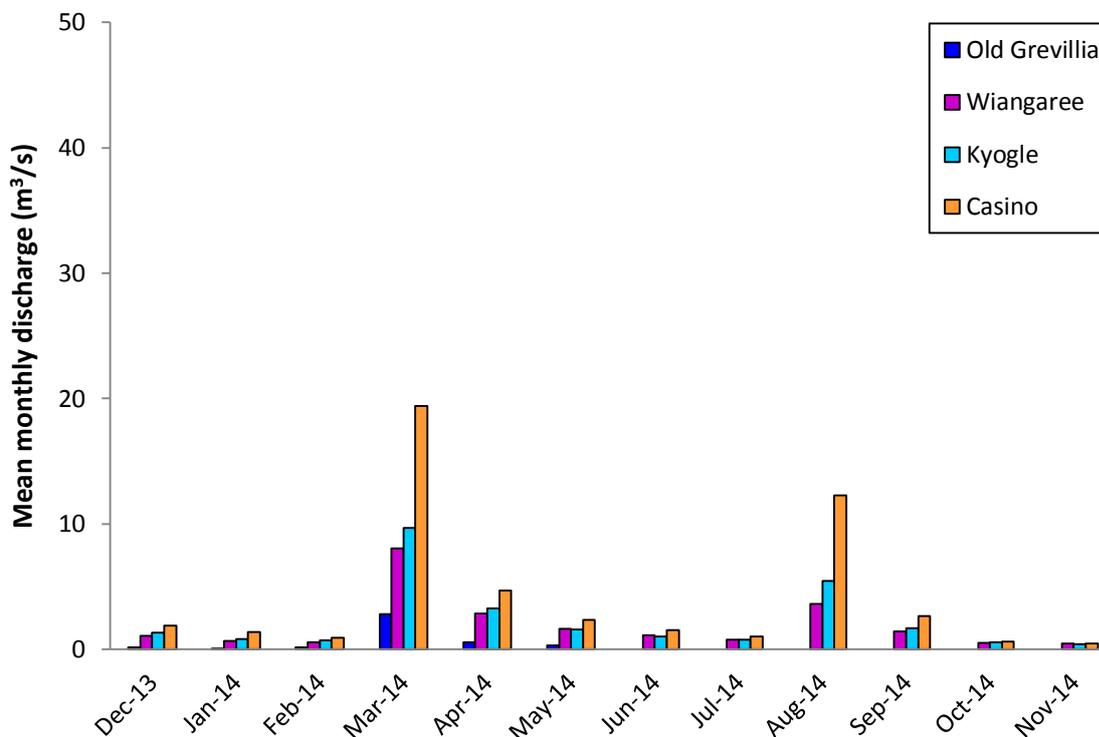
Figure 2.9 Mean monthly discharge (m³/s) for the sampling period in the Richmond River longitudinally downstream from Old Grevillia (gauge 203056), Wiangaree (gauge 203005), Kyogle (gauge 203900) to Casino (gauge 203004, NSW Office of Water).

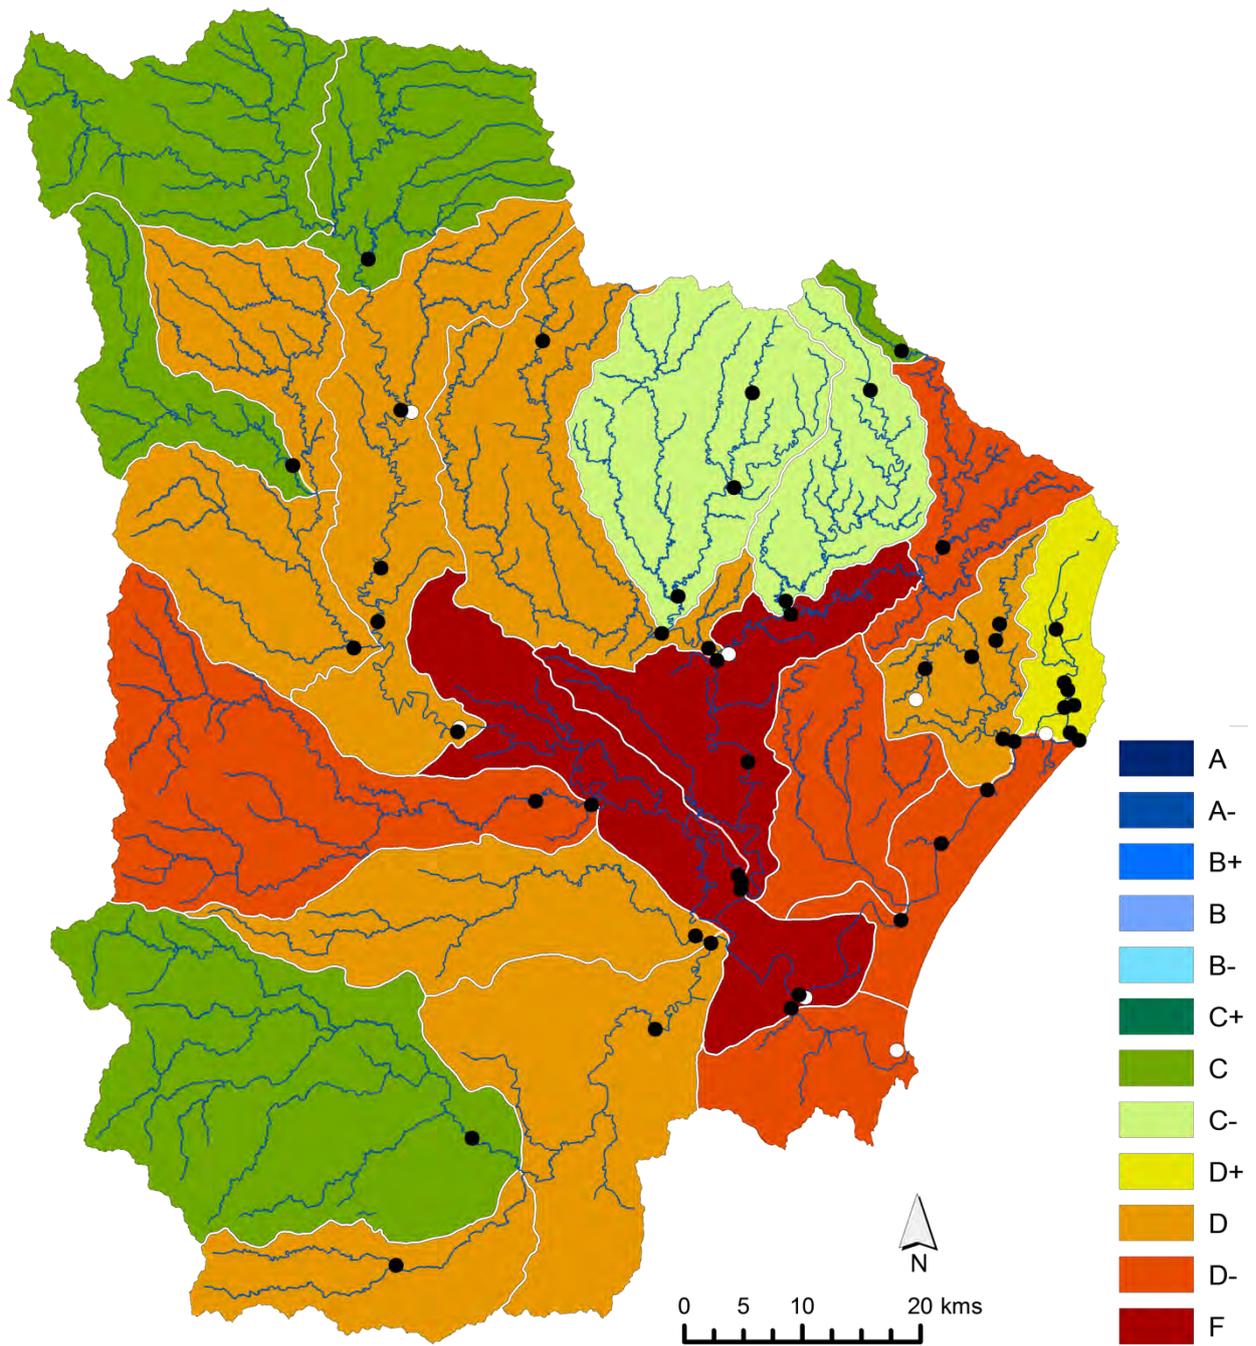
Figure 3.1 Overall Ecohealth grades for subcatchments in the Richmond.

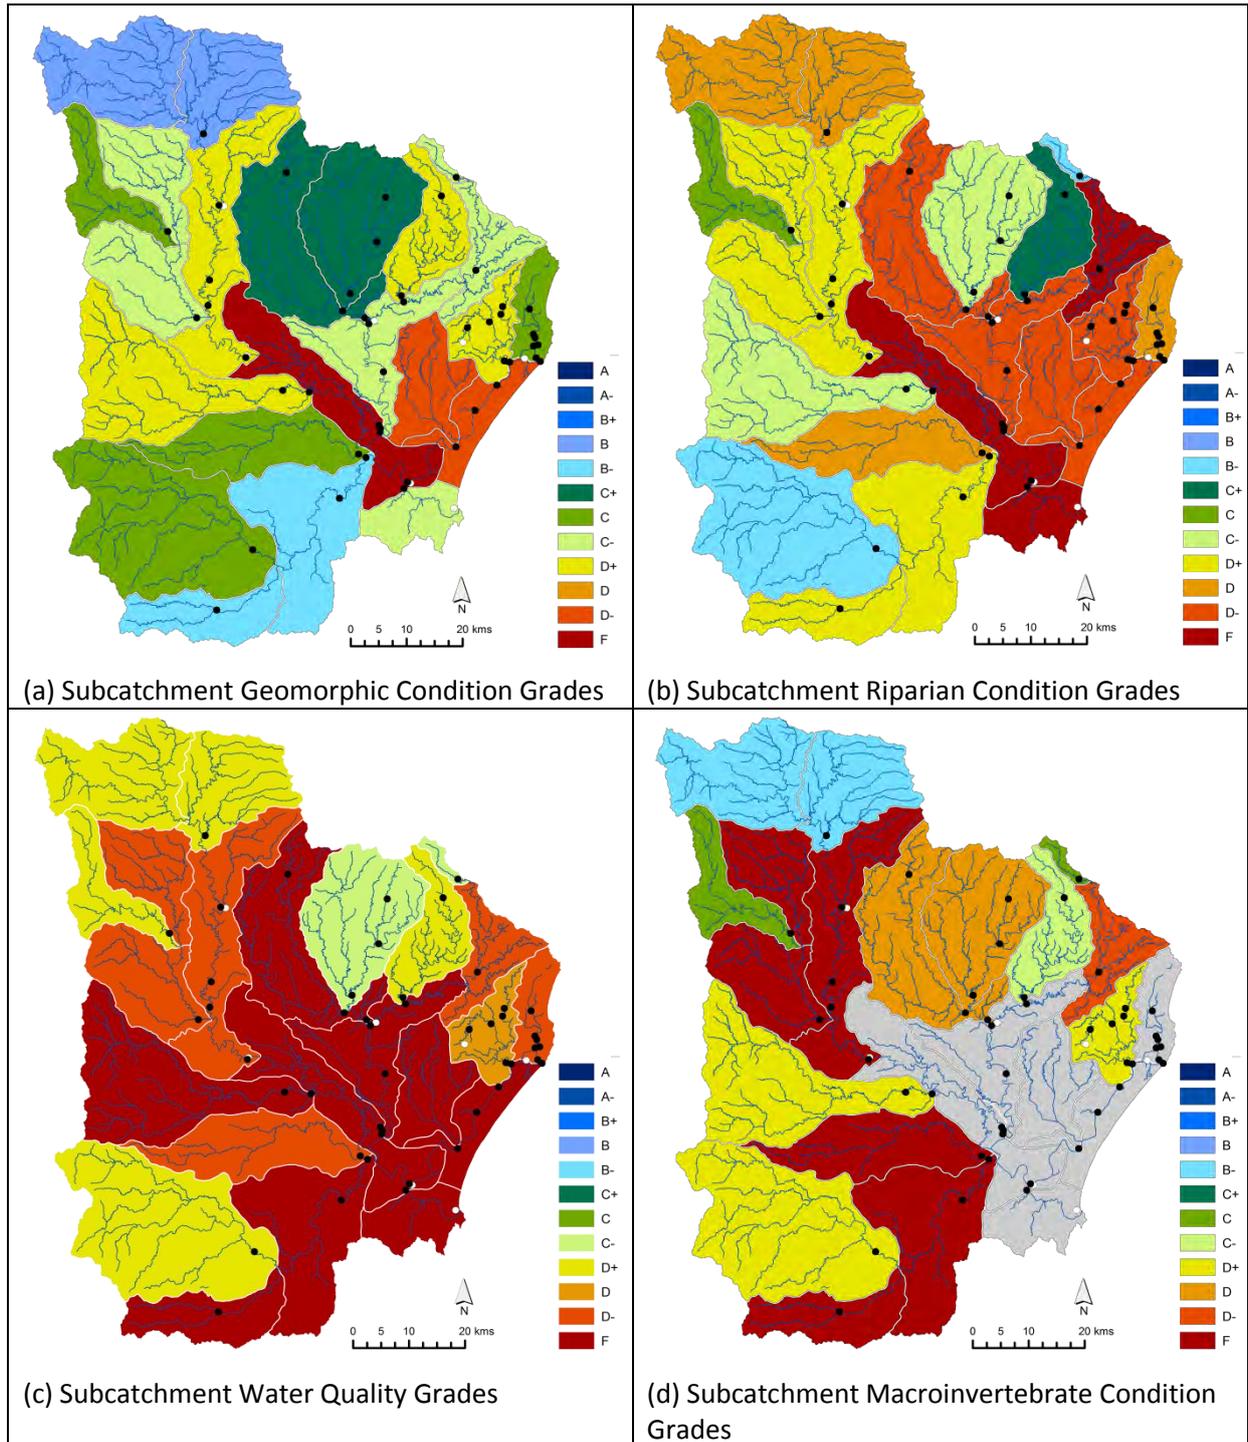
Figure 3.2 Subcatchment Ecohealth grades for (a) geomorphic condition, (b) riparian condition, (c) water quality and (d) aquatic macroinvertebrate communities. Aquatic macroinvertebrate communities were not assessed for estuarine reaches (greyed areas).

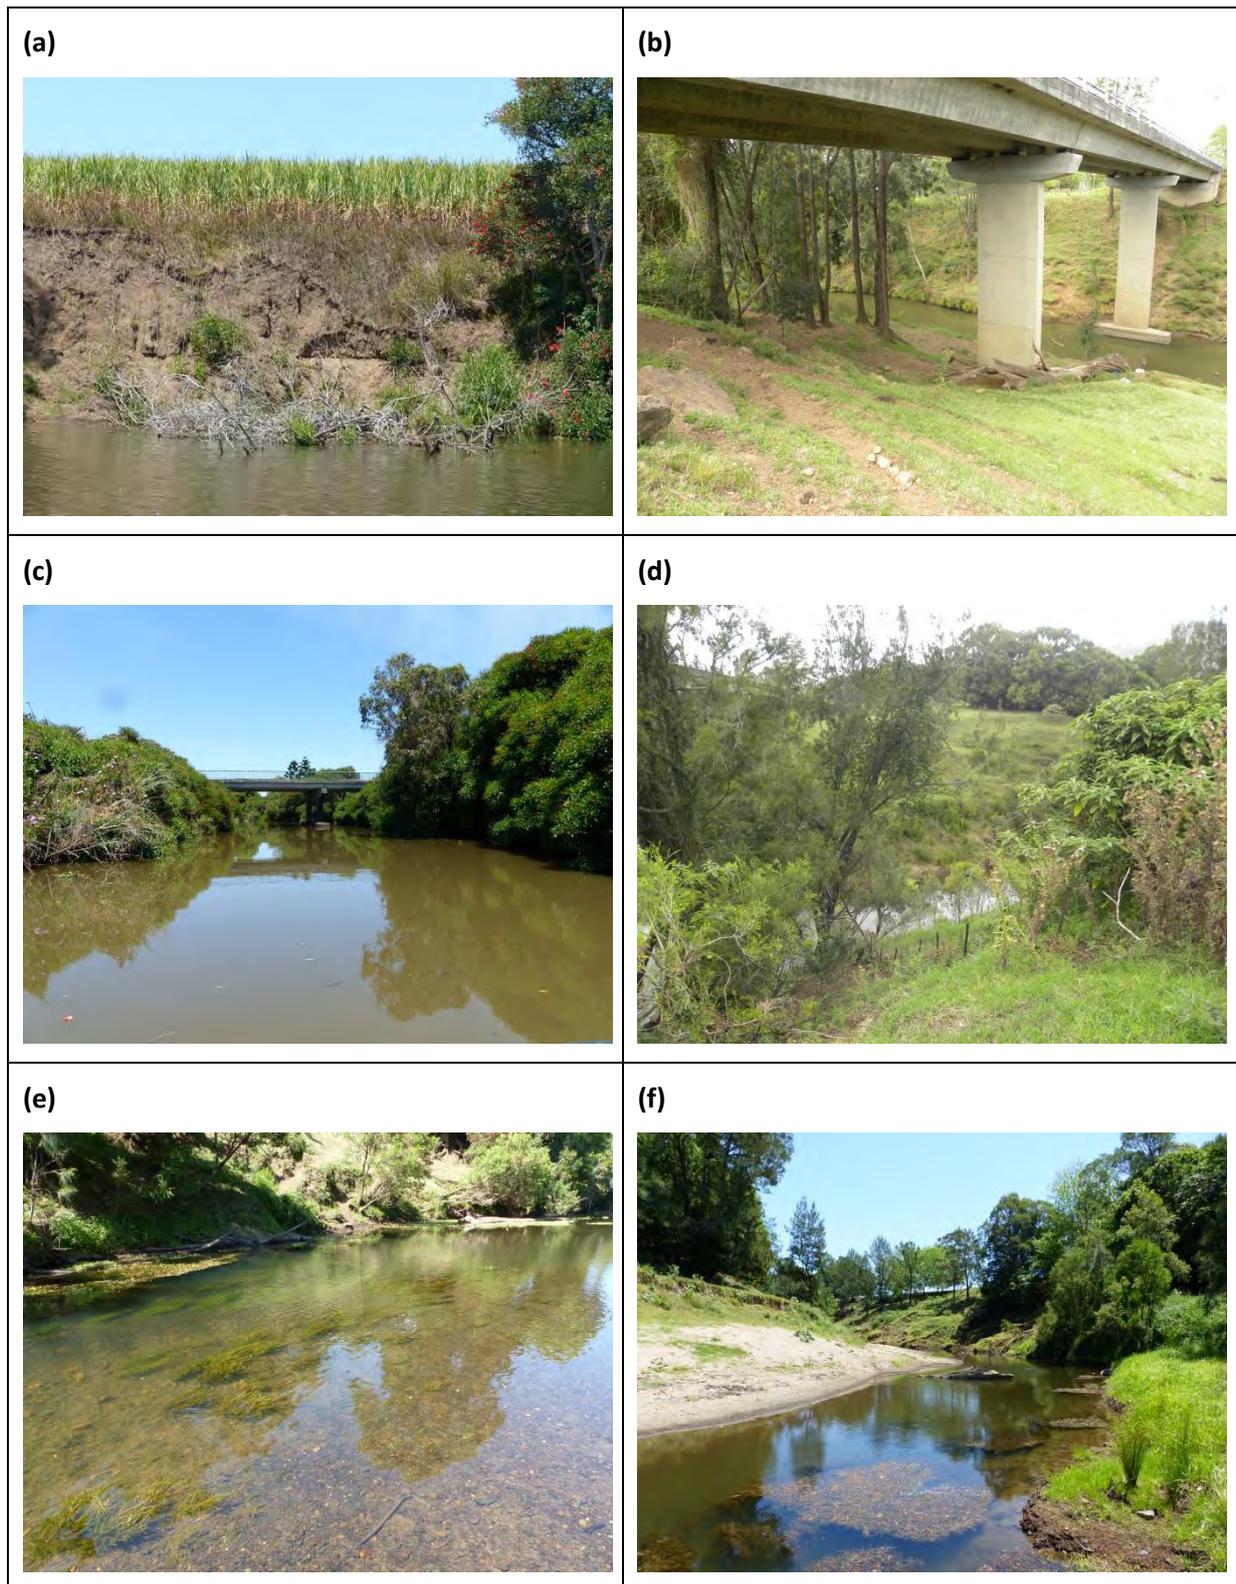
Figure 3.3 Sites on the Richmond Main Stem showing (a) cleared riparian zones adjacent to sugarcane crops (RR8), (b) poor geomorphic condition of banks and streambed associated with stock access (RR12), (c) dominant invasive weeds in estuarine reaches (RMC1), (d) invasive weeds in freshwater reaches (RR13), (e) good habitat for aquatic macroinvertebrate communities (RR14), and (f) poor habitat for aquatic macroinvertebrate communities (RR13).

Strongly linked to riparian condition, the active restoration of riparian revegetation as a long term action for improving geomorphic condition must be a priority in the Richmond catchment. The poor geomorphic condition is directly linked to low scores in water quality, macroinvertebrates and riparian vegetation. Improving geomorphic condition, particularly in the mid and lower (including estuary) reaches will lead to an improvement in all other indicators.

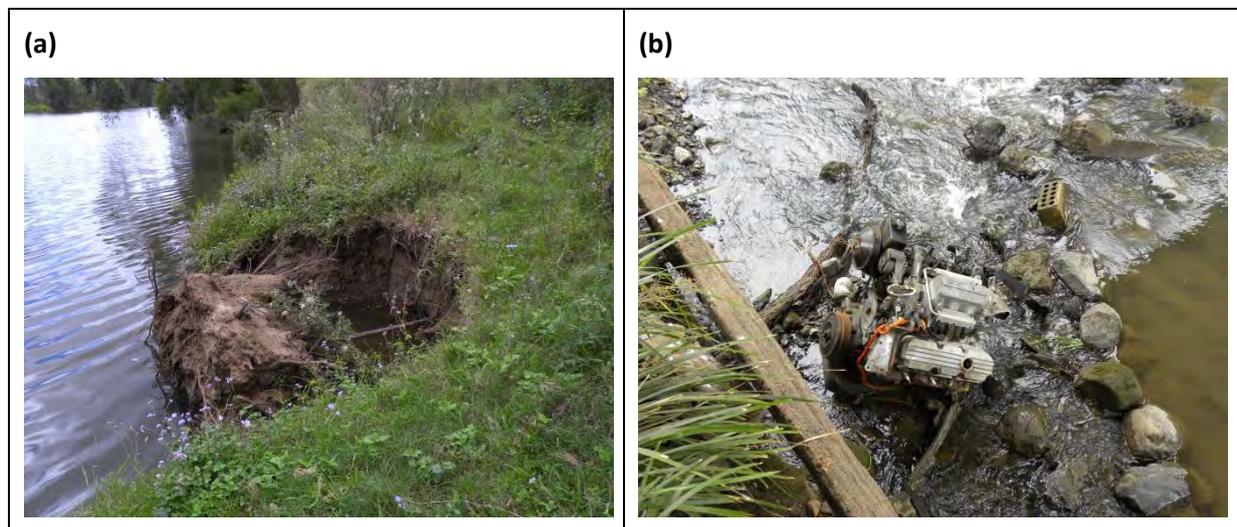
Figure 3.5 Sites on the Richmond Main Stem showing (a) localized mass failure of river banks (RR9), (b) fine-grained sediments smothering a cobble riffle (RR11).

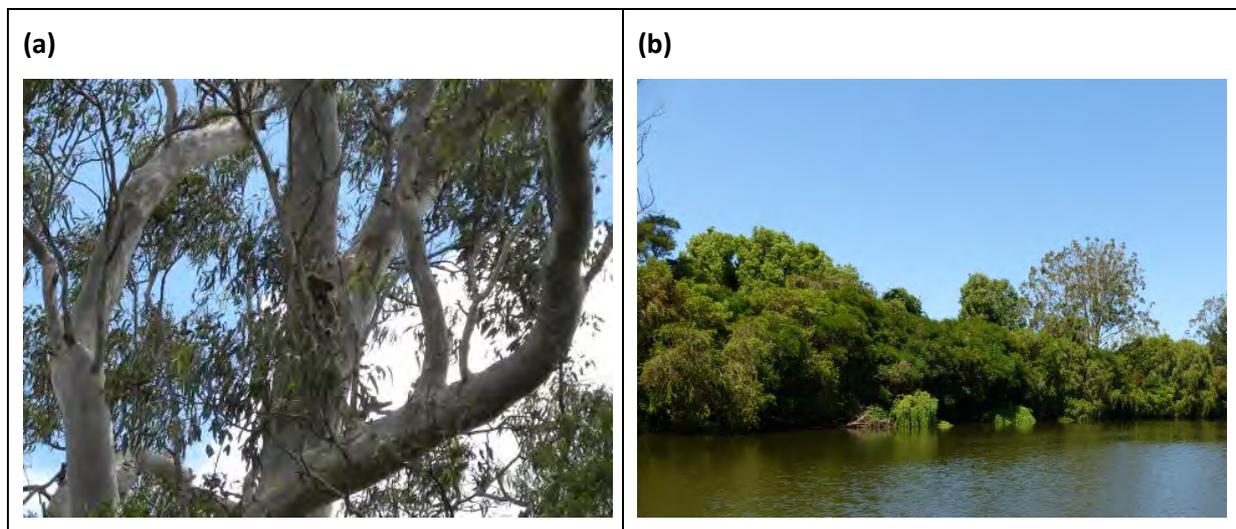
Figure 3.6 Sites on the Richmond Main Stem showing (a) mature eucalypt trees in the riparian zone provide habitat for koalas (between RR6 and RR7), (b) mature Weeping Bottlebrush are scattered through a riparian zone dominated by woody invasive weeds (between RR6 and RR7).

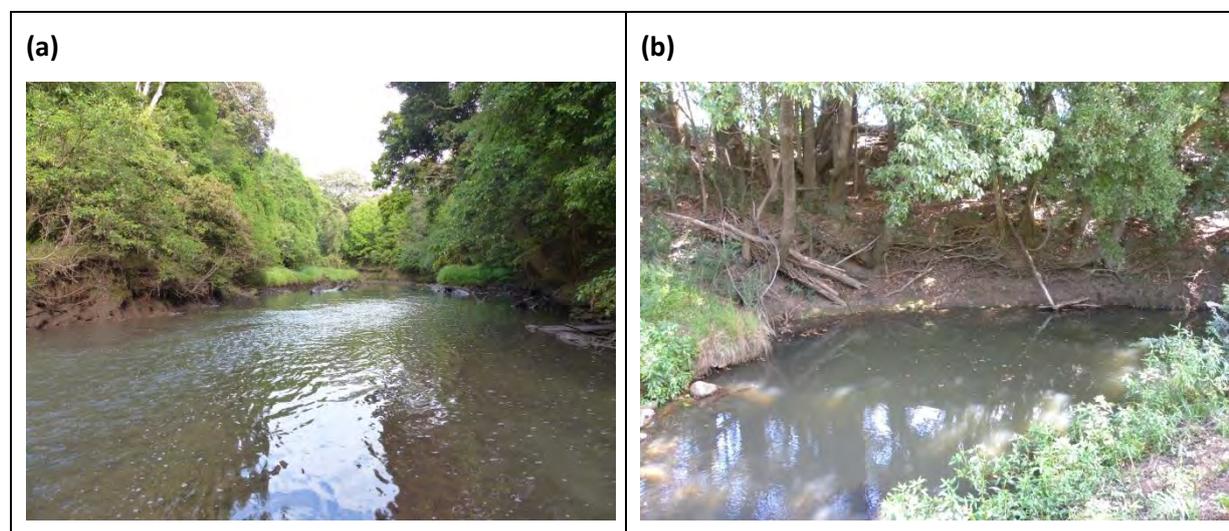
Figure 3.8 Sites in the Wilsons catchment showing (a) bank erosion and smothering of the streambed by fine-grained sediments (WR4), (b) poor bank condition at a heavily grazed site with sparse ground cover (BYC1).

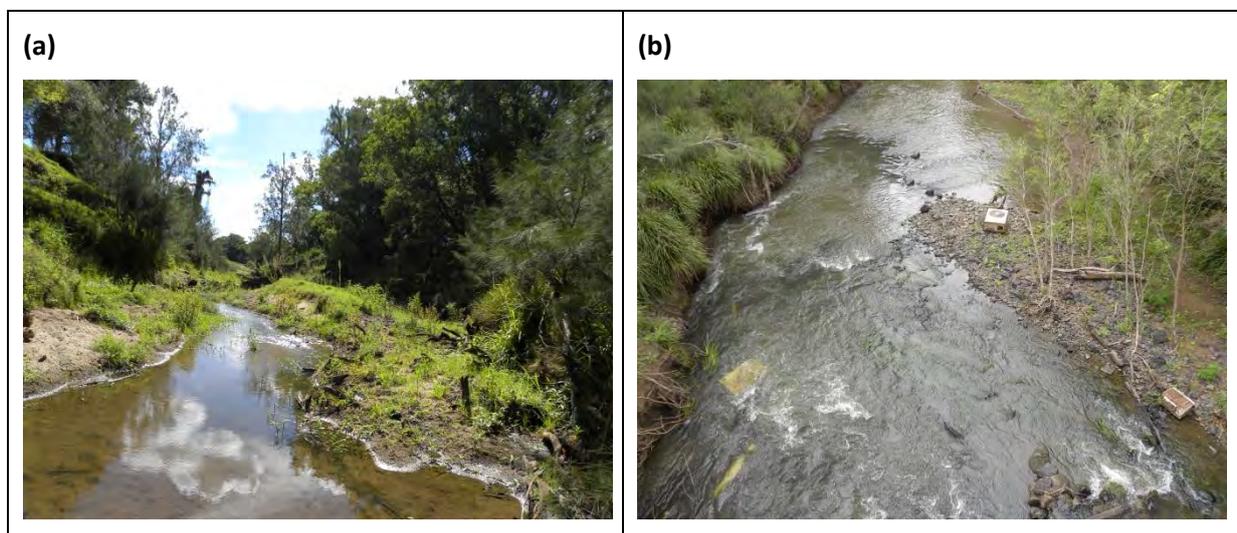
Figure 3.10 Sites in Iron Pot Creek and Shannon Brook showing (a) poor geomorphic condition due to stock access (IPC1), and (b) rubbish dumped in the channel (SB1).
