DUNOON DAM SITE

CONCEPT STAGE GEOTECHNICAL INVESTIGATION

Report No. GQ86A

Rous Water
REGIONAL WATER SUPPLY

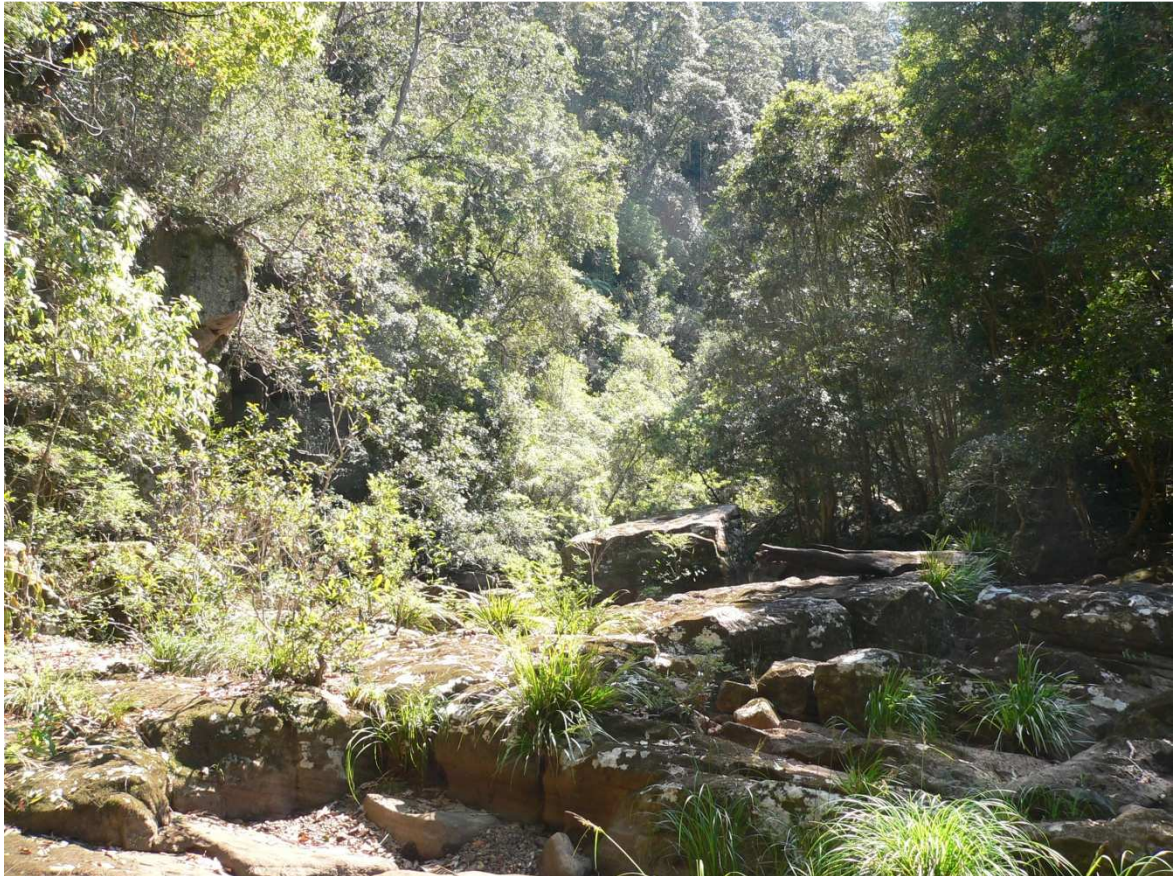
PHOTO 1 View looking up valley from downstream of the embankment toe, showing the steep right abutment. Note the sandstone exposure in the creek bed in the foreground.

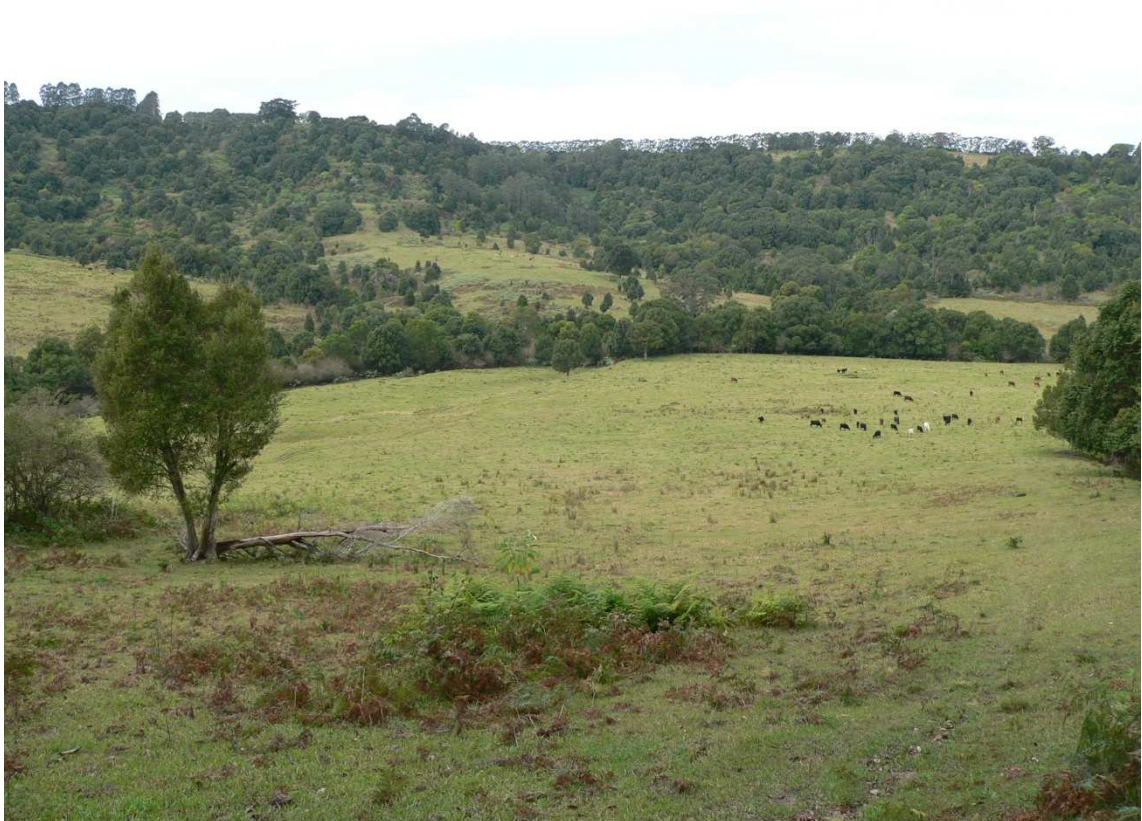
PHOTO 2 Upstream view across the right bank alluvial terrace towards a gently sloping spur in the borrow area. Note the steeper slope in the upper wooded slope in basalt.

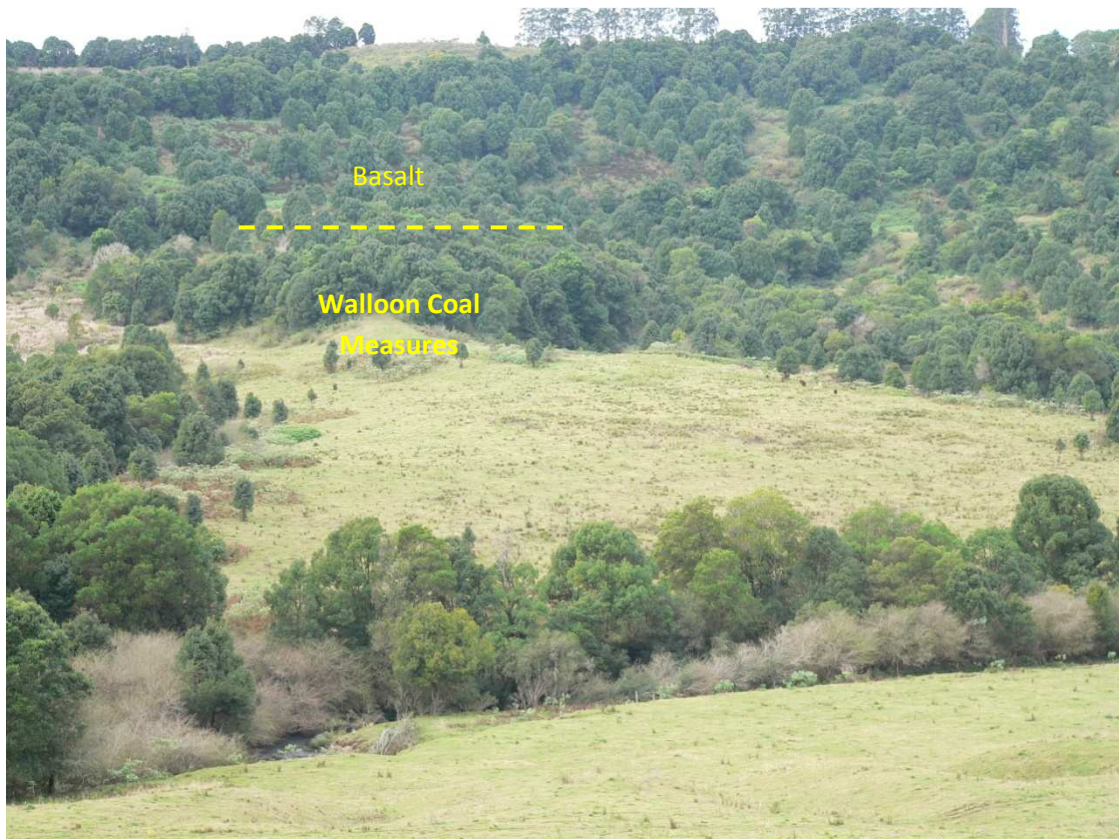
PHOTO 4 Close view of the northern borrow area spur showing steeper wooded slope in basalt.

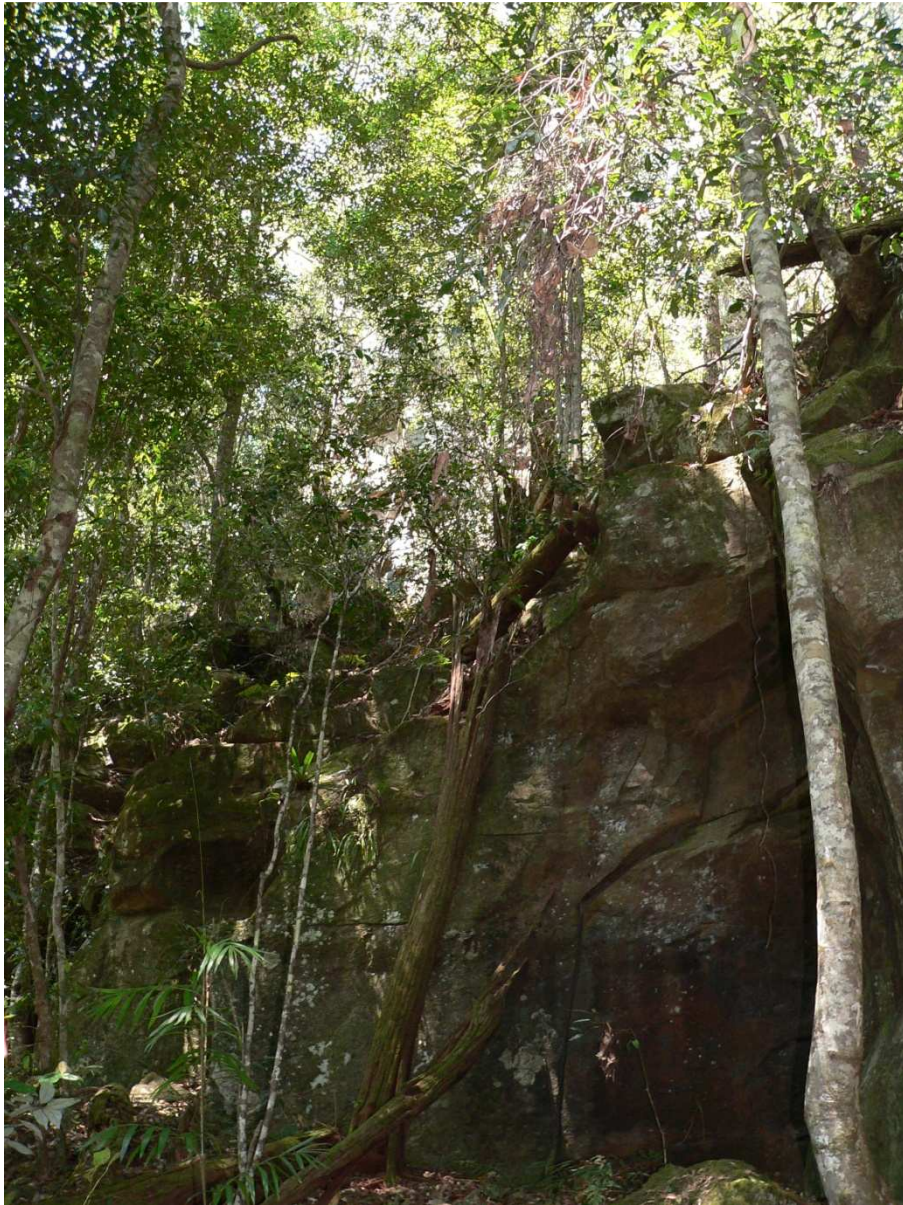
PHOTO 5 (Left) View of continuous cliff on the lower left abutment in thickly and very thickly bedded, widely jointed sandstone.

The cliff-like nature of the topography indicates that there will be high foundation steps, especially on the steeper left abutment. Near vertical foundation steps will require slope correction with concrete to a maximum batter of $\frac{1}{2}H:1V$, to allow good clay contact and avoid differential settlements in the core trench of an embankment dam. Slope correction will not be as critical for a roller compacted concrete wall; however, overhangs and negative slopes will require correction.

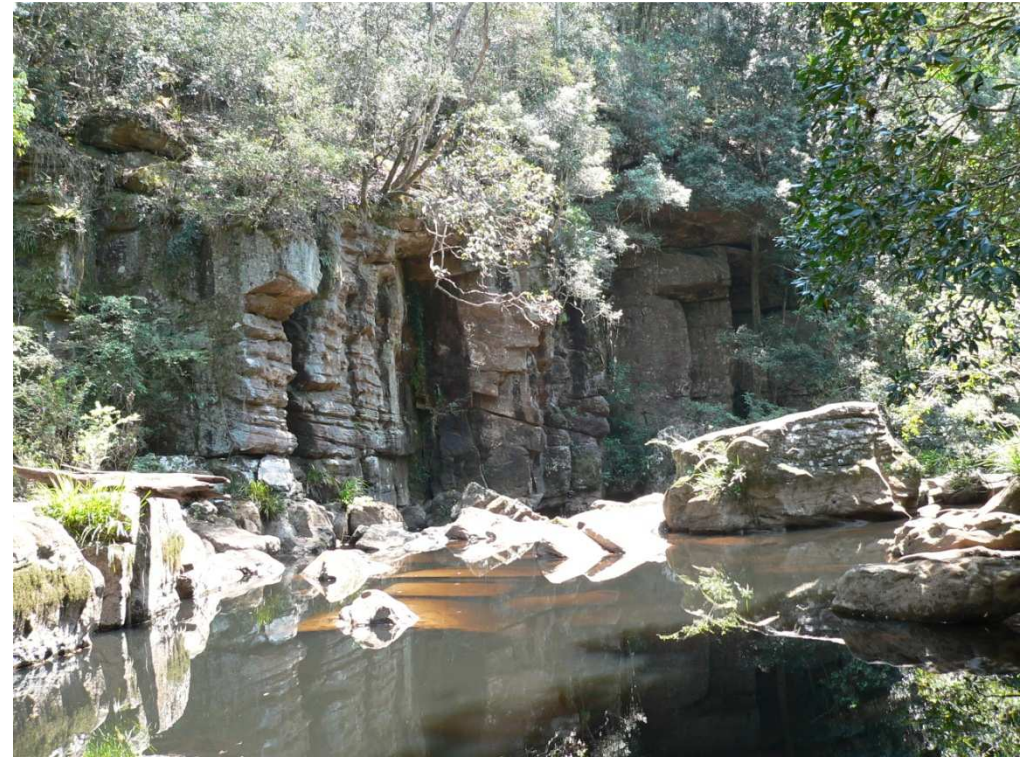
PHOTO 6 (Above) View of sandstone cliffs downstream of the embankment toe, in the vicinity of the downstream diversion tunnel portal. Note the very large boulders in the stream channel.

Joints were readily observed in outcrop downstream of the embankment site, and on the left abutment (see **Photos 6 and 9**). In exposures of Kangaroo Creek Sandstone, joints are laterally continuous for several tens of metres. However, exposures also indicate that joints are generally vertically discontinuous, and may be off-set or terminated at bedding planes. Joint patterns are interpreted to have a major influence on topography, and the direction of stream flow. Within the Walloon Coal Measures, joints could not be observed in the test pits; however, they are interpreted to be less continuous, due to the interbedded nature of the strata.

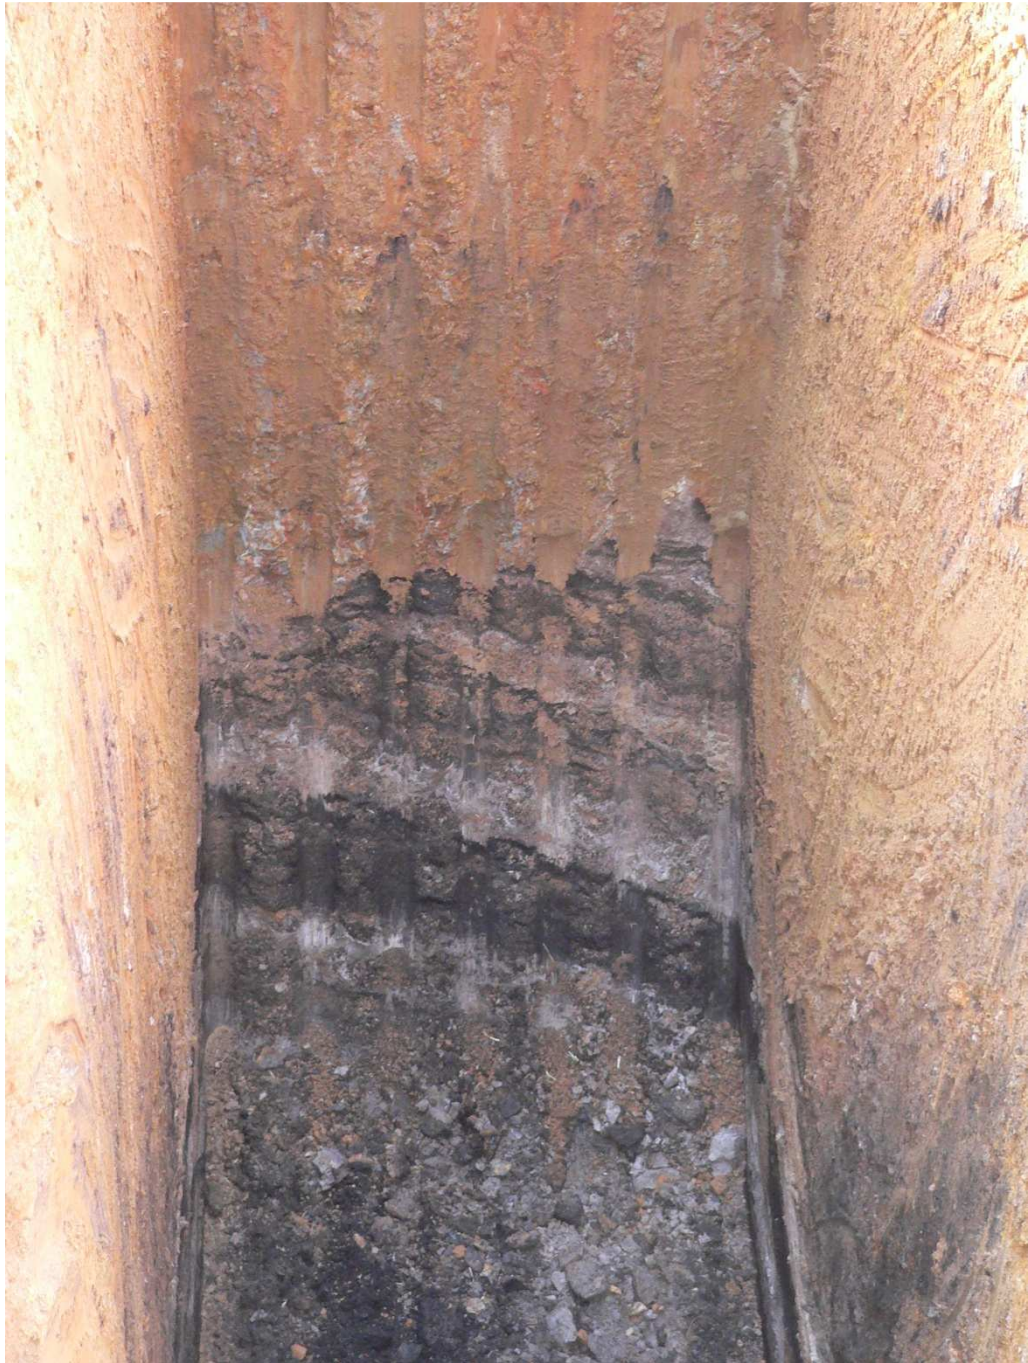
PHOTO 7 Test pit DTP 1, showing interbedded claystone, siltstone/shale and black coal of the Walloon Coal Measures. Beds dip at approximately 10° in direction 150°M .

Within the Walloon Coal Measures, partings were observed in test pits; however, their condition could not be accurately determined because of the extremely weathered nature of the rock. Based on experience of these rocks in other areas, partings are generally planar to sub-planar, and smooth to semi-rough. Partings also often have carbonaceous coatings, and have occasional laminations of coal. Thin coal seams were encountered in test pits in the borrow area (see **Appendix B**). Little is known of the continuity of bedding this geological unit; however, they are likely to be less continuous than sandstone beds in the Kangaroo Creek Sandstone. Beds are likely to be lensoidal in shape.

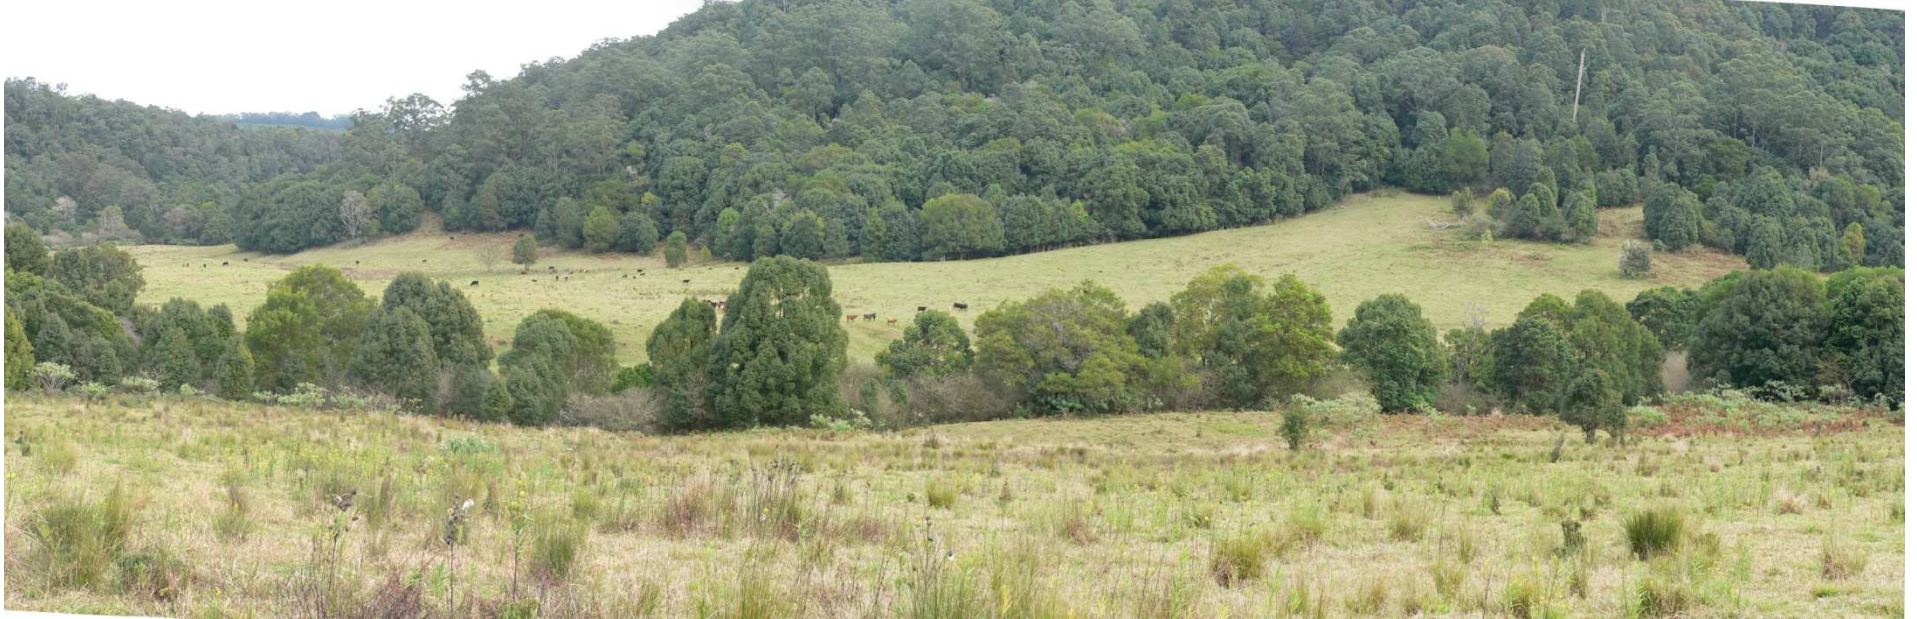
PHOTO 8 View of the alluvial terrace on the right creek bank, located immediately upstream of the dam site gorge.

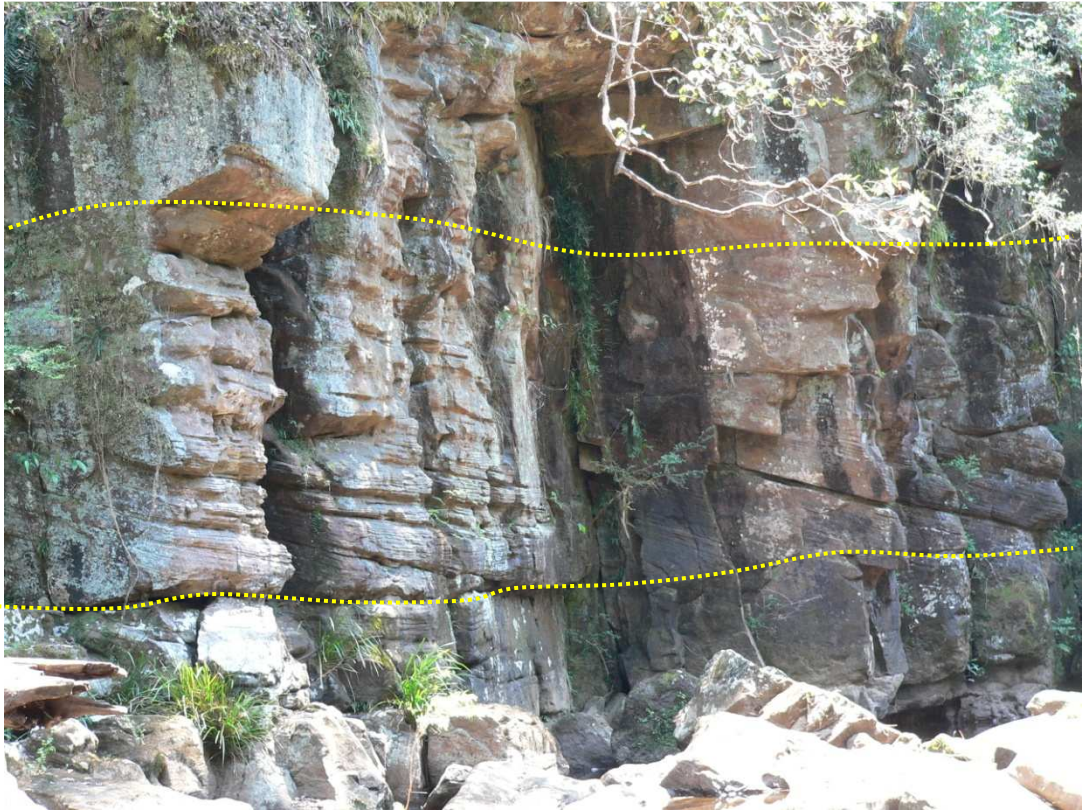
PHOTO 9 Close view of cross laminated bed in cliff face, downstream of the embankment toe, in the vicinity of the downstream diversion tunnel portal. The upper and lower surfaces of the bed are highlighted, with internal cross laminations at $\sim 15^\circ$.

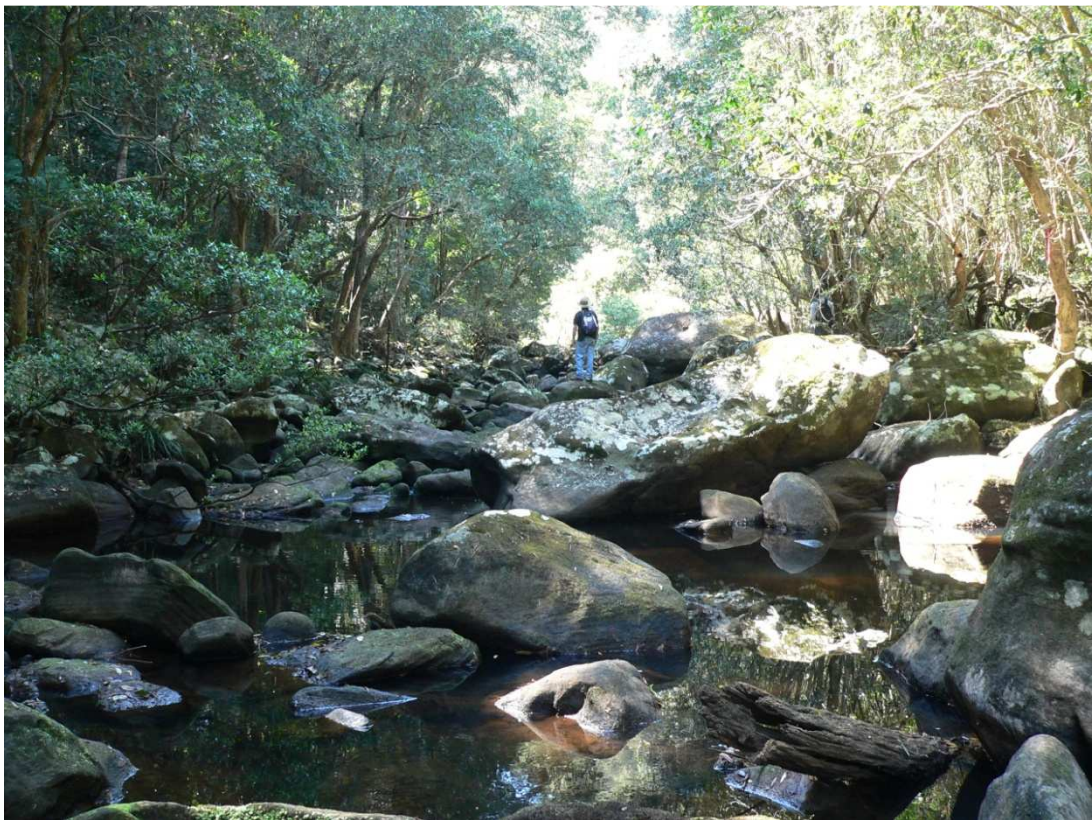
PHOTO 10 Sandstone boulders in the bed of Rocky Creek, looking downstream of the proposed embankment centreline.

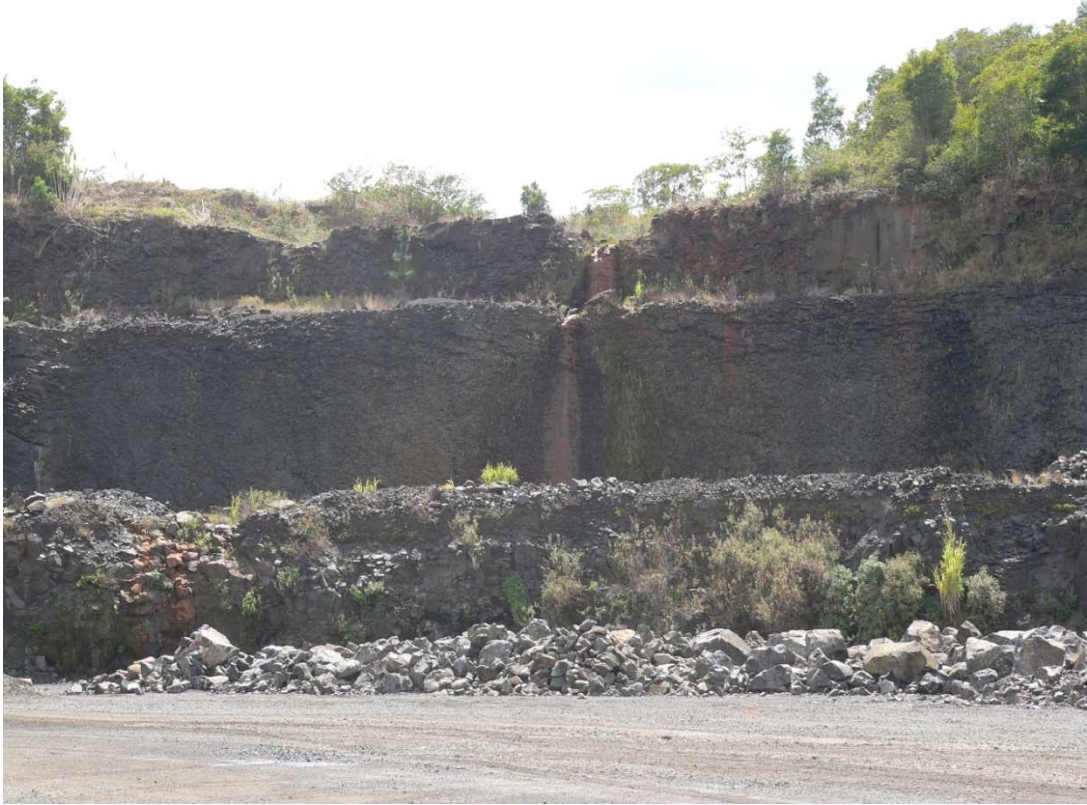
PHOTO 11 General view of faces in the basalt portion of Boral's Teven Quarry.

The quarry is located near Teven, at GR 488115 Lismore 1:25,000 sheet (9540-2-N), and is approximately 4km northwest of Ballina (see **Figure 7**). It is readily subdivided into two geologically distinct sub-areas: the basalt quarry in the east (see **Photo 11**), and an argillite quarry in the west (see **Photo 12**). The quarry is owned and operated by Boral Resources (Country) Pty. Limited.

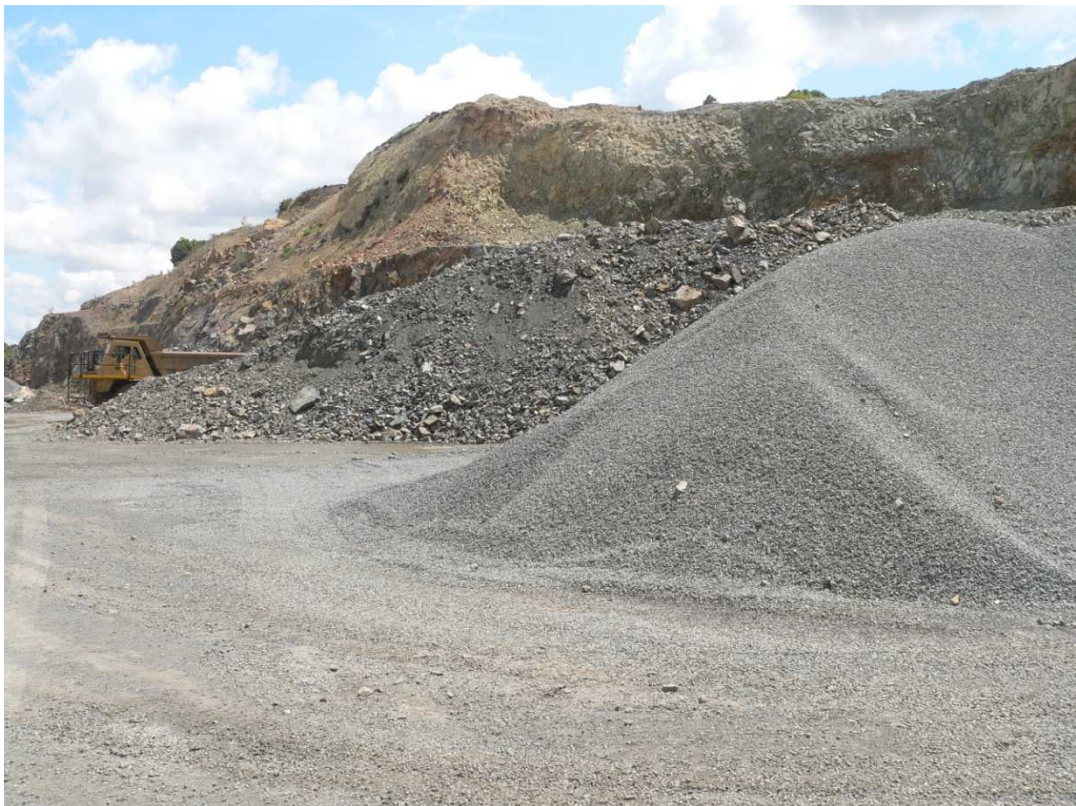
PHOTO 12 General view of faces, crushed rock and run of quarry rock piles in the argillite portion of Boral's Teven Quarry.

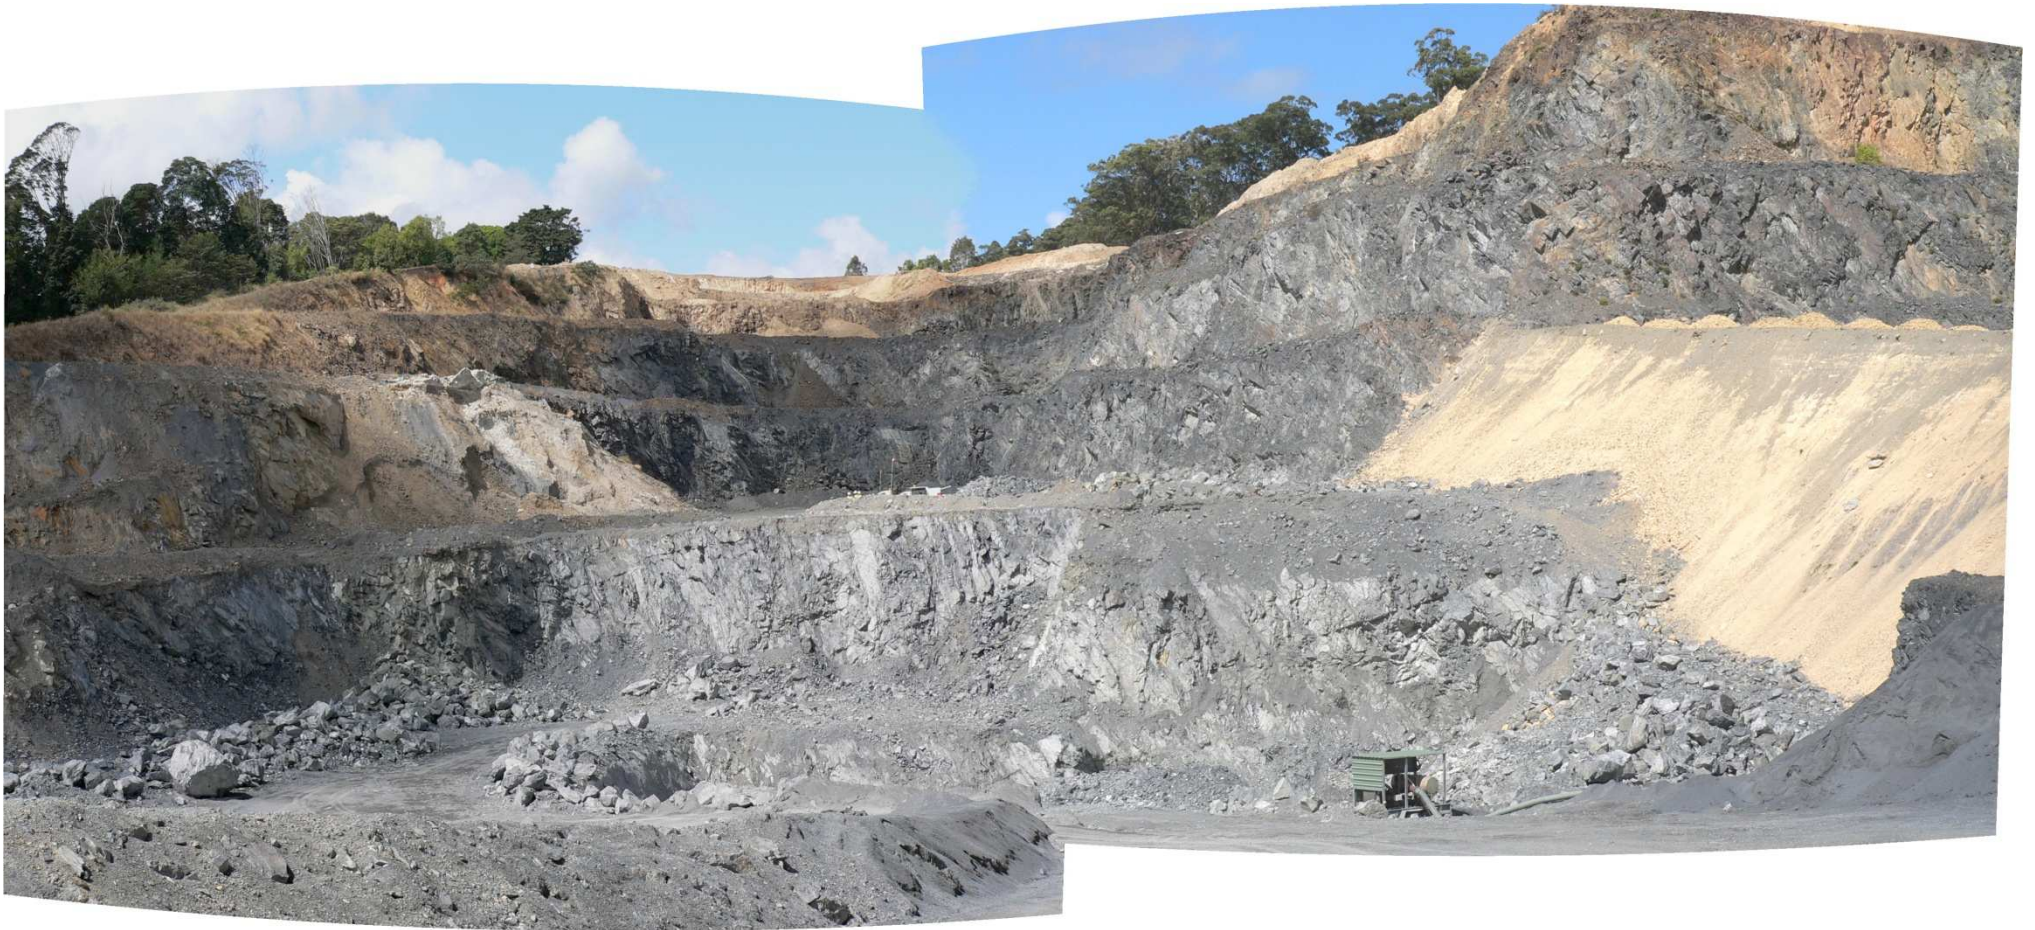
PHOTO 13 View of the main faces in Holcim's Teven Quarry, in metamorphosed argillite of the Neranleigh-Fernvale Group.

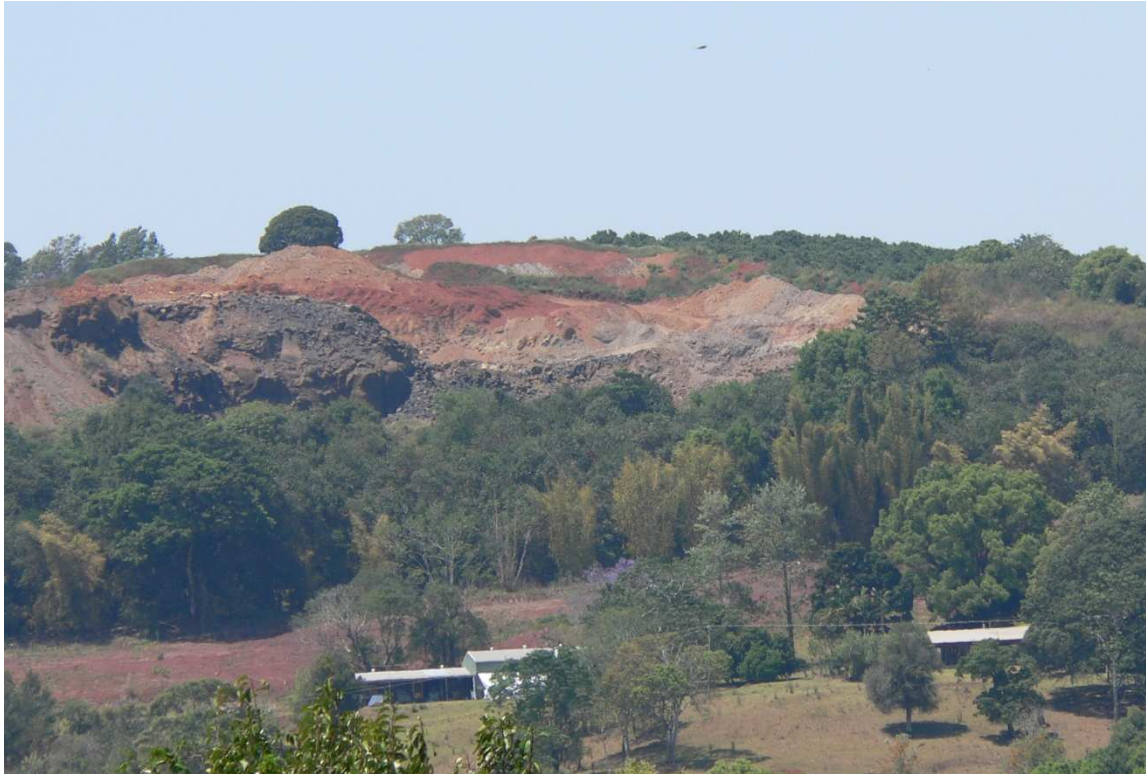
PHOTO 14 General view of Corndale Quarry, in basalt of the Lismore Basalt.

Corndale Quarry is a medium size hard rock quarry, producing rock for road construction and other use (see **Photo 14**). The quarry only has portable crushing facilities. The quarry is located at GR 364224 Dunoon 1:25,000 sheet (9540-1-S), off the James Gibson Road, in the area between the townships of Bexhill, Corndale and Clunes. It is the closest quarry to the dam site (see **Figure 7**). The quarry is owned and operated by Smith Plant (Lismore) Pty Ltd.

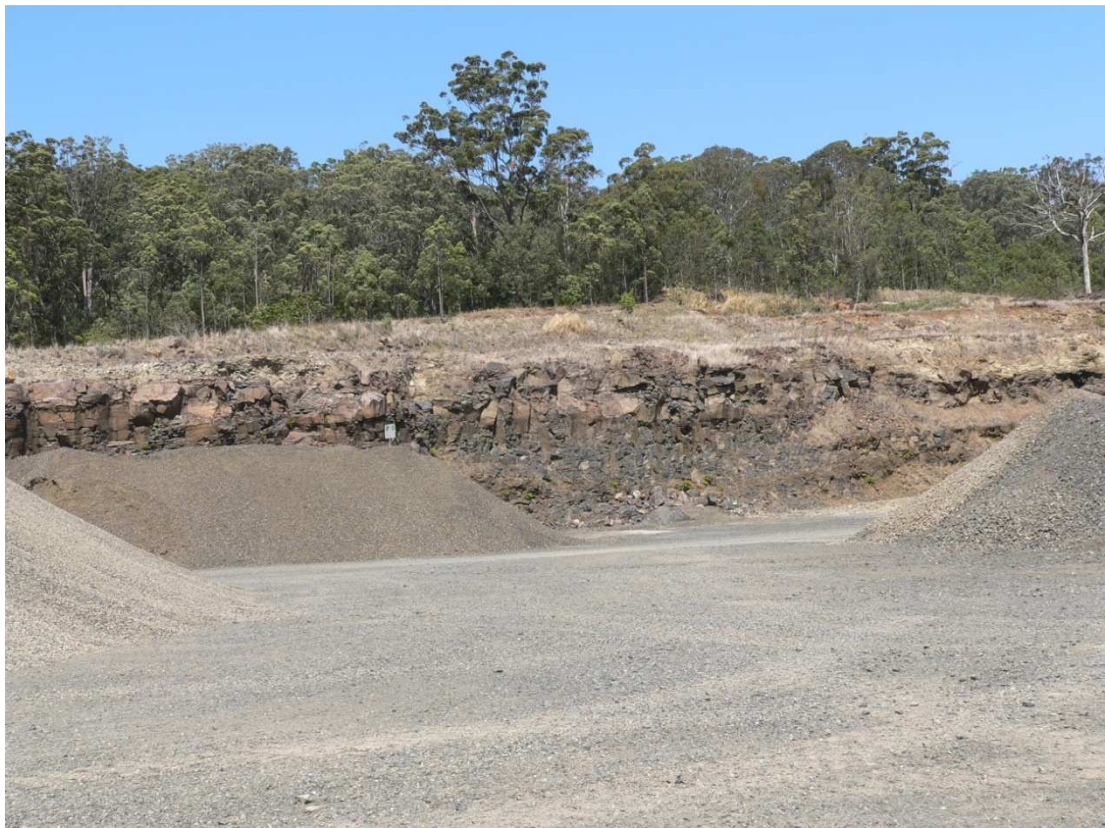
PHOTO 15 General view of portion of Blakebrook Quarry, in basalt of the Lismore Basalt.
Two basalt flows are exposed in the face, and piles of crushed rock in the foreground.

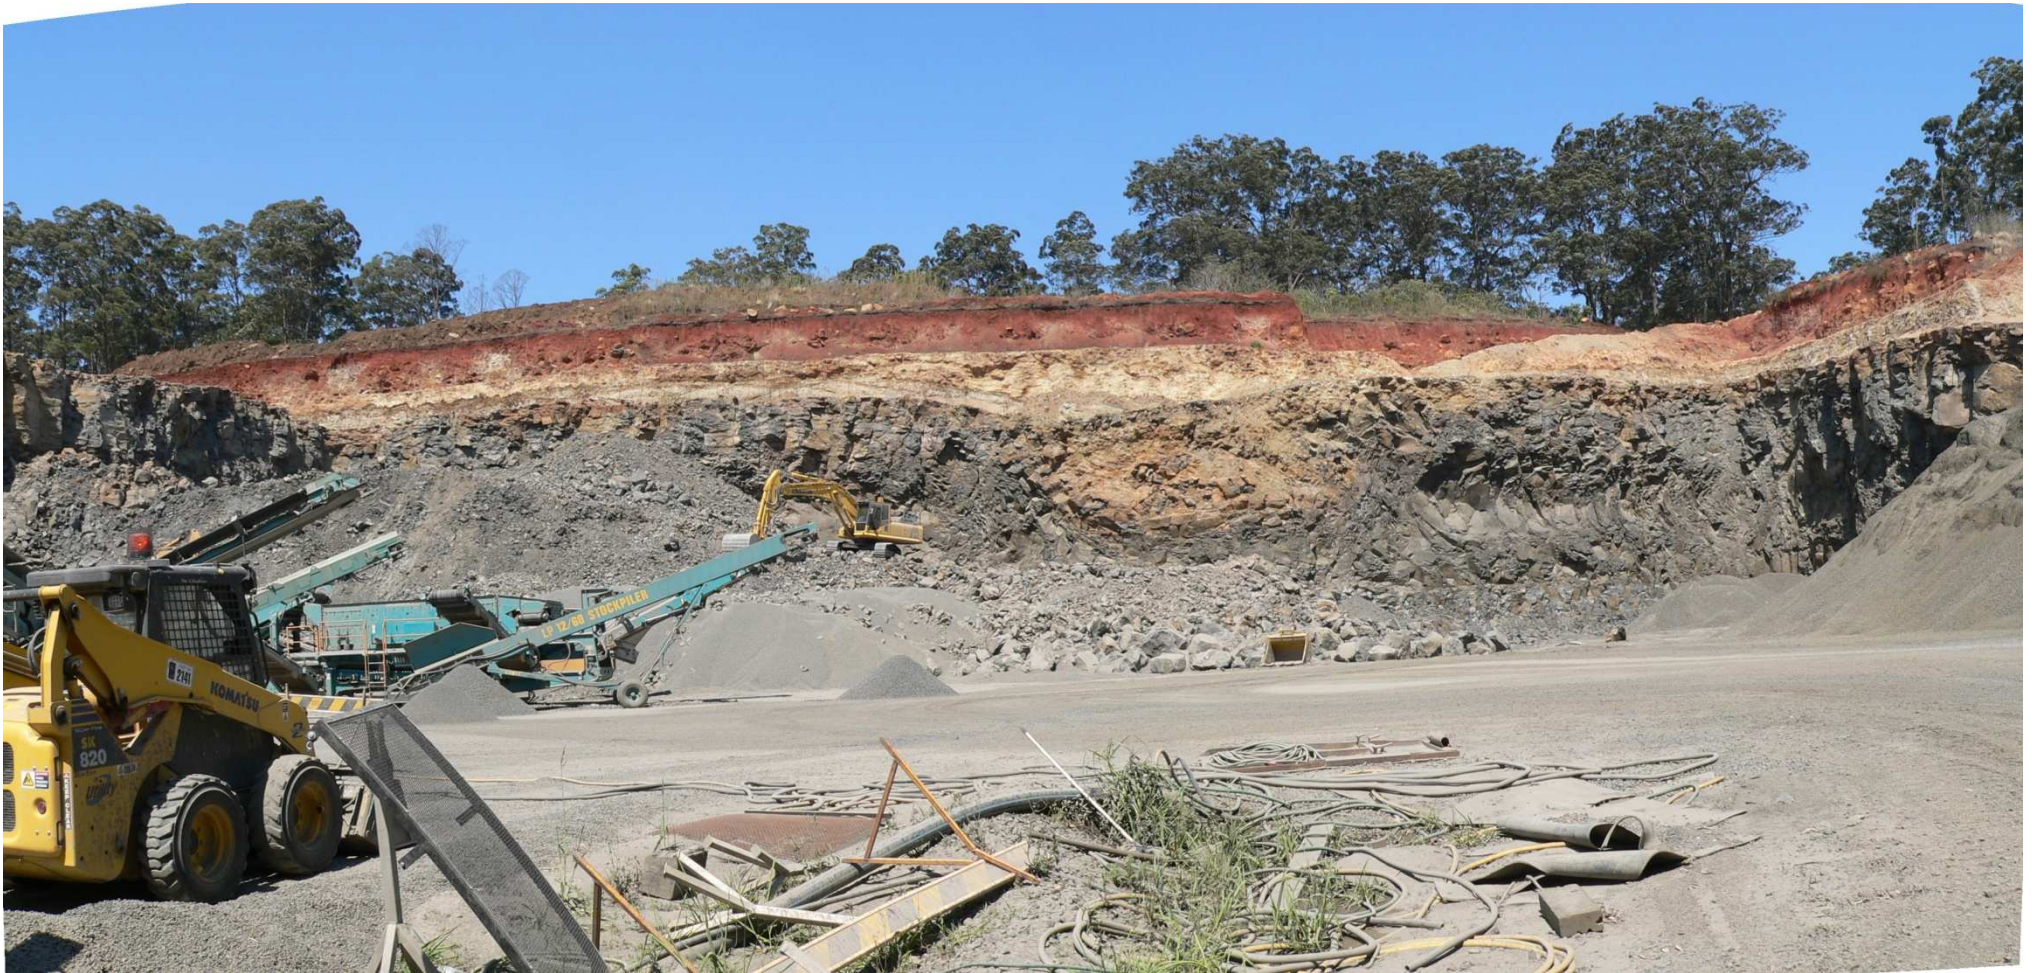
PHOTO 16 View of portion of the main working face in Blakebrook Quarry, in basalt of the Lismore Basalt. Note the light coloured inter-flow soil deposit (bole) near the top of the face.

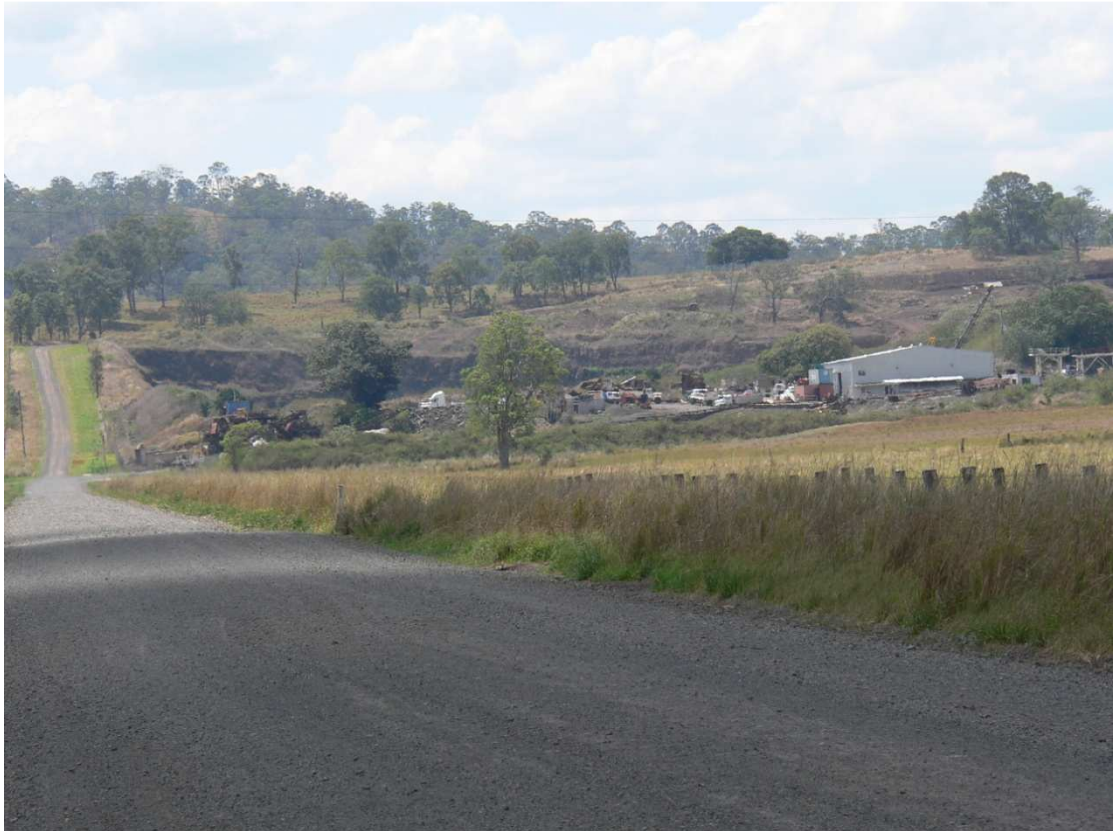
PHOTO 17 General view of Clovass Quarry, in basalt of the Lismore Basalt.

Clovass Quarry is a medium size, hard rock quarry, producing crushed basalt for road construction and concrete aggregates (see **Photo 17 and 18**). The quarry is located at GR 244181 Casino 1:25,000 (9540-3-N) sheet, on the northern side of the Bruxner Highway, at Clovass, approximately 10km east of Casino and 15km west-southwest of Lismore (see **Figure 7**). The quarry is owned and operated by R.K. and B.P. Holmes.

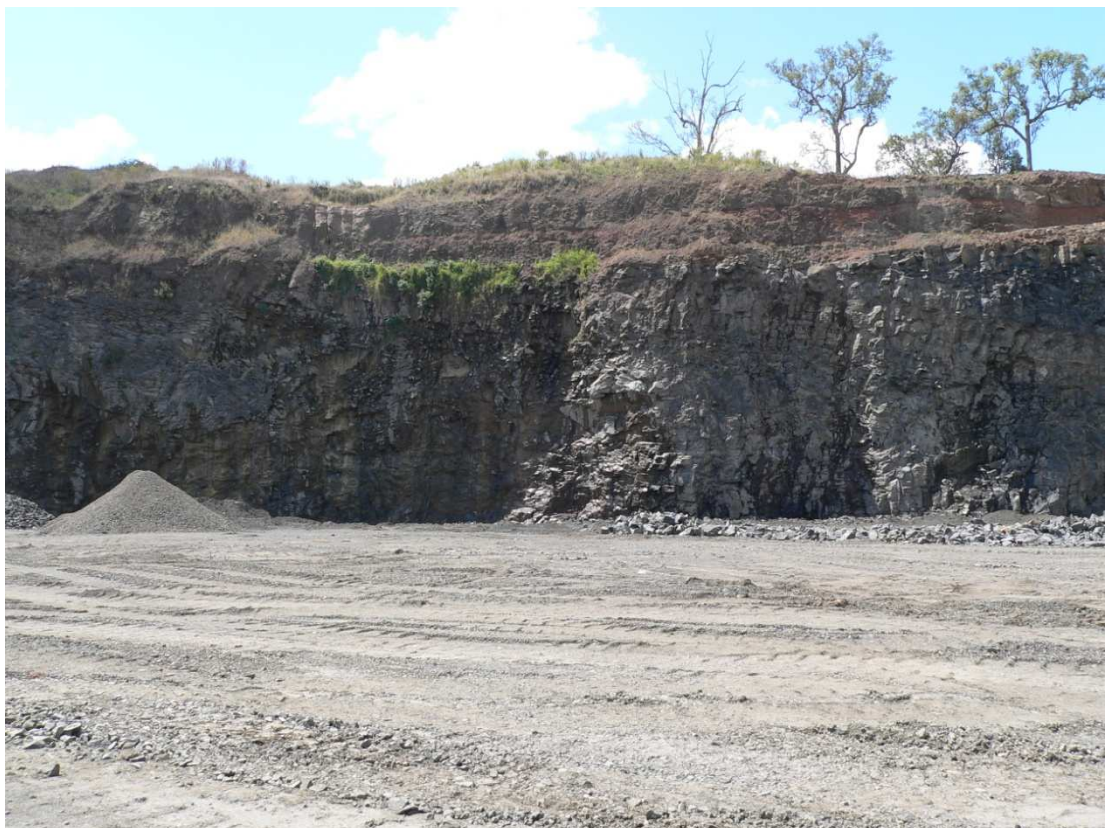
PHOTO 18 View of portion of the face Clovass Quarry, in basalt of the Lismore Basalt. The basalt is highly jointed and fractured.

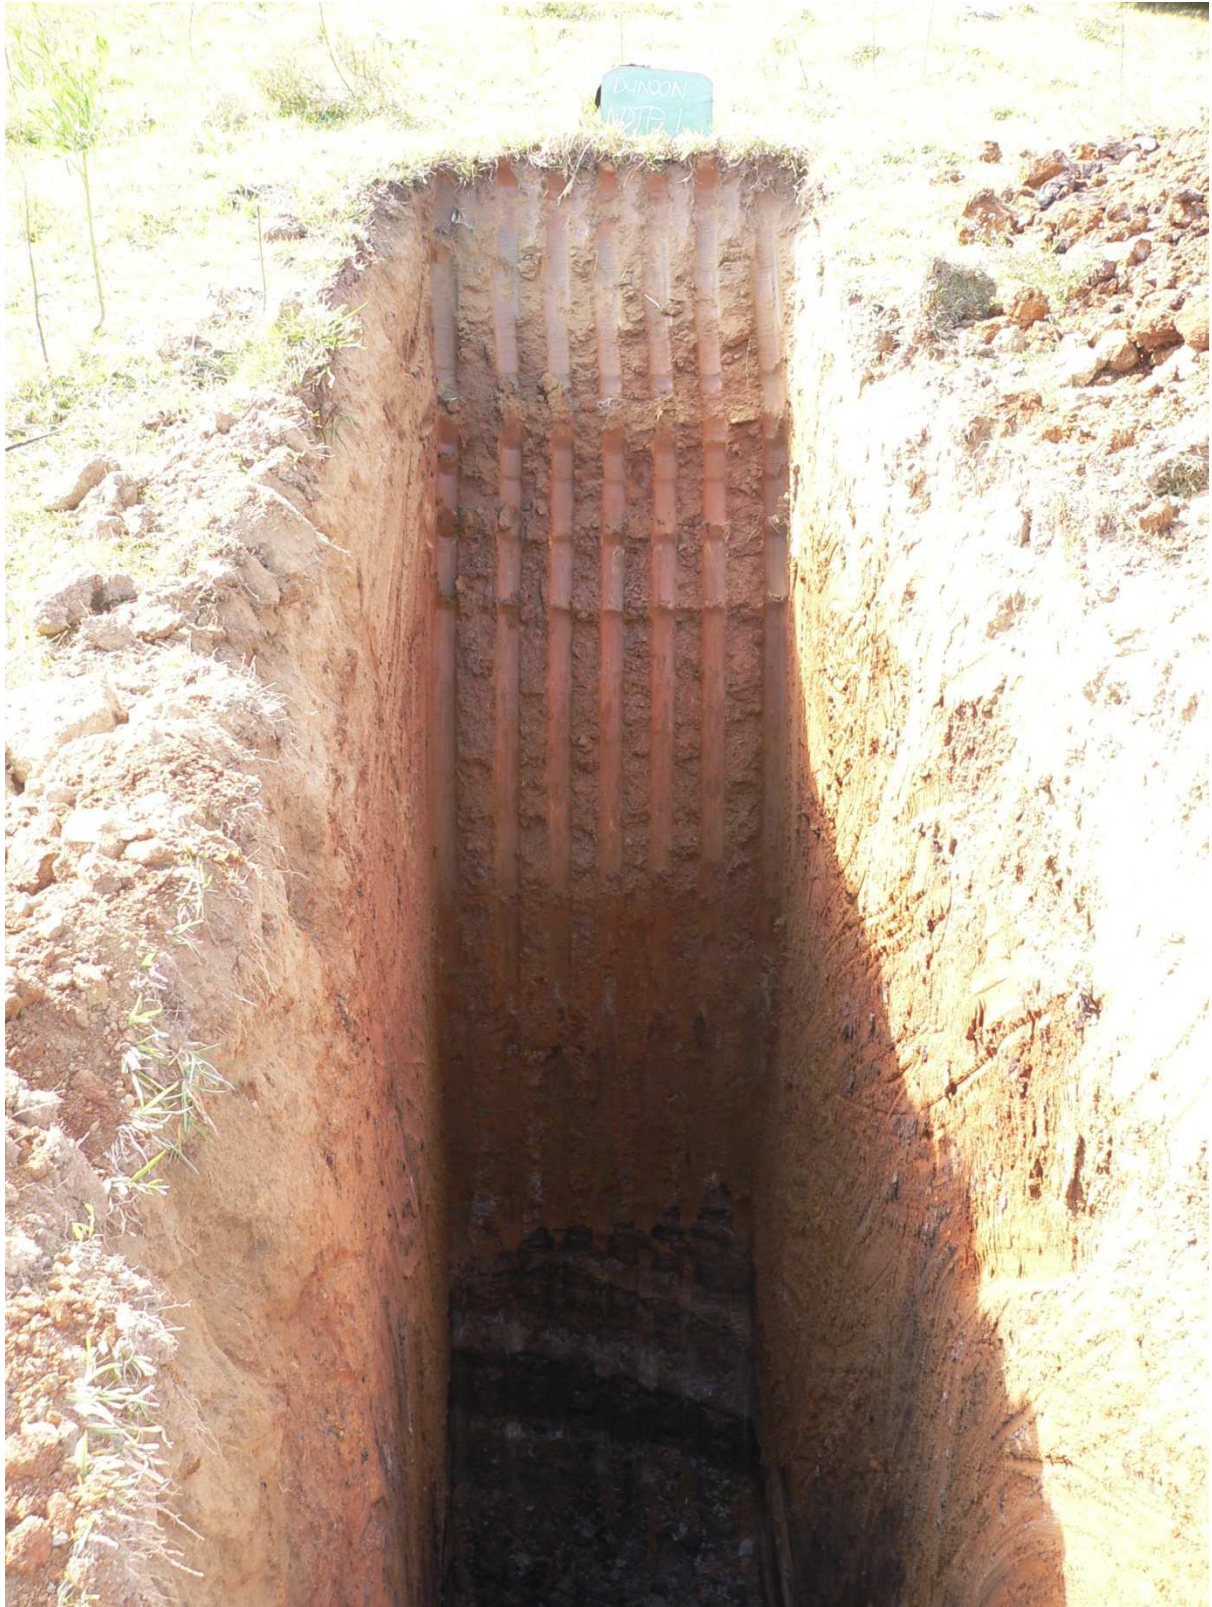
Test pit DTP 1

2.9m	4.3m		MH/ CH & Rock (Vis)	CLAYEY SILT/SILTY CLAY; as above, with sandstone/claystone fragments, with yellow-brown and white colours. Very moist at 3.1m. Small sandstone boulder, HW/MW, at ~3.6m. Very moist at 4.0m.

4.3m	5.4m		Rock	CLAYSTONE; EW, with COAL laminae/thin seams, behaves as CH. Becomes HW near the base of the pit. Coal ~10° dip in direction ~150°M.	
END OF PIT AT 5.4m – LIMIT OF REACH OF EXCAVATOR					
LOGGED: M. J. Neville
