DUNOON DAM SITE

CONCEPT STAGE GEOTECHNICAL INVESTIGATION

Report No. GQ86A

Rous Water
REGIONAL WATER SUPPLY

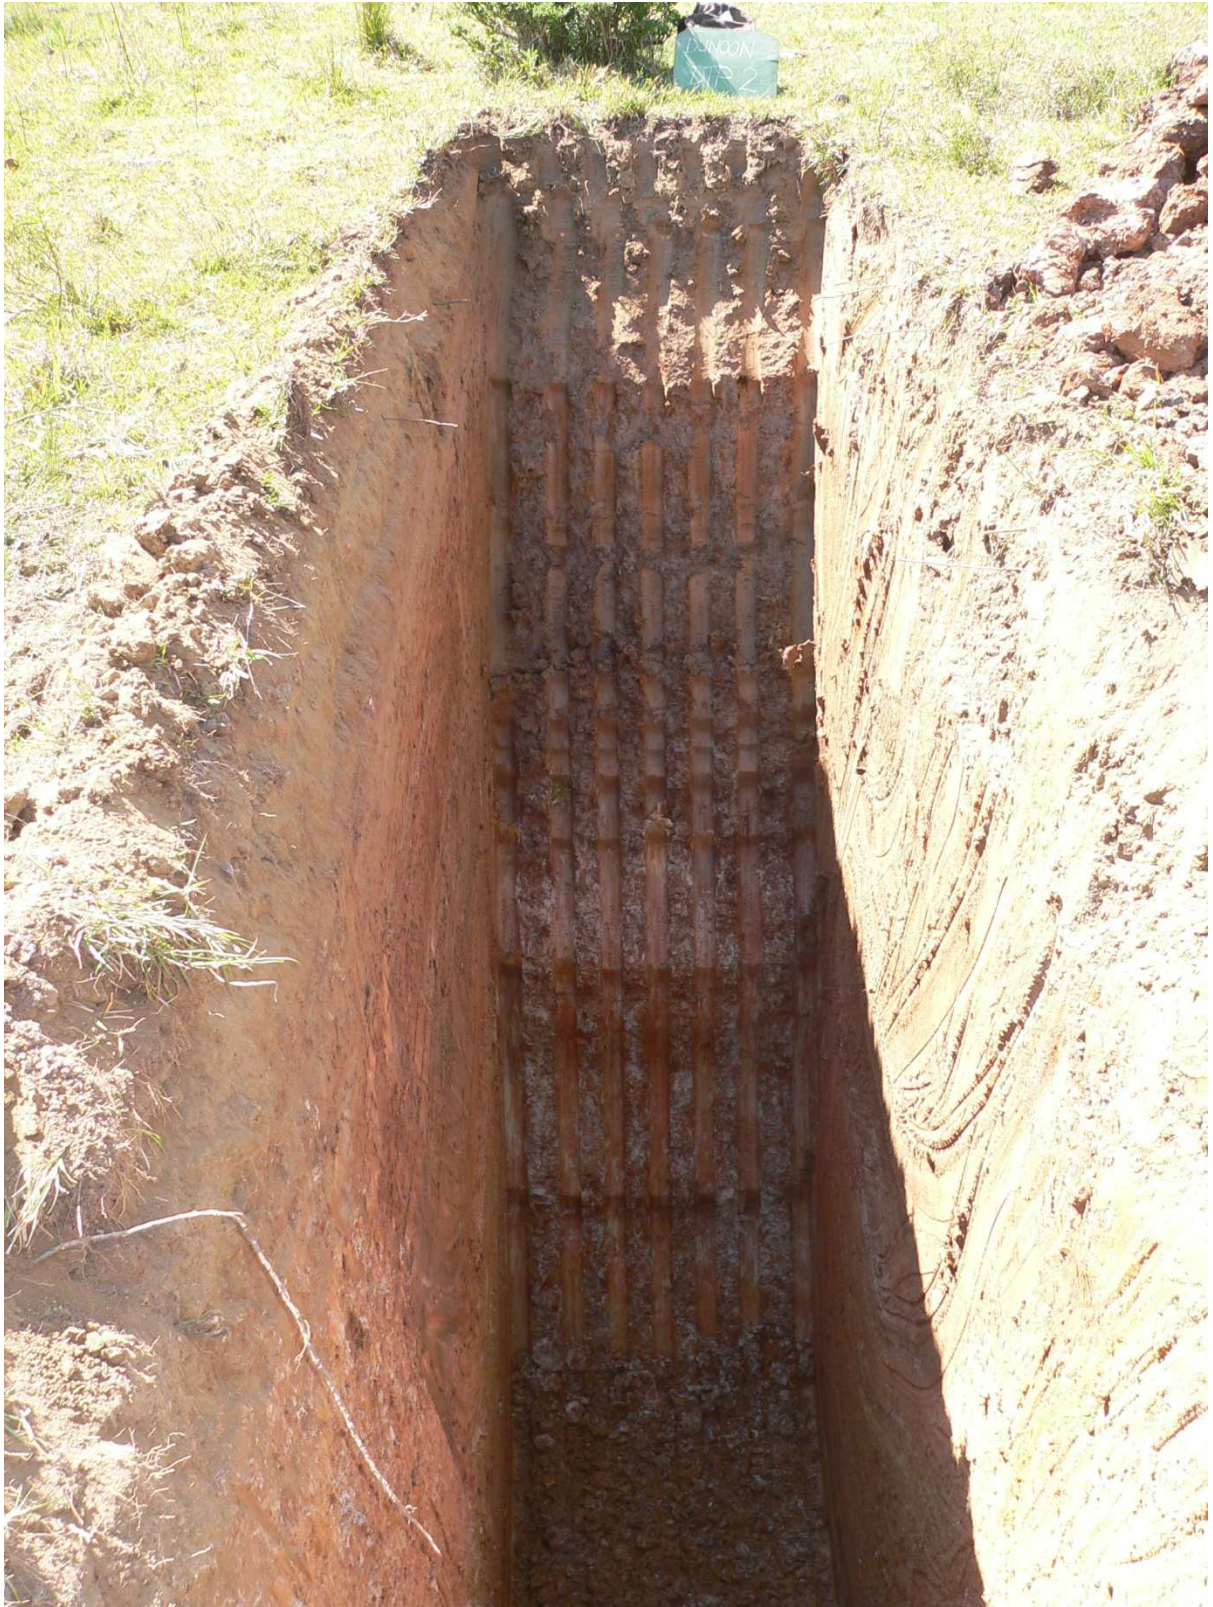
Test pit DTP 2

0.45m	0.9m	0.45 – 0.9	SC (Vis)	SANDY CLAY/CLAYEY SAND; fine grained sand, brown, red-brown and grey mottled, just moist, firm to stiff.					
0.9m	3.0m	1.0 – 1.5	CH (Vis)	SILTY CLAY; trace sand, grey with brown mottles, trace red-brown, moist, stiff.

3.0m	3.8m		MH (Vis)	CLAYEY SILT; trace HW/MW sandstone pebbles, light grey with brown, orange-brown and red-brown mottles/nodules, moist, firm.					
3.8m	5.1m		Rock	SANDSTONE; EW, fine grained, silty, brown with grey, breaks down to MH. Some claystone laminae/beds with traces of coal.					
END OF PIT AT 5.1m – NEAR LIMIT OF REACH									
LOGGED: M. J. Neville

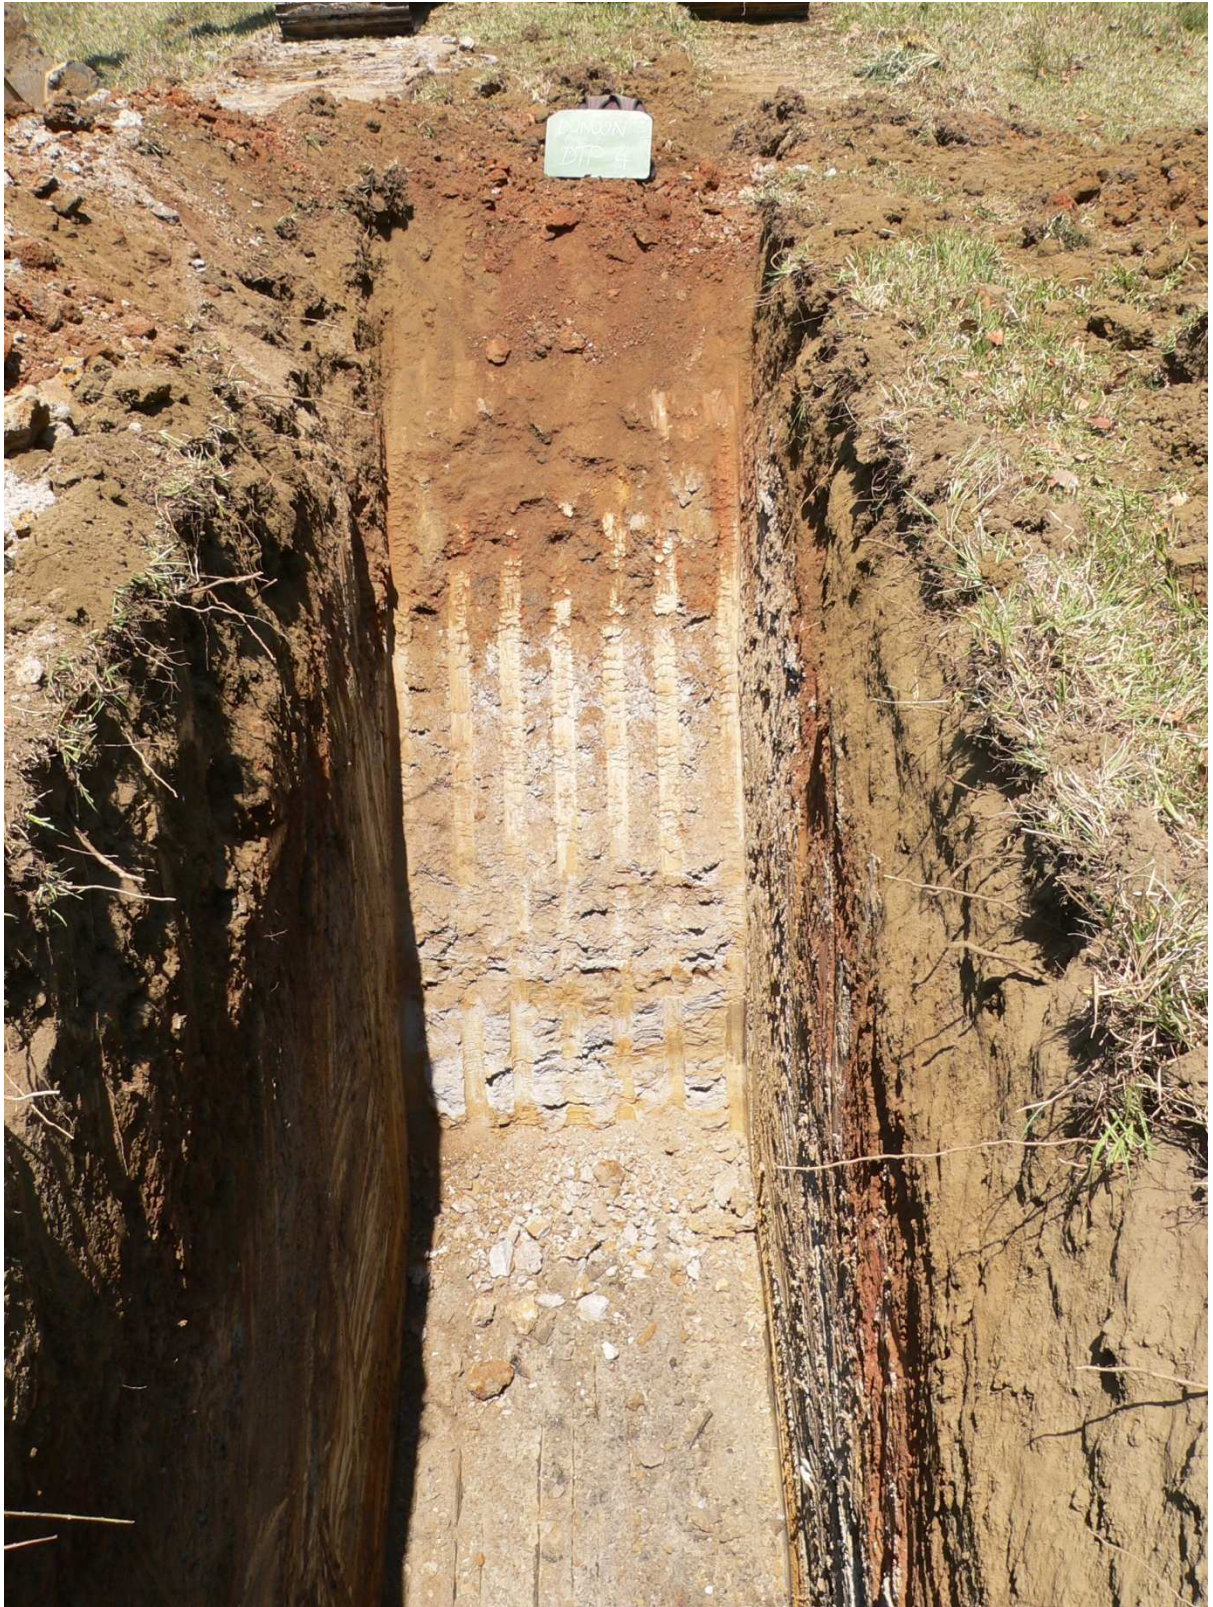
Test pit DTP 4

NSW GOVERNMENT		Public Works		DAMS & CIVIL		TEST PIT		DTP 4	
DUNOON DAM SITE						DATE		9.10.2012	
LOCATION		E 0529332		N 6827885		RL (m)		44	
CONTRACTOR J & M Bashforth				OPERATOR L McLeod		EQUIPMENT Caterpillar 320D L			
From	To	Sample	Class	Description					
0	0.5m		ML (Vis)	SILT; trace sand, dark grey-brown, possibly alluvial, trace grass roots and fine tree roots, dry, firm. CLAYEY SILT; trace small sandstone boulders, grey-brown and red-brown mottled, moist, firm. SILTY CLAY; light grey with trace orange-brown, moist, stiff. CLAYSTONE; EW, then HW/EW with interbedded sandstone, trace coal. HW sandstone at base.					
0.5m	1.3m		MH (Vis)						
1.3m	2.5m		CH (Vis)						
2.5m	3.8m		Rock						
END OF PIT AT 3.8m – EXCAVATOR REFUSAL ON SANDSTONE BEDDING PLANE									
LOGGED: M. J. Neville

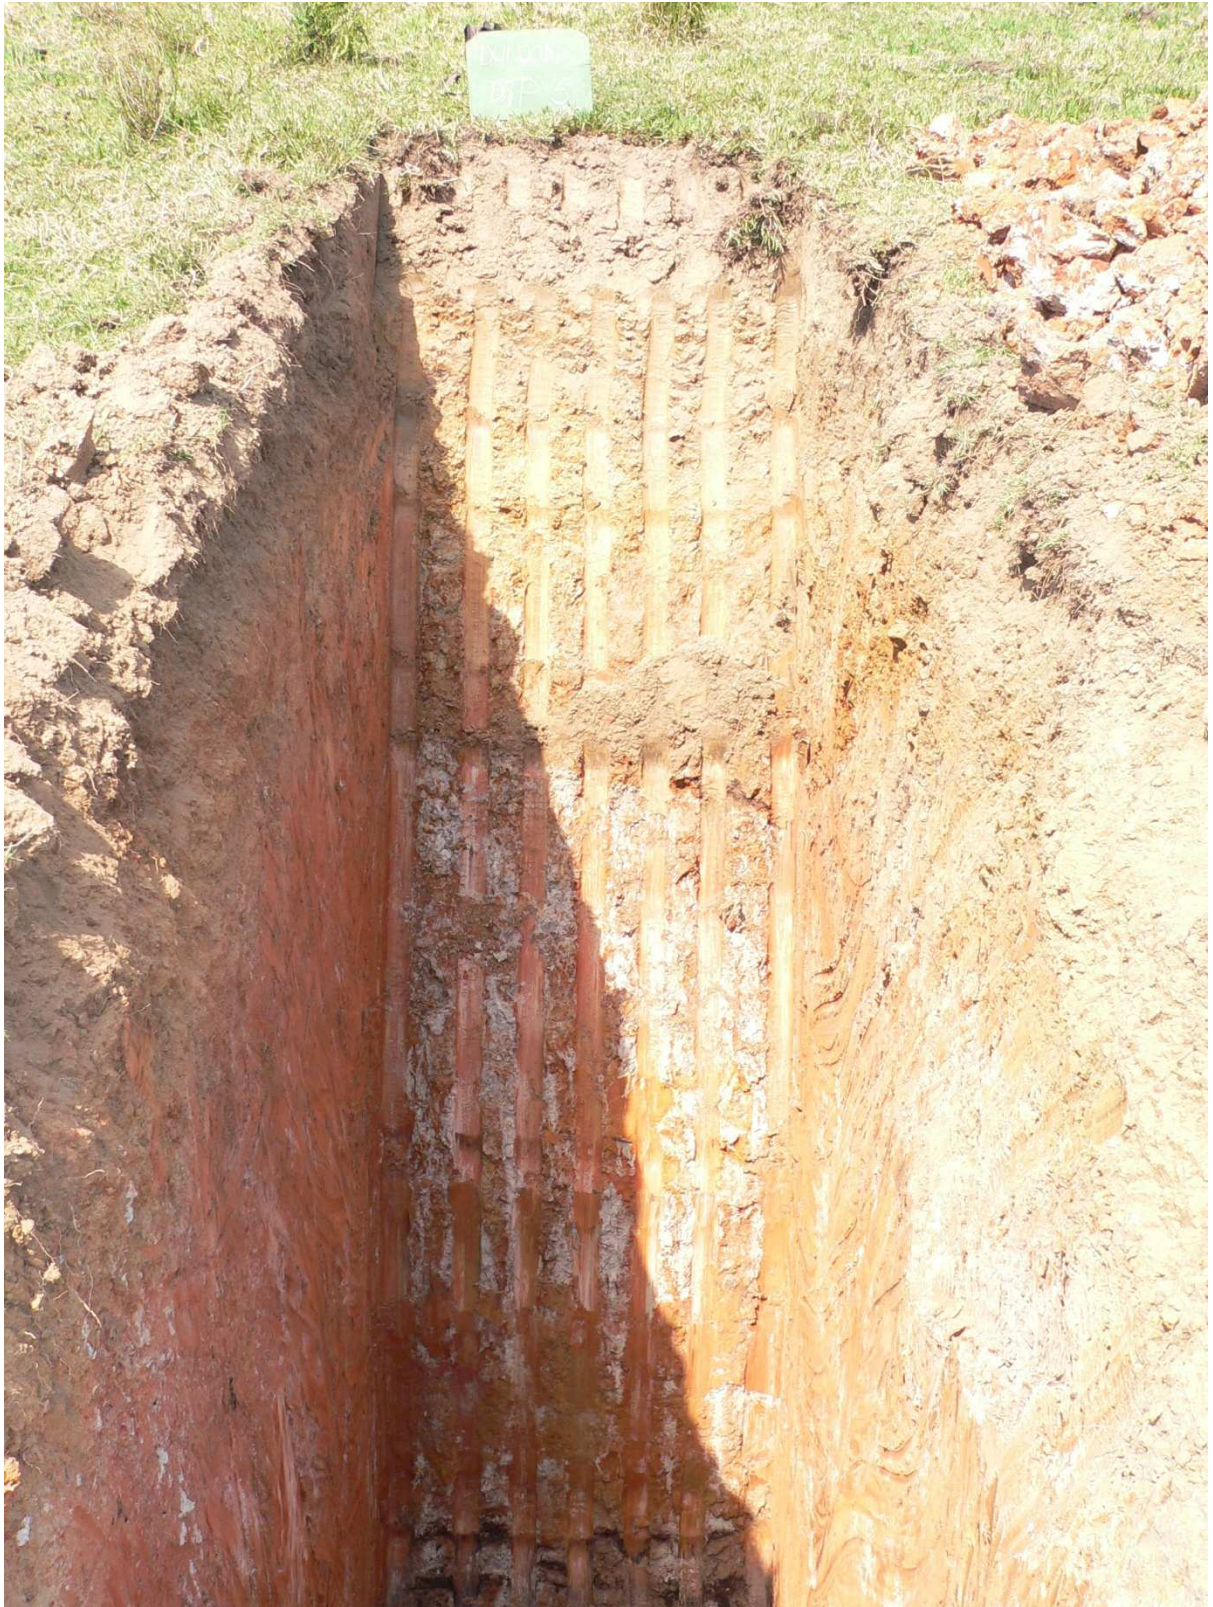
Test pit DTP 5

NSW GOVERNMENT		Public Works		DAMS & CIVIL		TEST PIT		DTP 5	
DUNOON DAM SITE						DATE		9.10.2012	
LOCATION		E 0529554		N 6827953		RL (m)		78	
CONTRACTOR J & M Bashforth				OPERATOR L McLeod		EQUIPMENT Caterpillar 320D L			
From	To	Sample	Class	Description					
0	0.3m		SM (Vis)	SANDY SILT (TOPSOIL); trace clay, grey-brown, organic, trace ash, trace grass roots, dry, firm. SILTY CLAY; trace (one) pebble, grey-brown and orange-brown, clay peds, trace grass roots, just moist, stiff. SILTY CLAY; trace fine rock fragments, brown, grey, red-brown and grey-brown mottles, moist, stiff/very stiff. SILTY CLAY; as above, with minor EW CLAYSTONE. CLAYSTONE, minor SANDSTONE, trace COAL; EW, grey, grey-brown, and trace black, thinly bedded/laminated.

0.3m	0.75m	0.3 – 0.75	CH/MH (Lab)						
0.75m	1.75m	0.75 – 1.75	CH (Lab)						
1.75m	4.1m		CH & Rock (Vis)						
4.1m	5.3m		Rock						
END OF PIT AT 5.3m – LIMIT OF REACH OF EXCAVATOR									
LOGGED: M. J. Neville

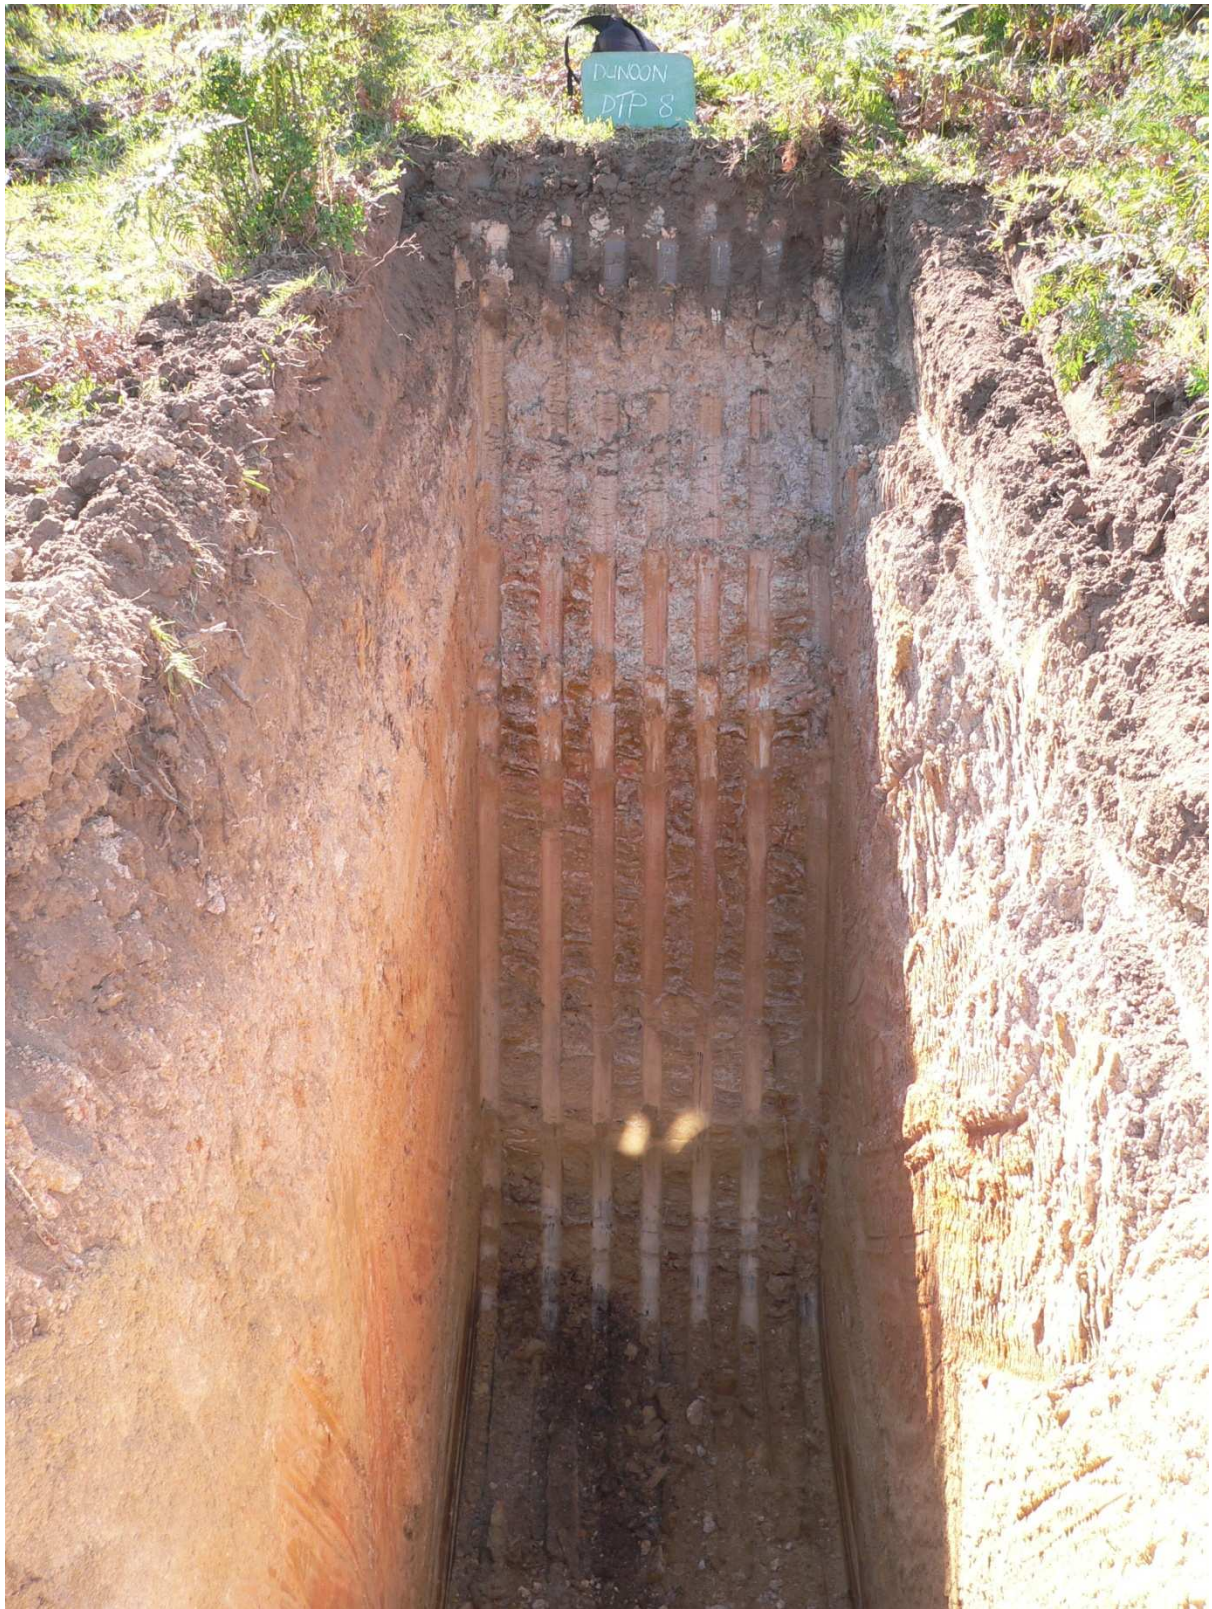
Test pit DTP 8

NSW GOVERNMENT		Public Works		DAMS & CIVIL		TEST PIT		DTP 8	
DUNOON DAM SITE						DATE		10.10.2012	
LOCATION		E 0529359		N 6828019		RL (m)		54	
CONTRACTOR J & M Bashforth				OPERATOR L McLeod		EQUIPMENT Caterpillar 320D L			
From	To	Sample	Class	Description					
0	0.2m		ML (Vis)	SANDY SILT (TOPSOIL); dark grey-brown, to grey-brown, organic, trace ash, trace grass roots and fine tree roots, dry, firm.					
0.2m	0.5m		MI (Vis)	CLAYEY SILT; trace sand, grey-brown, trace fine roots, trace ash, dry, firm.					
0.5m	1.1m		CH (Vis)	SILTY CLAY; trace sand, grey with orange-brown mottles, moist, stiff.					
1.1m	4.1m	2.5 - 2.7	SM & Rock (Lab)	CLAYSTONE; EW, with silty clay, behaves as SM, grey, red-brown, and orange-brown mottled, moist, stiff. With EW sandstone at depth, possibly SM/MI.					
END OF PIT AT 4.1m – NEAR REFUSAL ON HW SANDSTONE									
LOGGED: M. J. Neville

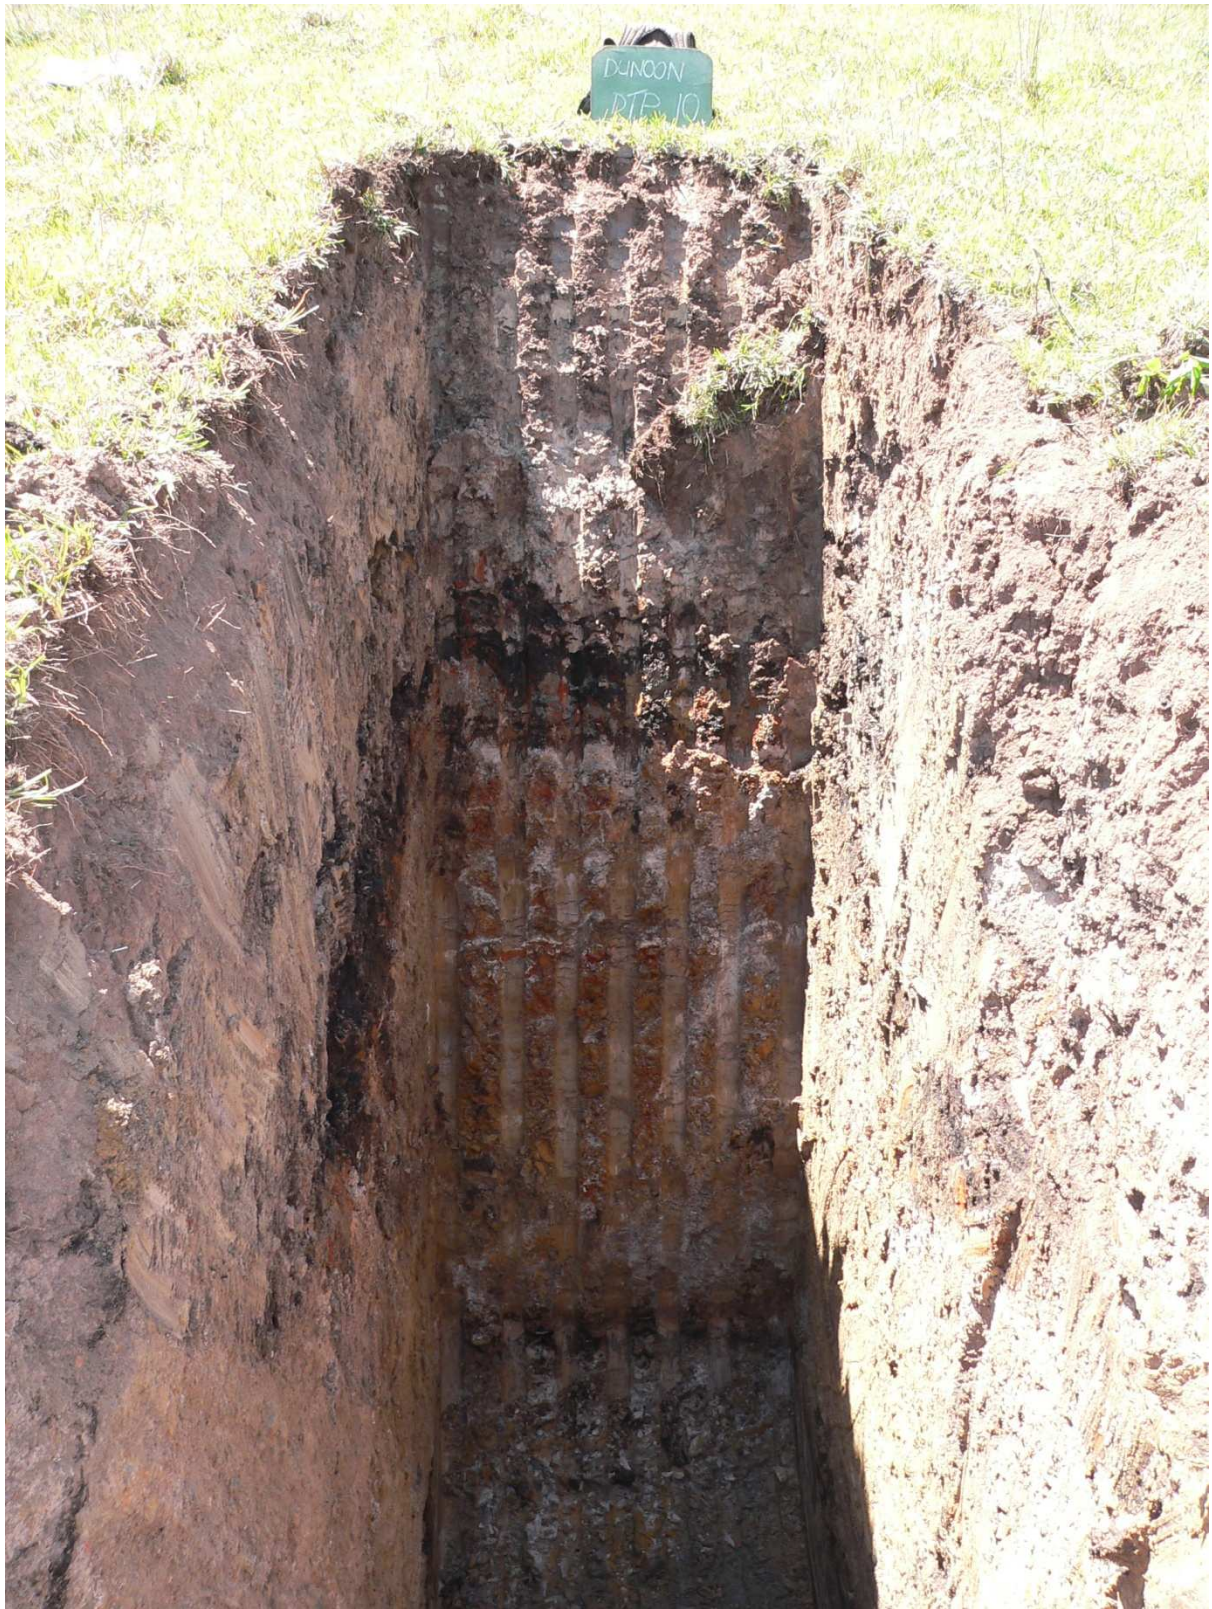
Test pit DTP 10

NSW GOVERNMENT		Public Works		DAMS & CIVIL		TEST PIT		DTP 10	
DUNOON DAM SITE						DATE		10.10.2012	
LOCATION		E 0529586		N 6827869		RL (m)		76	
CONTRACTOR J & M Bashforth				OPERATOR L McLeod		EQUIPMENT Caterpillar 320D L			
From	To	Sample	Class	Description					
0	0.25m		ML (Vis)	CLAYEY SILT (TOPSOIL); trace to minor sand, dark grey-brown becoming grey-brown with depth, organic, trace grass roots, moist, firm.					
0.25m	0.9m		CH (Vis)	SILTY CLAY; grey with traces of orange-brown, trace fine roots in upper half, moist, firm to stiff.					
0.9m	4.5m		CH & Rock (Vis)	CLAYSTONE & COAL; EW, with silty clay, behaves as CH, several thin to medium lensoidal coal seams (basal seam 0.2m thick), minor fine grained sandstone. Approx. 3m - becomes HW/EW					
END OF PIT AT 4.5m IN HW/EW CLAYSTONE WITH MINOR COAL									
LOGGED: M. J. Neville

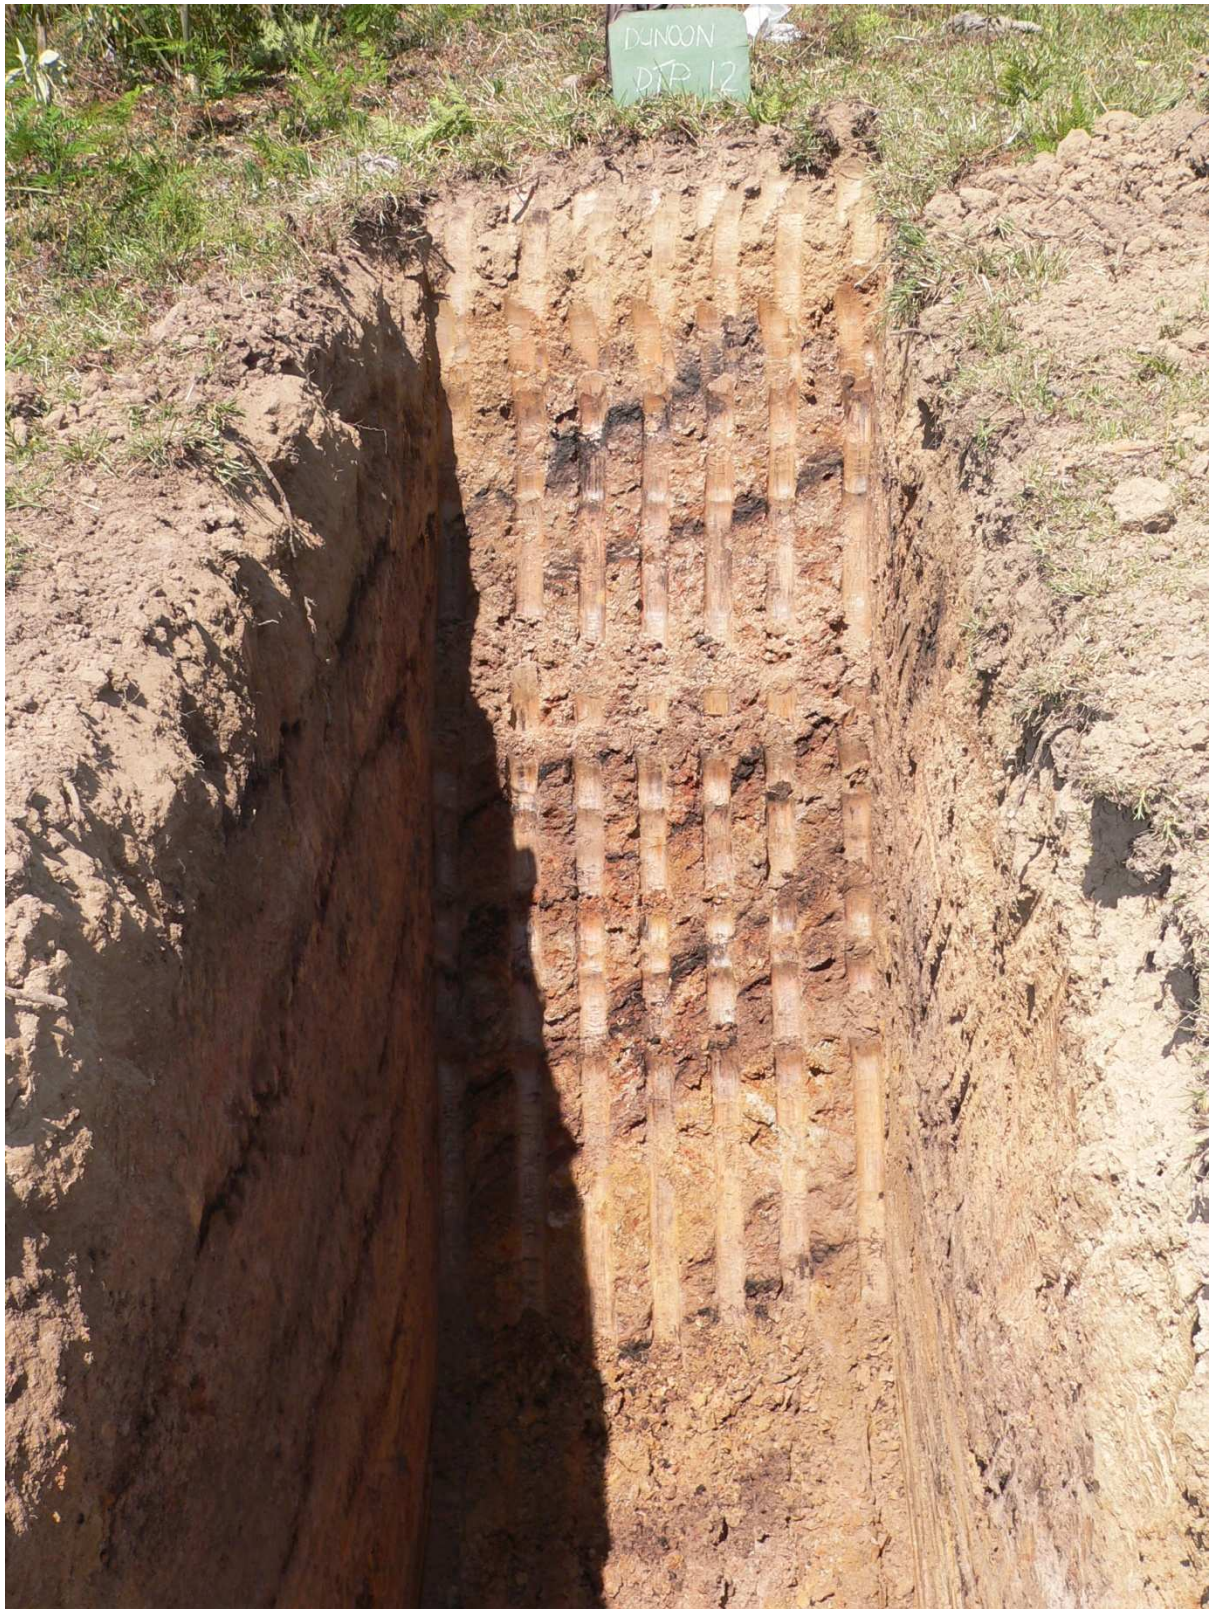
Test pit DTP 12

NSW GOVERNMENT		Public Works		DAMS & CIVIL		TEST PIT		DTP 12	
DUNOON DAM SITE						DATE		10.10.2012	
LOCATION		E 0529709		N 6828011		RL (m)		81	
CONTRACTOR J & M Bashforth				OPERATOR L McLeod		EQUIPMENT Caterpillar 320D L			
From	To	Sample	Class	Description					
0	0.25m		ML (Vis)	CLAYEY SILT (TOPSOIL); trace sand, grey-brown, organic, trace fine roots, dry, firm.					
0.25	0.6m		MI (Vis)	CLAYEY SILT; grey-brown with traces red-brown mottles, trace roots, moist, firm, some ped development.					
0.6	3.2m	3.1 – 3.2	MH & Rock (Lab)	CLAYSTONE & COAL; EW, with silty clay, behaves as Cl. Each clay seam is thin and lensoidal with thin to medium beds of claystone in between. Seven coal seams; local dip ~20° in direction ~020°M					
END OF PIT AT 3.2m IN EW CLAYSTONE									
LOGGED: M. J. Neville

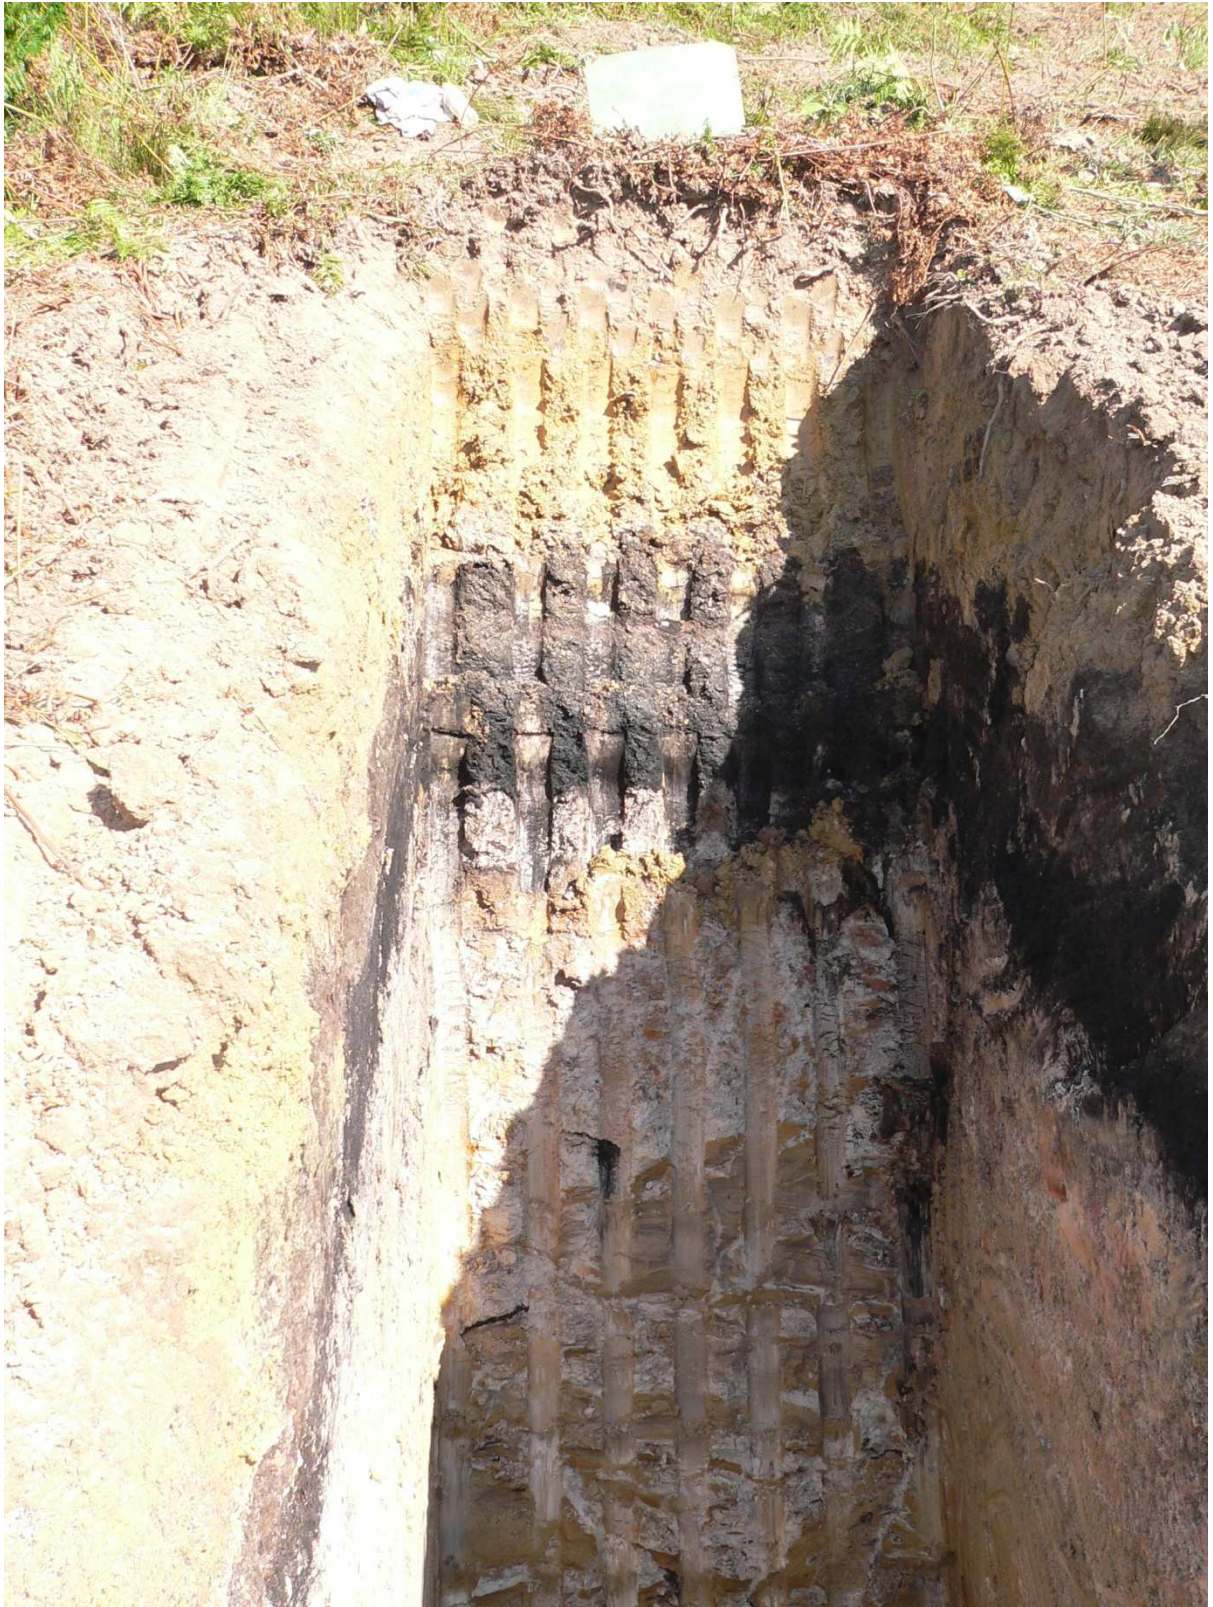
Test pit DTP 13

1.2	2.8m		CH & Rock (Vis)	CLAYSTONE; EW, with silty clay, grey with traces of brown, behaves as a silty clay (CH), moist, stiff; minor sandstone, EW, thinly/very thinly bedded.

2.8	3.8m		Rock	SANDSTONE; EW, brown with grey, breaks down to silty clay/clayey silt with minor sand, MI/CI.					
END OF PIT AT 3.8m IN HW/EW SANDSTONE									
LOGGED: M. J. Neville

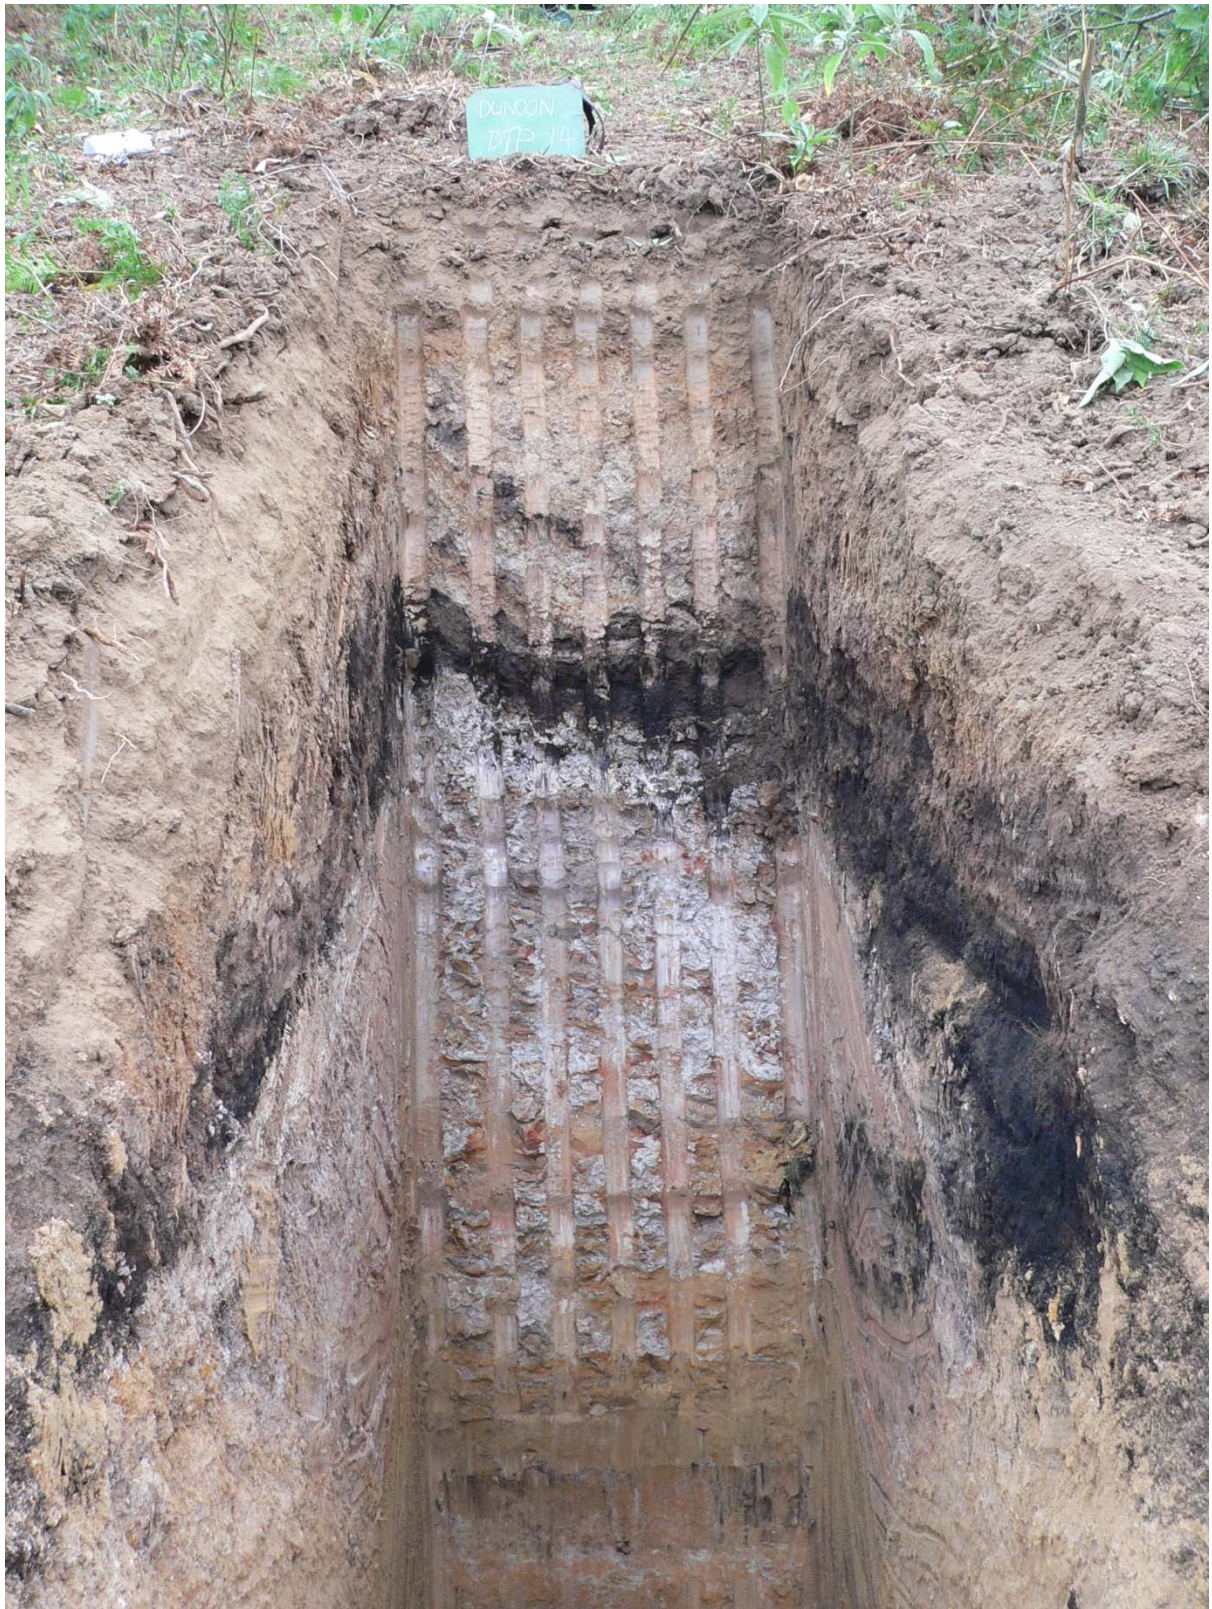
Test pit DTP 14

1.5	3.4m		CH & Rock (Vis)	CLAYSTONE; EW, with SILTY CLAY, light grey with brown & traces of red-brown, moist, firm to stiff. Becomes HW/EW at ~2.2m.

3.4	4.3m		Rock	SANDSTONE; HW/EW, lithic, medium to coarse grained, grey-brown, breaks down to clayey silt.					
END OF PIT AT 4.3m IN HW SANDSTONE (WEAK).									
LOGGED: M. J. Neville

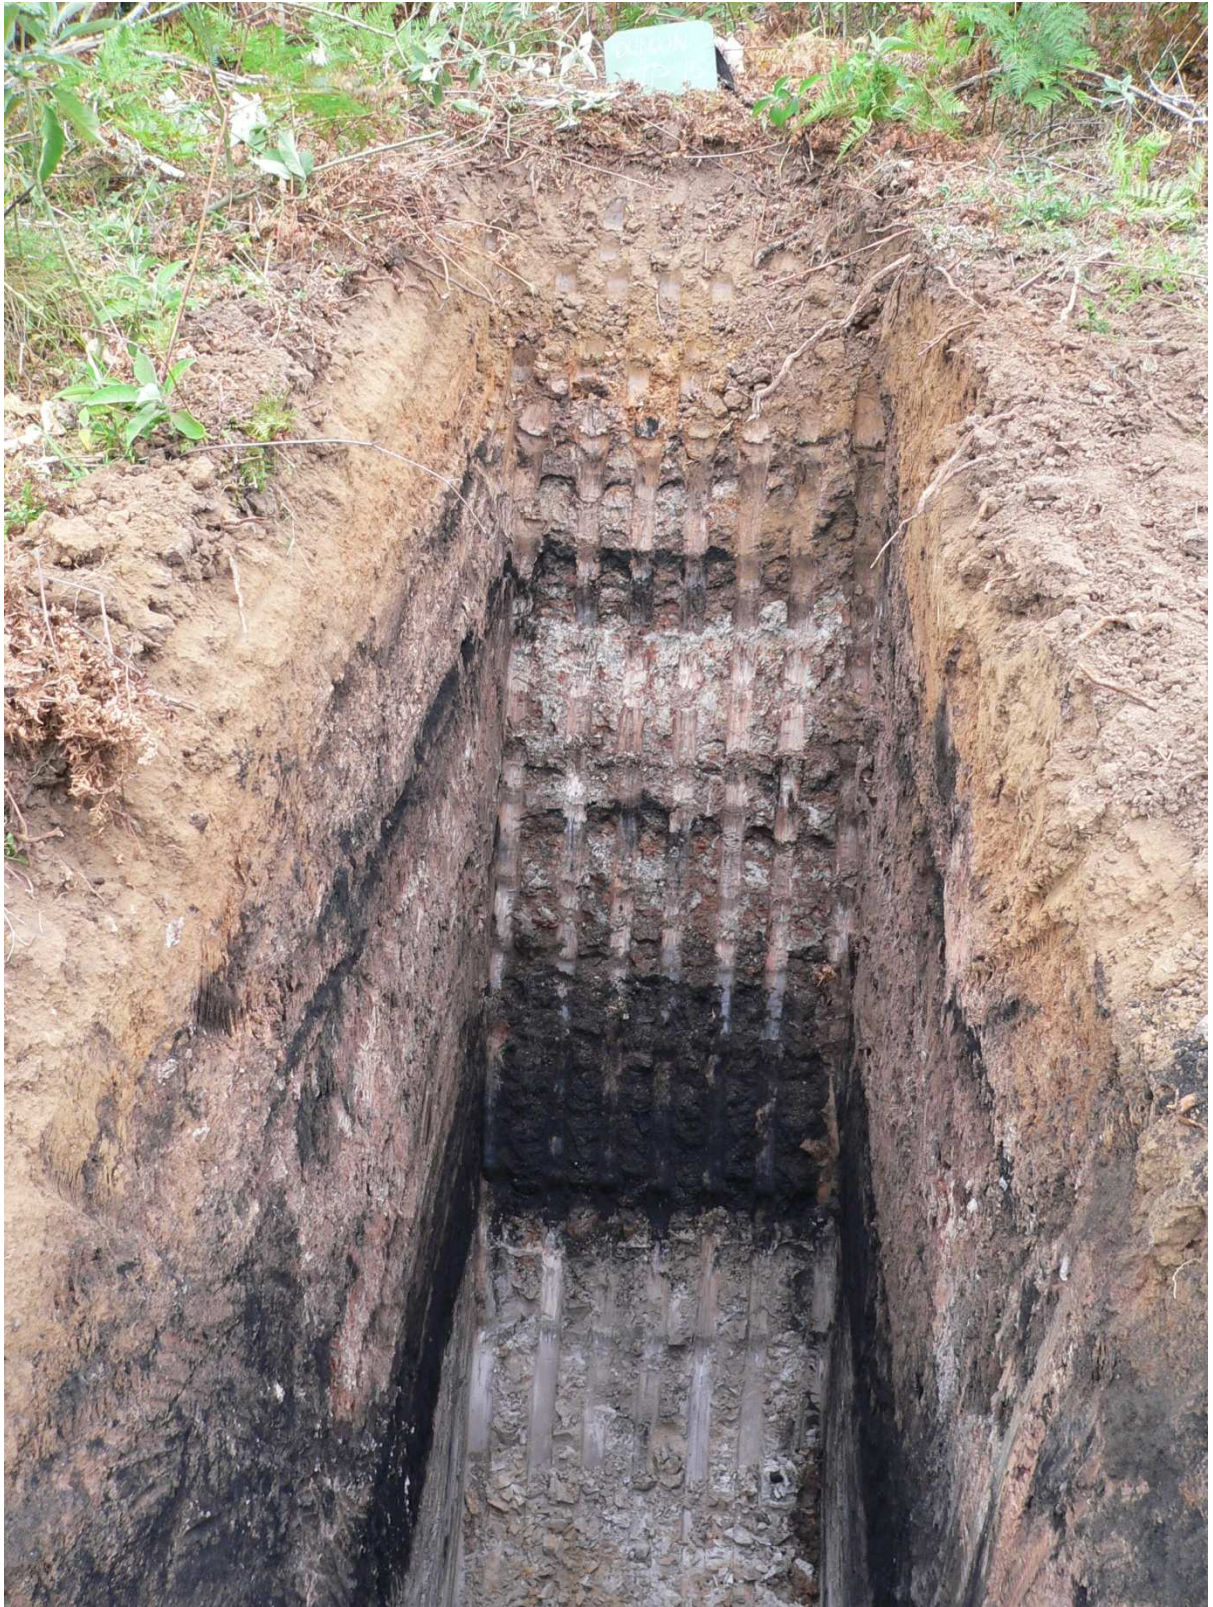
Test pit DTP 15

NSW GOVERNMENT		Public Works		DAMS & CIVIL		TEST PIT		DTP 15	
DUNOON DAM SITE						DATE		11.10.2012	
LOCATION		E 0529427		N 6827996		RL (m)		60	
CONTRACTOR J & M Bashforth				OPERATOR L McLeod		EQUIPMENT Caterpillar 320D L			
From	To	Sample	Class	Description					
0	0.15m		ML (Vis)	CLAYEY SILT (TOPSOIL); trace sand, grey-brown, organic, trace grass and plant roots, dry, firm, cracked into peds.

0.15	0.75m		MH (Vis)	CLAYEY SILT; trace sand, grey-brown with minor orange-brown, just moist, stiff, ped development.					
0.75	4.4m		CH & Rock (Vis)	CLAYSTONE; EW, with thin coal seams and laminations, acts as a silty clay with minor sand, light grey with red-brown, and black horizons, dip ~5° in direction ~010° – 020°M. ~2.4m becomes HW/EW 2.8 – 3.4m COAL, HW/MW 3.4 – 4.4m CLAYSTONE; HW/EW, light grey, some fine grained sandstone laminations.					
END OF PIT AT 4.4m IN HW CLAYSTONE.									
LOGGED: M. J. Neville

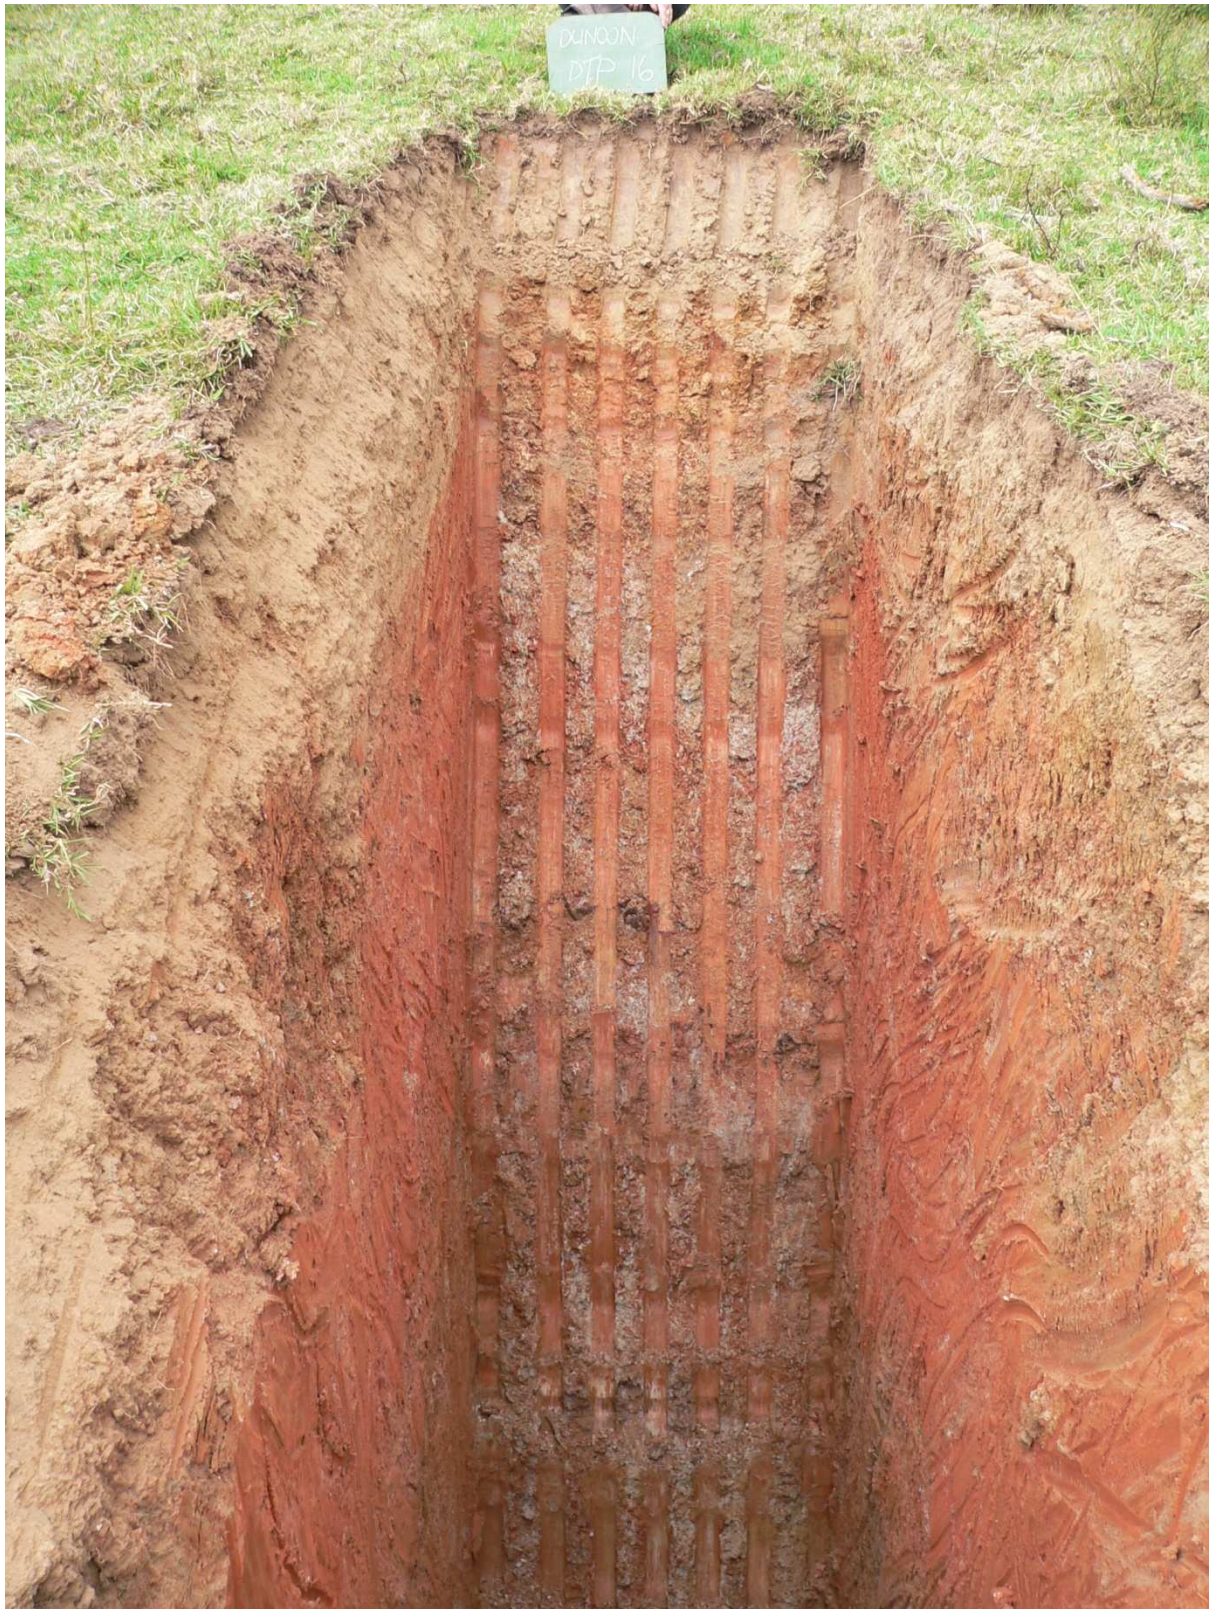
Test pit DTP 16

NSW GOVERNMENT		Public Works		DAMS & CIVIL		TEST PIT		DTP 16	
DUNOON DAM SITE						DATE		11.10.2012	
LOCATION		E 0529528		N 6828259		RL (m)		81	
CONTRACTOR J & M Bashforth				OPERATOR L McLeod		EQUIPMENT Caterpillar 320D L			
From	To	Sample	Class	Description					
0	0.4m		ML (Vis)	CLAYEY SILT (TOPSOIL); minor sand, grey-brown with trace brown, organic, trace grass roots, dry, firm.					
0.4	~4.0	1.2 – 2.2	CH (Lab)	SILTY CLAY; grey & red-brown mottled, moist, stiff.					
~4.0	5.4		CI & Rock (Vis)	SILTY CLAY; as above, possibly fine-grained rock, slightly higher silt content with depth, tending towards CI.					
END OF PIT AT 5.4m; LIMIT OF REACH OF EXCAVATOR									
LOGGED: M. J. Neville
