DUNOON DAM SITE

CONCEPT STAGE GEOTECHNICAL INVESTIGATION

Report No. GQ86A

Rous Water
REGIONAL WATER SUPPLY

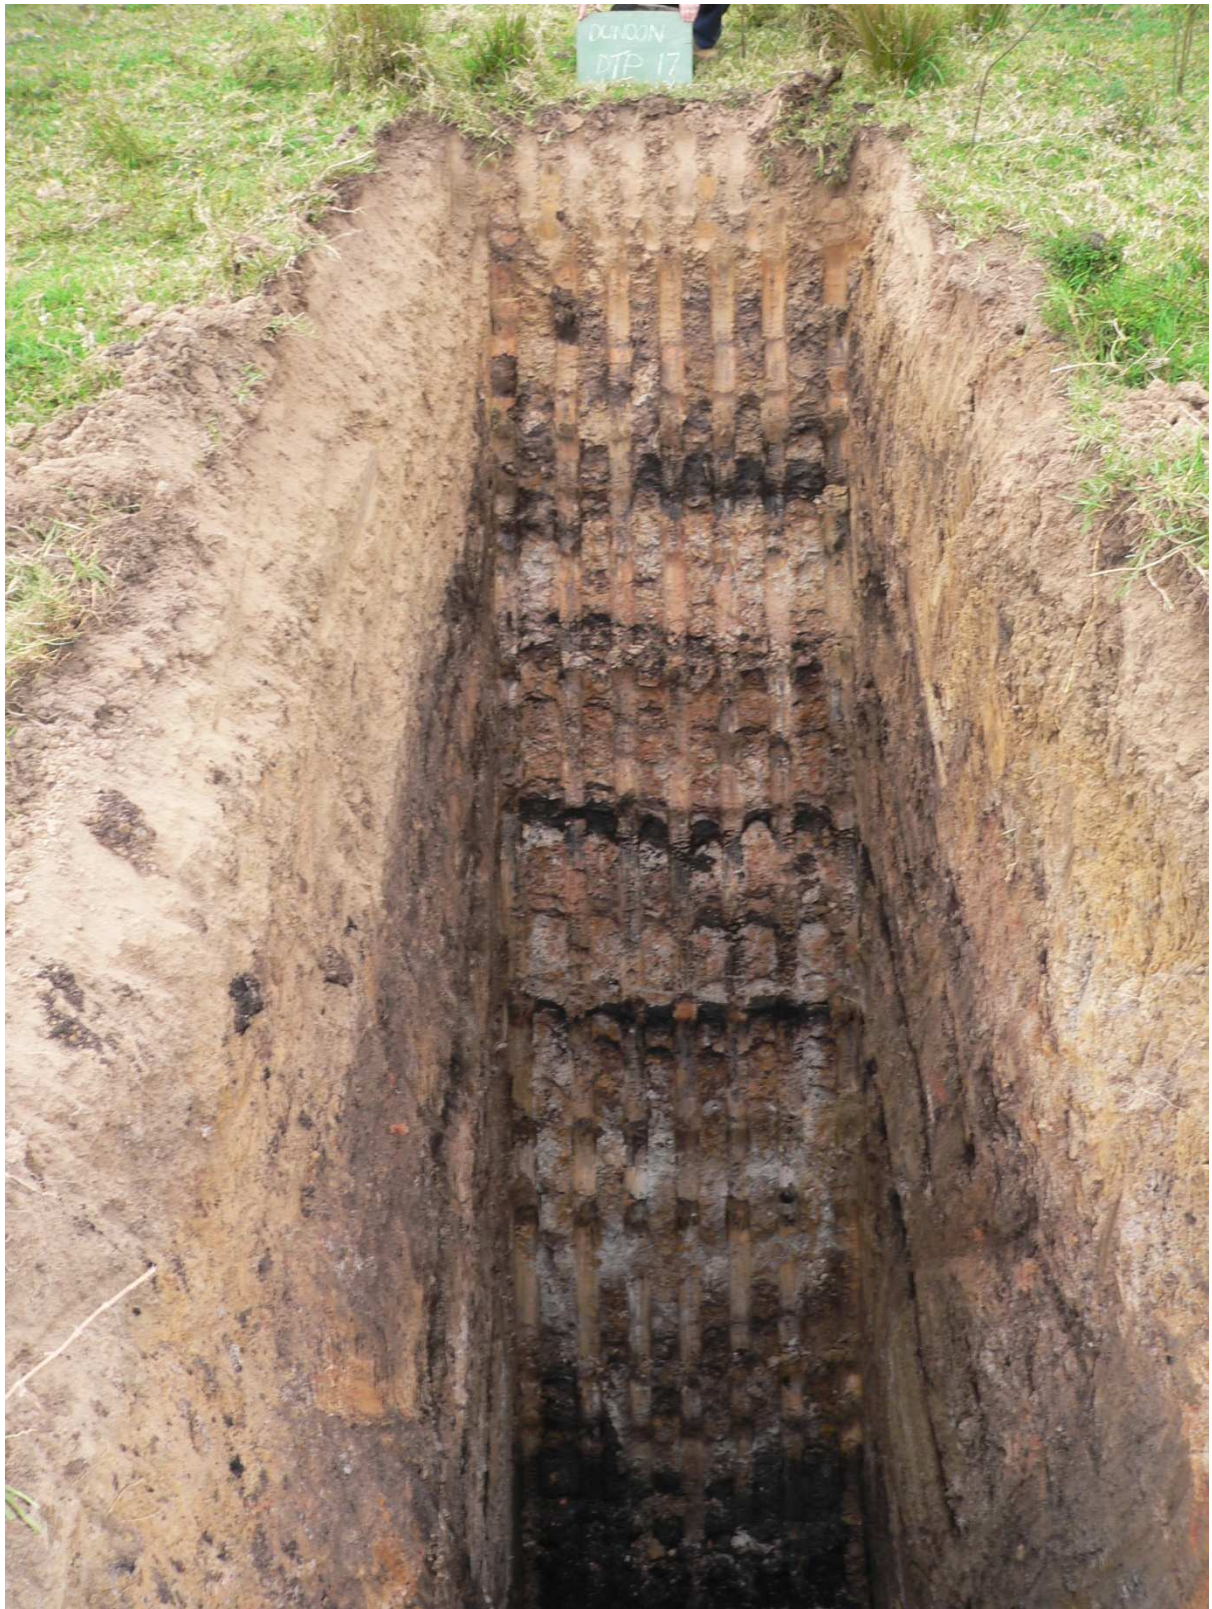
Test pit DTP 17

Public Works		DAMS & CIVIL		TEST PIT	DTP 17
DUNOON DAM SITE				DATE	11.10.2012
LOCATION		E 0529465	N 6828214	RL (m)	75
CONTRACTOR		J & M Bashforth	OPERATOR	L McLeod	EQUIPMENT Caterpillar 320D L
From	To	Sample	Class	Description	
0	0.2m		ML (Vis)	CLAYEY SILT (TOPSOIL); grey-brown and brown mottled, organic, trace grass plant roots, dry, firm.	
0.2	0.7m		CH (Vis)	SILTY CLAY; mid grey with brown mottles, trace grass roots, just moist, stiff.	
0.7	5.0m		CH & Rock (Vis)	CLAYSTONE; EW, with thin coal seams/laminae and silty clay, behaves as CH, grey with brown and red-brown mottles plus black seams. 2.1m HW/EW, mainly claystone with coal laminae and seams.	
<p>END OF PIT AT 5.0m; NEAR LIMIT OF REACH OF EXCAVATOR IN EW CLAYSTONE WITH COAL</p>					
<p>LOGGED: M. J. Neville</p>

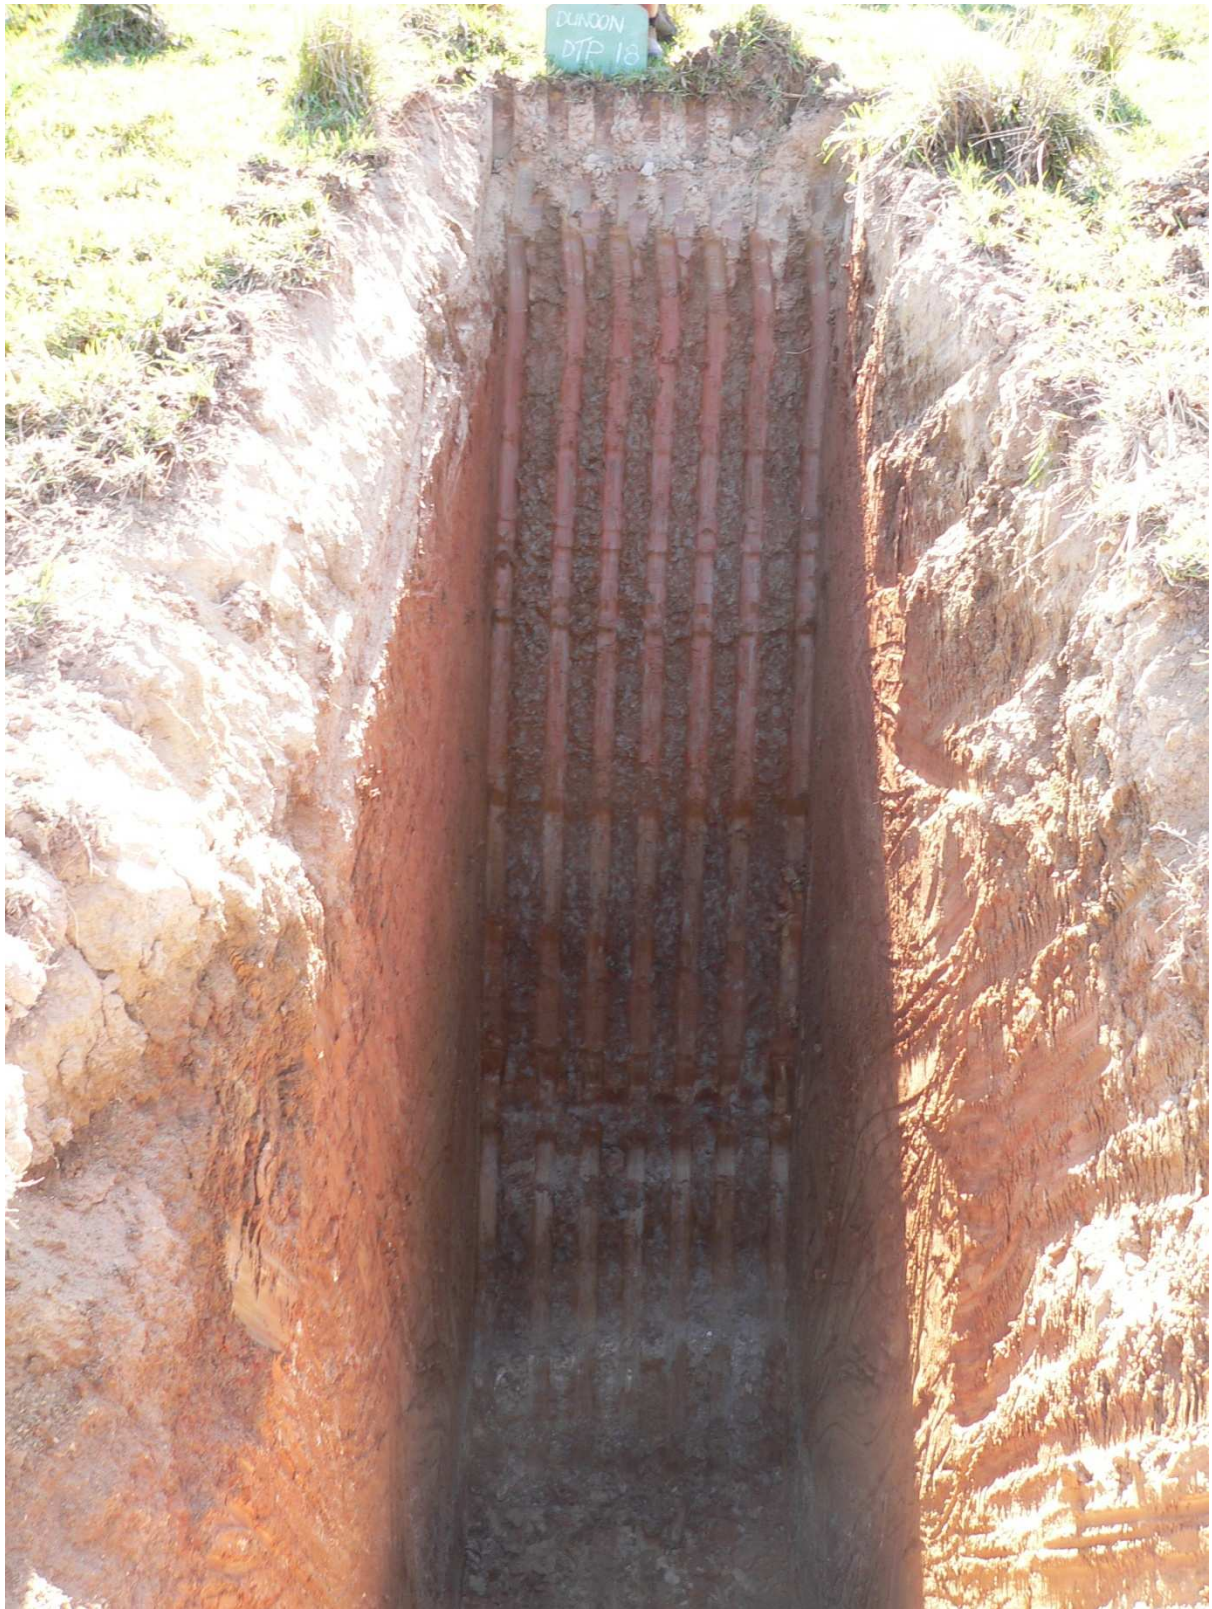
Test pit DTP 18

NSW GOVERNMENT		Public Works		DAMS & CIVIL		TEST PIT		DTP 18	
DUNOON DAM SITE						DATE		12.10.2012	
LOCATION		E 0529308		N 6828156		RL (m)		52	
CONTRACTOR J & M Bashforth				OPERATOR L McLeod		EQUIPMENT Caterpillar 320D L			
From	To	Sample	Class	Description					
0	0.3m		SM (Vis)	SILTY SAND (TOPSOIL); fine to medium grainsize, trace clay increasing to minor clay with depth, grey-brown, organic, trace grass roots, dry, medium dense. CLAYEY SILT/SILTY CLAY; trace fine to medium grained sand, grey-brown with traces of red-brown, trace grass roots, moist, stiff. SILTY CLAY; dark grey & red-brown mottled, moist, stiff/very stiff. Dark grey with some chocolate-brown mottles from 4.0m. EW/HW rock with SILTY CLAY, trace sand, behaves as CH, grey with white and brown, moist, stiff. SANDSTONE; HW/EW, medium to coarse grainsize, brown.

0.3	0.6m		CH (Vis)						
0.6	4.7m	1.0 – 2.0	CH (Vis)						
4.7	5.1m		CH & Rock (Vis)						
5.1	5.4m		Rock						
END OF PIT AT 5.4m IN HW SANDSTONE; REFUSAL – LIMIT OF REACH OF EXCAVATOR									
LOGGED: M. J. Neville

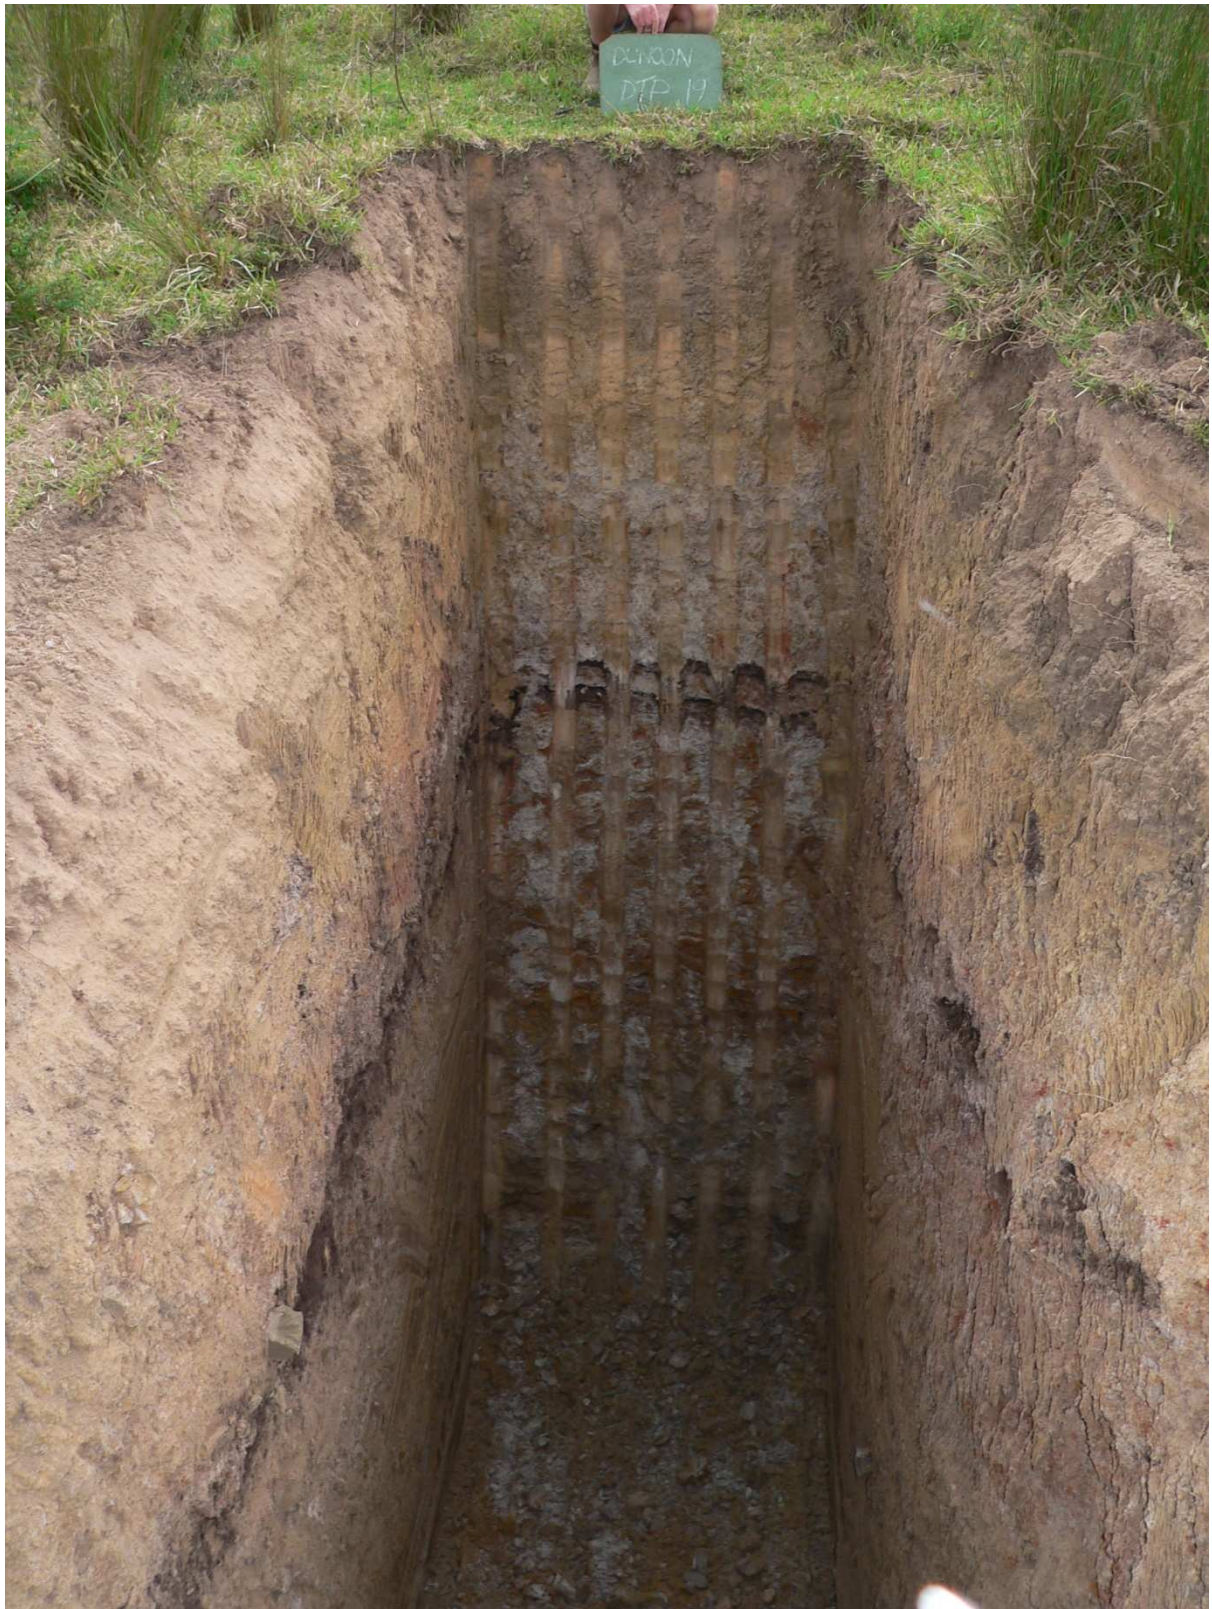
Test pit DTP 19

Public Works		DAMS & CIVIL		TEST PIT	DTP 19
DUNOON DAM SITE				DATE	11.10.2012
LOCATION		E 0529392	N 6828185	RL (m)	63
CONTRACTOR		J & M Bashforth	OPERATOR	L McLeod	EQUIPMENT Caterpillar 320D L
From	To	Sample	Class	Description	
0	0.4m		ML (Vis)	CLAYEY SILT (TOPSOIL); trace sand, grey-brown and brown, organic, trace grass roots, dry, firm.	
0.4	1.0m	0.5 – 1.0	CH (Lab)	SILTY CLAY; grey, grey-brown, brown & trace red-brown, moist, stiff.	
1.0	1.7m	1.0 – 1.7	CH & Rock (Lab)	SILTY CLAY & CLAYSTONE; EW, trace coal, light grey with minor red-brown mottles, moist, stiff.	
1.7	4.1m		CH & Rock (Vis)	CLAYSTONE WITH COAL SEAMS/LAMINAE; EW, light grey with brown & red-brown. Some EW/HW at 1.9m, behaves as CH. Dip ~5° in direction ~050°M. HW from ~2.9m, claystone & siltstone with minor fine sandstone.	
END OF PIT AT 4.1m IN HW CLAYSTONE					
LOGGED: M. J. Neville

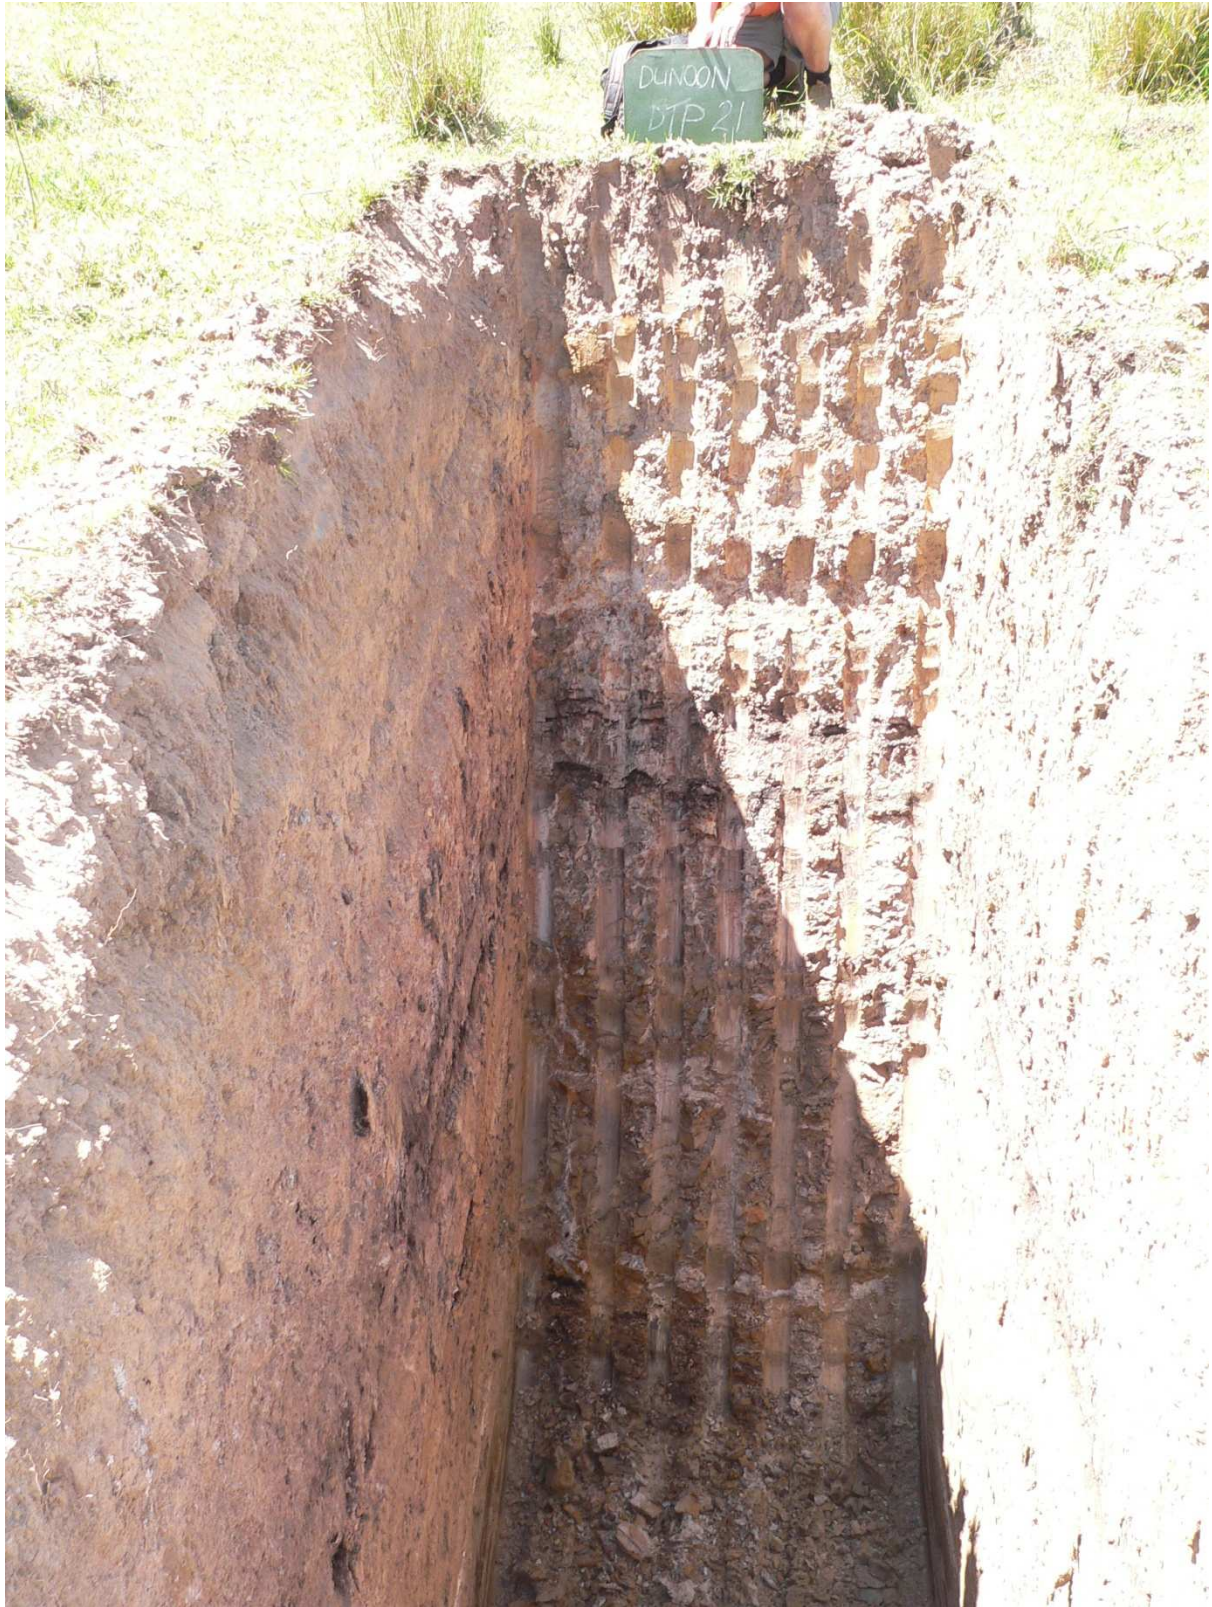
Test pit DTP 21

NSW GOVERNMENT		Public Works		DAMS & CIVIL		TEST PIT		DTP 21	
DUNOON DAM SITE						DATE		12.10.2012	
LOCATION		E 0529367		N 6828246		RL (m)		70	
CONTRACTOR J & M Bashforth				OPERATOR L McLeod		EQUIPMENT Caterpillar 320D L			
From	To	Sample	Class	Description					
0	0.35m		ML/MI (Vis)	CLAYE SILT (TOPSOIL); grey with some brown mottles, organic, trace grass roots, just moist, firm to stiff.

0.35	1.1m		CH (Vis)	SILTY CLAY; grey with brown & minor red-brown mottles, moist, stiff. GRADATIONAL LOWER BOUNDARY					
1.1	3.9m	1.1 – 1.6	CH & Rock (Lab)	CLAYSTONE; EW with SILTY CLAY/CLAYEY SILT; behaves as CH, grey with traces of red-brown & black, moist, stiff. 1.7 – 2.0m thin coal seams, the CLAYSTONE, EW/HW, becoming HW/MW by the base of the pit. Coal dip ~2° – 3° in direction ~150°M					
<p>END OF PIT AT 3.9m IN HW/MW CLAYSONE – DIFFICULT TO EXCAVATE</p>									
<p>LOGGED: M. J. Neville</p>

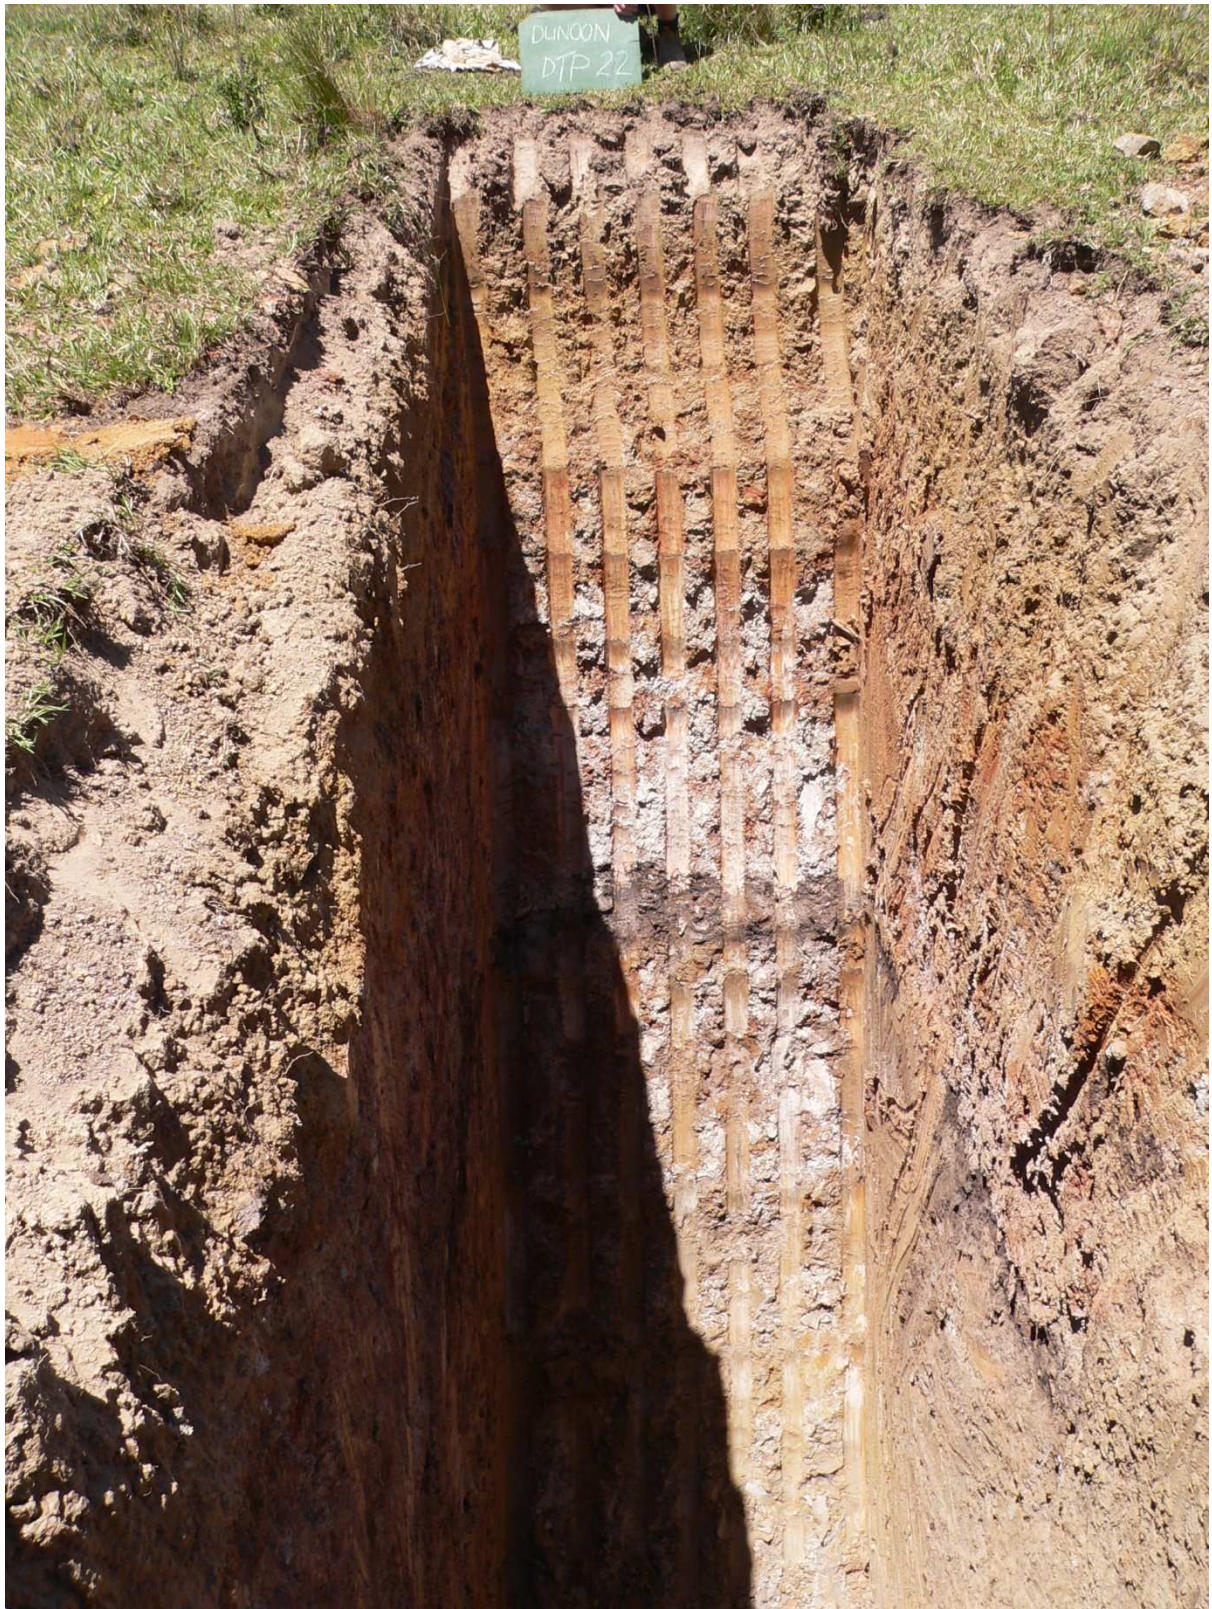
Test pit DTP 22

NSW GOVERNMENT		Public Works		DAMS & CIVIL		TEST PIT		DTP 22	
DUNOON DAM SITE						DATE		12.10.2012	
LOCATION		E 0529458		N 6828280		RL (m)		69	
CONTRACTOR J & M Bashforth				OPERATOR L McLeod		EQUIPMENT Caterpillar 320D L			
From	To	Sample	Class	Description					
0	0.35m		ML (Vis)	CLAYEY SILT (TOPSOIL); minor sand, grey-brown, organic, trace grass roots, dry, firm.					
0.35	0.9m		CH (Vis)	SILTY CLAY; grey-brown & brown, trace grass roots in upper half, moist, stiff.					
0.9	2.1m		CH & Rock (Vis)	CLAYSTONE; EW & SILTY CLAY, trace coal, grey & minor brown, minor red-brown & black, behaves as CH, moist, stiff.					
2.1	5.1m		Rock	SILTSTONE; EW/HW, grey & brown, becomes grey with some brown, moist, stiff.					
END OF PIT AT 5.1m IN HW SILTSTONE – NEAR LIMIT OF REACH OF EXCAVATOR									
LOGGED: M. J. Neville

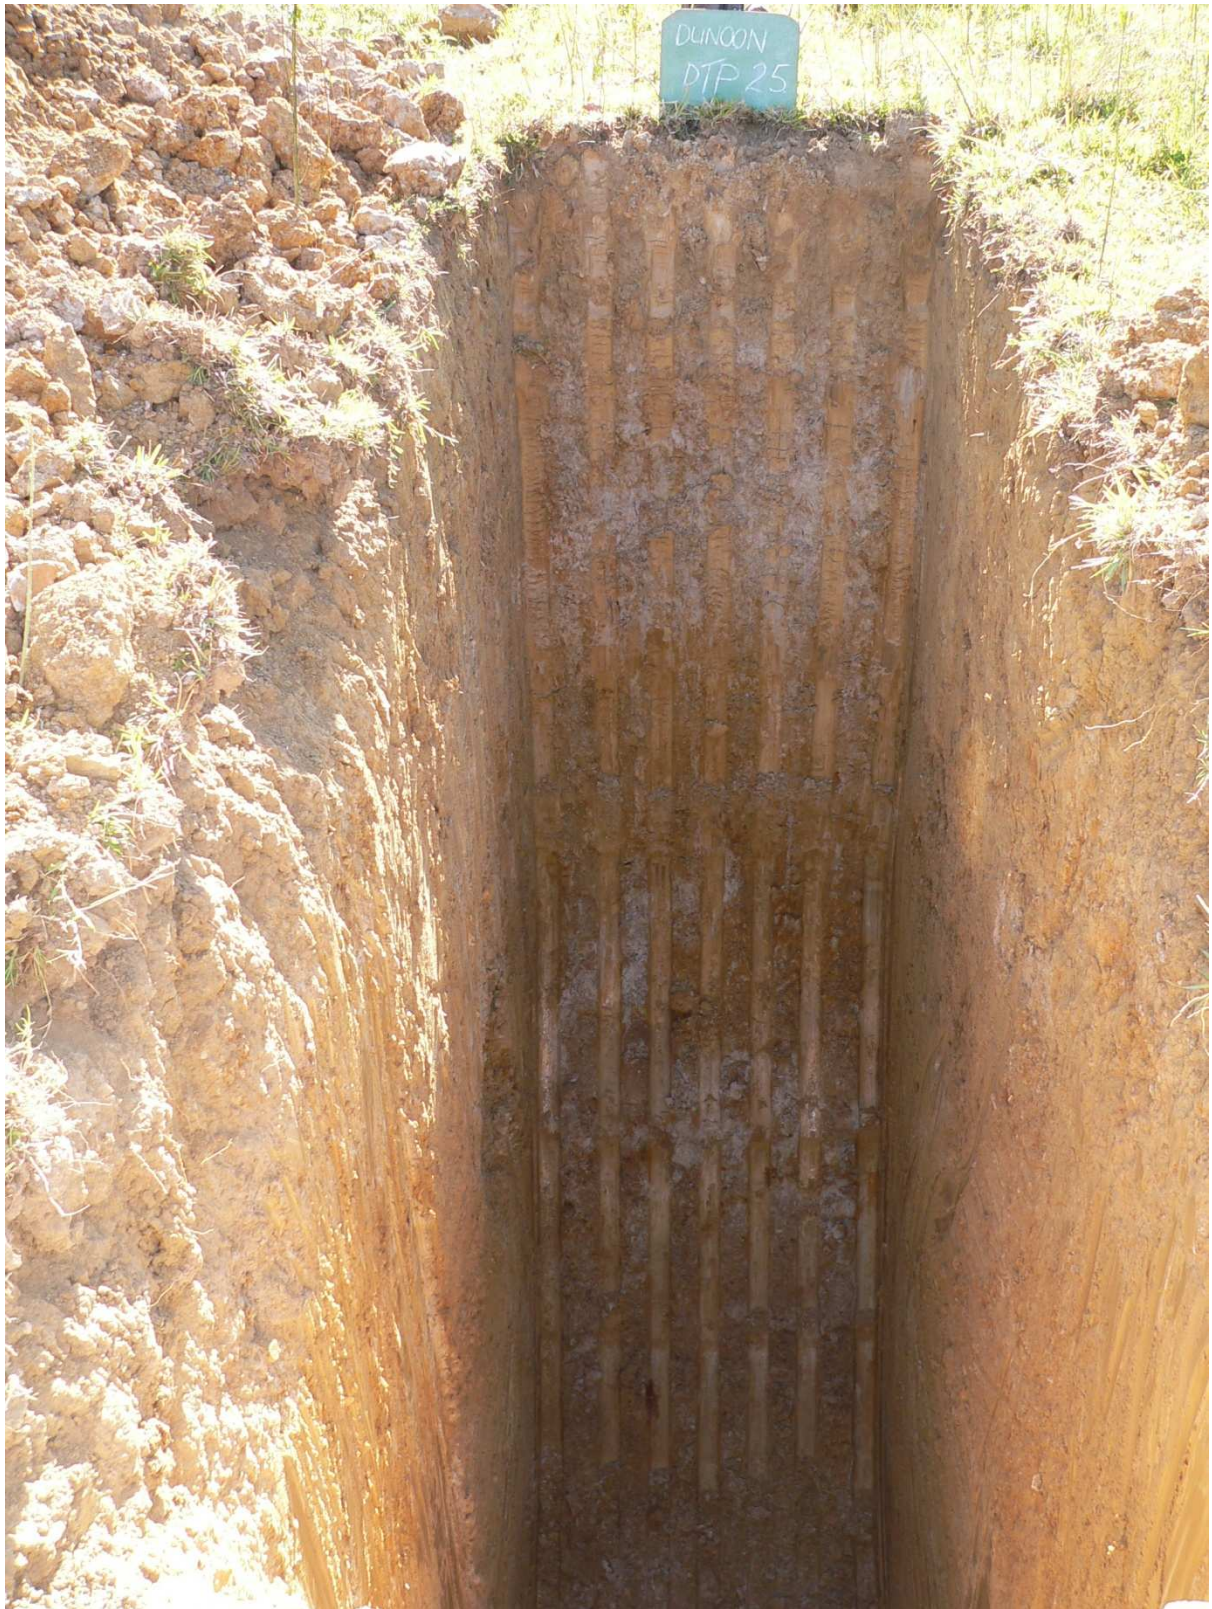
Test pit DTP 25

Public Works		DAMS & CIVIL		TEST PIT	DTP 25
DUNOON DAM SITE				DATE	13.10.2012
LOCATION		E 0529602	N 6828233	RL (m)	84
CONTRACTOR		J & M Bashforth	OPERATOR	L McLeod	EQUIPMENT Caterpillar 320D L
From	To	Sample	Class	Description	
0	0.2m		ML (Vis)	CLAYEY SILT (TOPSOIL); trace to minor sand, grey-brown, organic, trace grass roots, dry, firm.

0.2	0.6m		MI (Vis)	CLAYEY SILT; minor sand, grey-brown with minor yellow-brown, trace grass roots at top, moist, stiff.	
0.6	~3.0m	0.6 – 1.2	CI & Rock (Lab)	SANDSTONE; EW, with SANDY SILTY CLAY/CLAYEY SAND, behaves as CI, grey & orange-brown mottled, moist, stiff. Minor seepage at ~2.5m (single point source).	
~3.0	5.3m		CH & Rock (Vis)	CLAYSTONE; EW, & SILTY CLAY, behaves as CH, grey with brown mottles, moist, stiff. Some interbedded fine grained sandstone, EW.	
<p>END OF PIT AT 5.3m – LIMIT OF REACH OF EXCAVATOR – Minor grit at base, rock fragments.</p>					
<p>LOGGED: M. J. Neville</p>

No obvious springs were observed at the embankment/wall site. In the proposed borrow area, an area of boggy ground between test pits DTP 25 and DTP 29 suggests a area of slight seepage from the side of the spur, possibly flowing from the base of basalt that crops out higher on the spur.

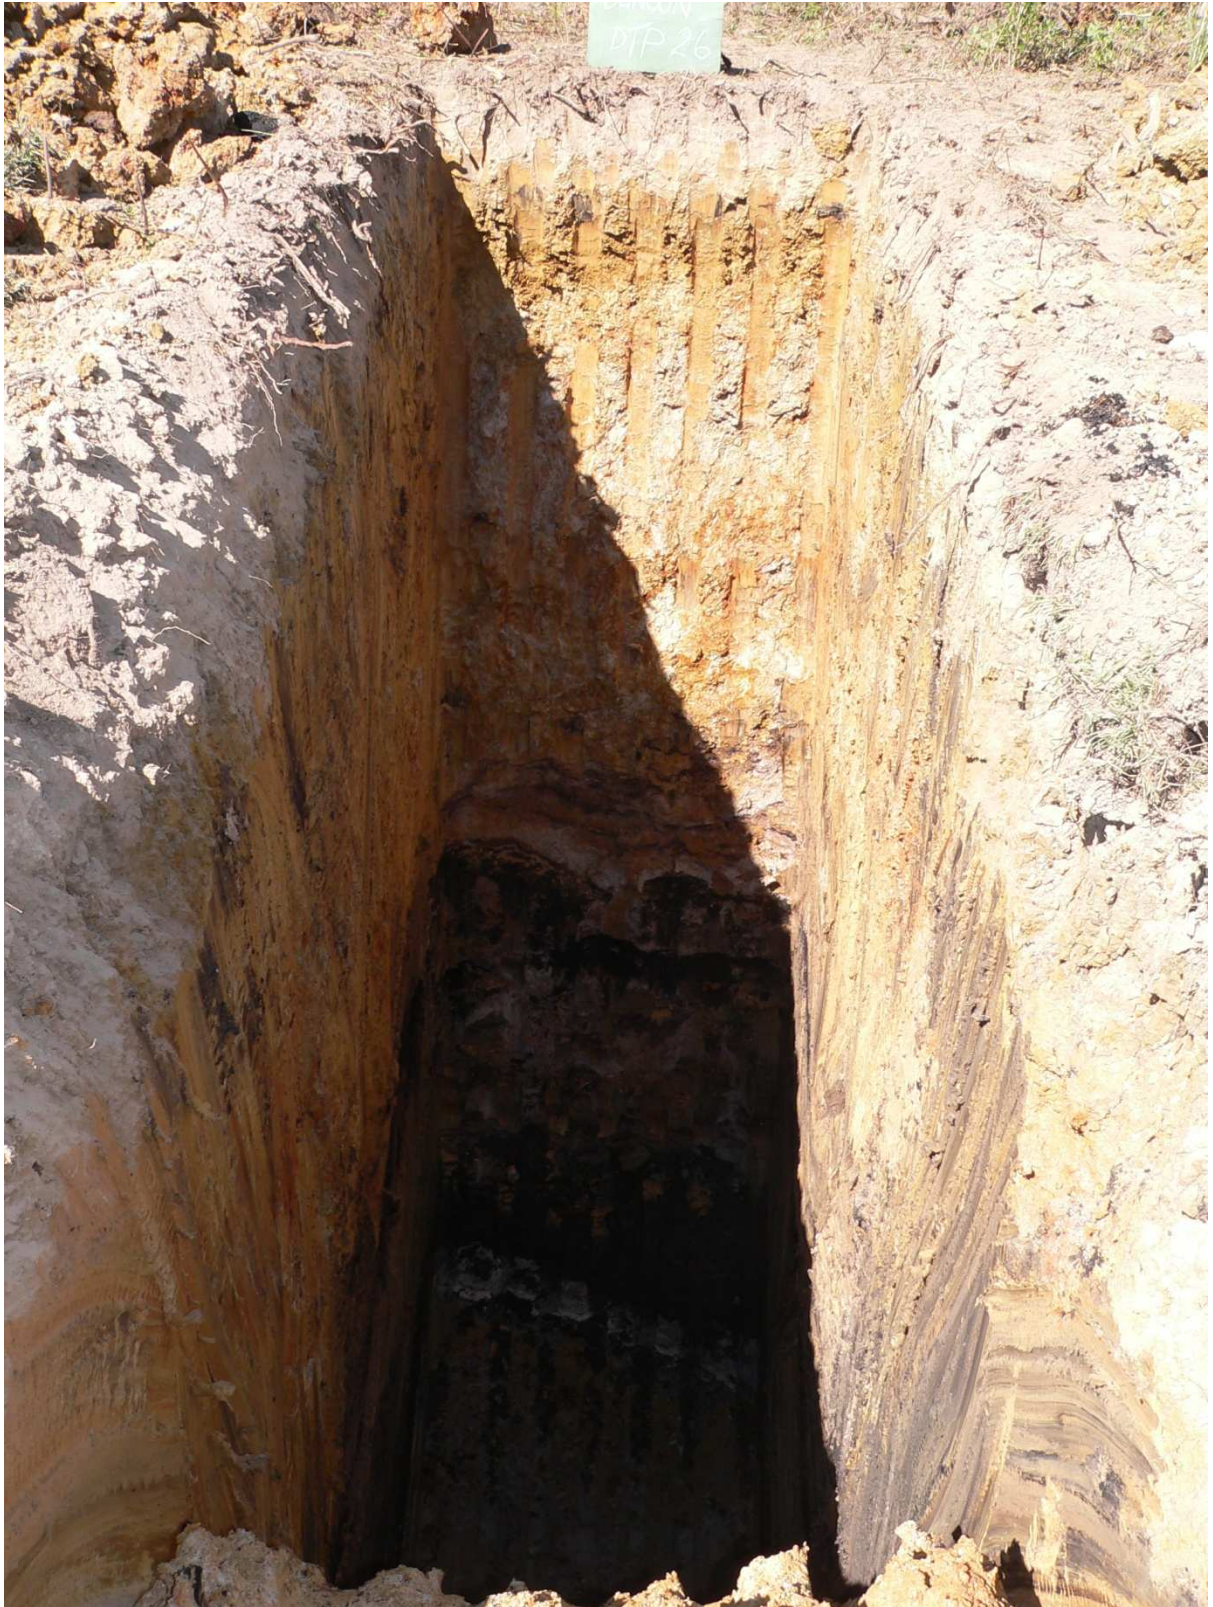
Test pit DTP 26

Public Works		DAMS & CIVIL		TEST PIT	DTP 26
DUNOON DAM SITE				DATE	13.10.2012
LOCATION		E 0529539	N 6828175	RL (m)	79
CONTRACTOR		J & M Bashforth	OPERATOR	L McLeod	EQUIPMENT Caterpillar 320D L
From	To	Sample	Class	Description	
0	0.2m		SM (Vis)	SANDY SILT/SILTY SAND (TOPSOIL); grey-brown, organic, trace grass roots, dry, firm.	
0.2	0.65m		CH (Vis)	SILTY CLAY; grey-brown, yellow-brown, with traces of grey & red-brown, moist, stiff.	
0.65	3.7m	0.7 – 1.8	CH & Rock (Vis)	CLAYSTONE/SILTY CLAY; EW, behaves as CH, grey with brown & red-brown mottles, moist, stiff. 2.4 – 2.7m Coal laminae dip ~2° in direction ~200°M	
3.7	5.5m		MH & Rock (Vis)	CLAYSTONE; EW/HW, with silty clay, behaves as MH, grey with brown, moist, stiff. ~4.3m Coal seam, ~0.1m.	
<p>END OF PIT AT 5.5m – LIMIT OF REACH OF EXCAVATOR IN EW CLAYSTONE/ SILTY CLAY, MH.</p>					
LOGGED: M. J. Neville

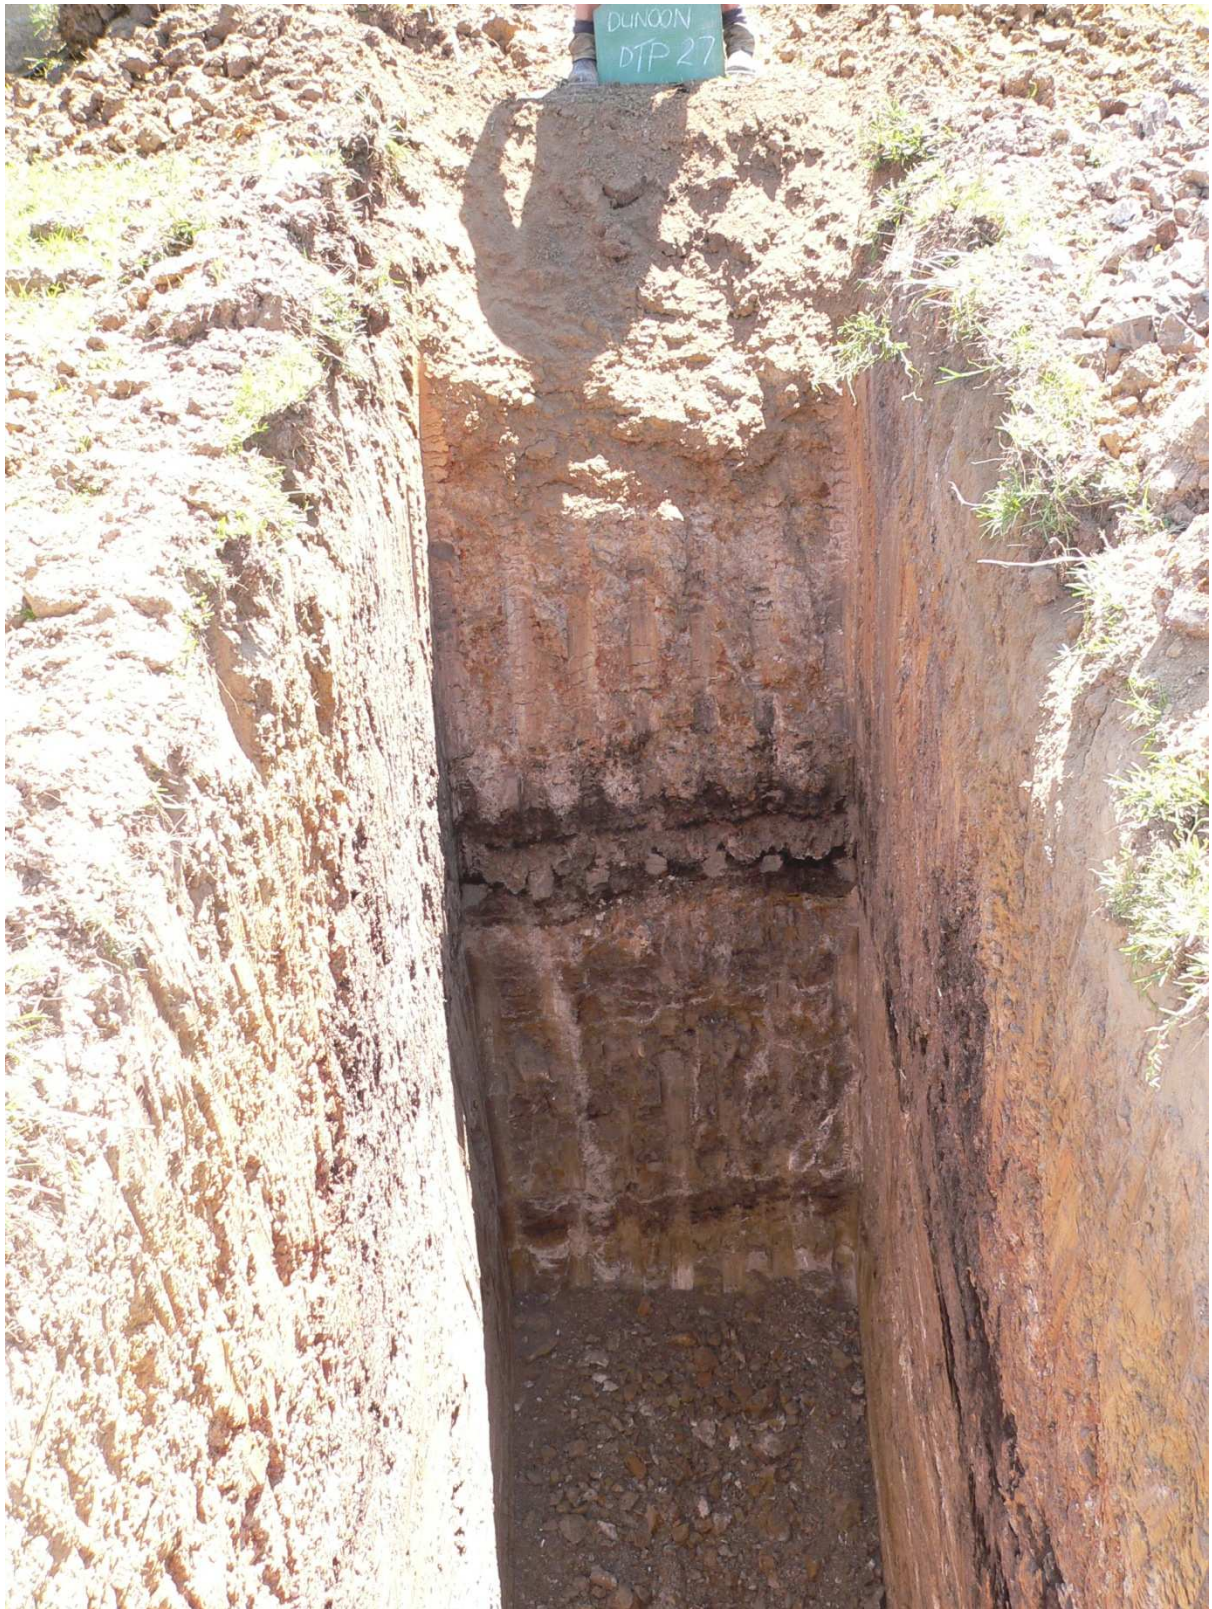
Test pit DTP 27

0.4	0.9m		CH (Vis)	SILTY CLAY; grey-brown & brown with trace red-brown, trace grass roots in upper half, moist, stiff.					
0.9	2.4m		CH & Rock (Vis)	SILTY CLAY/CLAYSTONE; EW, behaves as CH, grey with grey-brown, brown & red-brown mottles, moist, stiff. Minor coal seams at 1.5m, black, dip ~2° – 3° in direction ~270°M.

2.4	4.7m		MH & Rock (Vis)	CLAYSTONE; EW/HW, with silty clay, behaves as MH, grey with brown, moist, stiff. Minor coal seams. Predominantly HW from 3.3m, some white coatings on some partings – talc-like.					
PIT TERMINATED AT 4.7m IN HW CLAYSTONE									
LOGGED: M. J. Neville

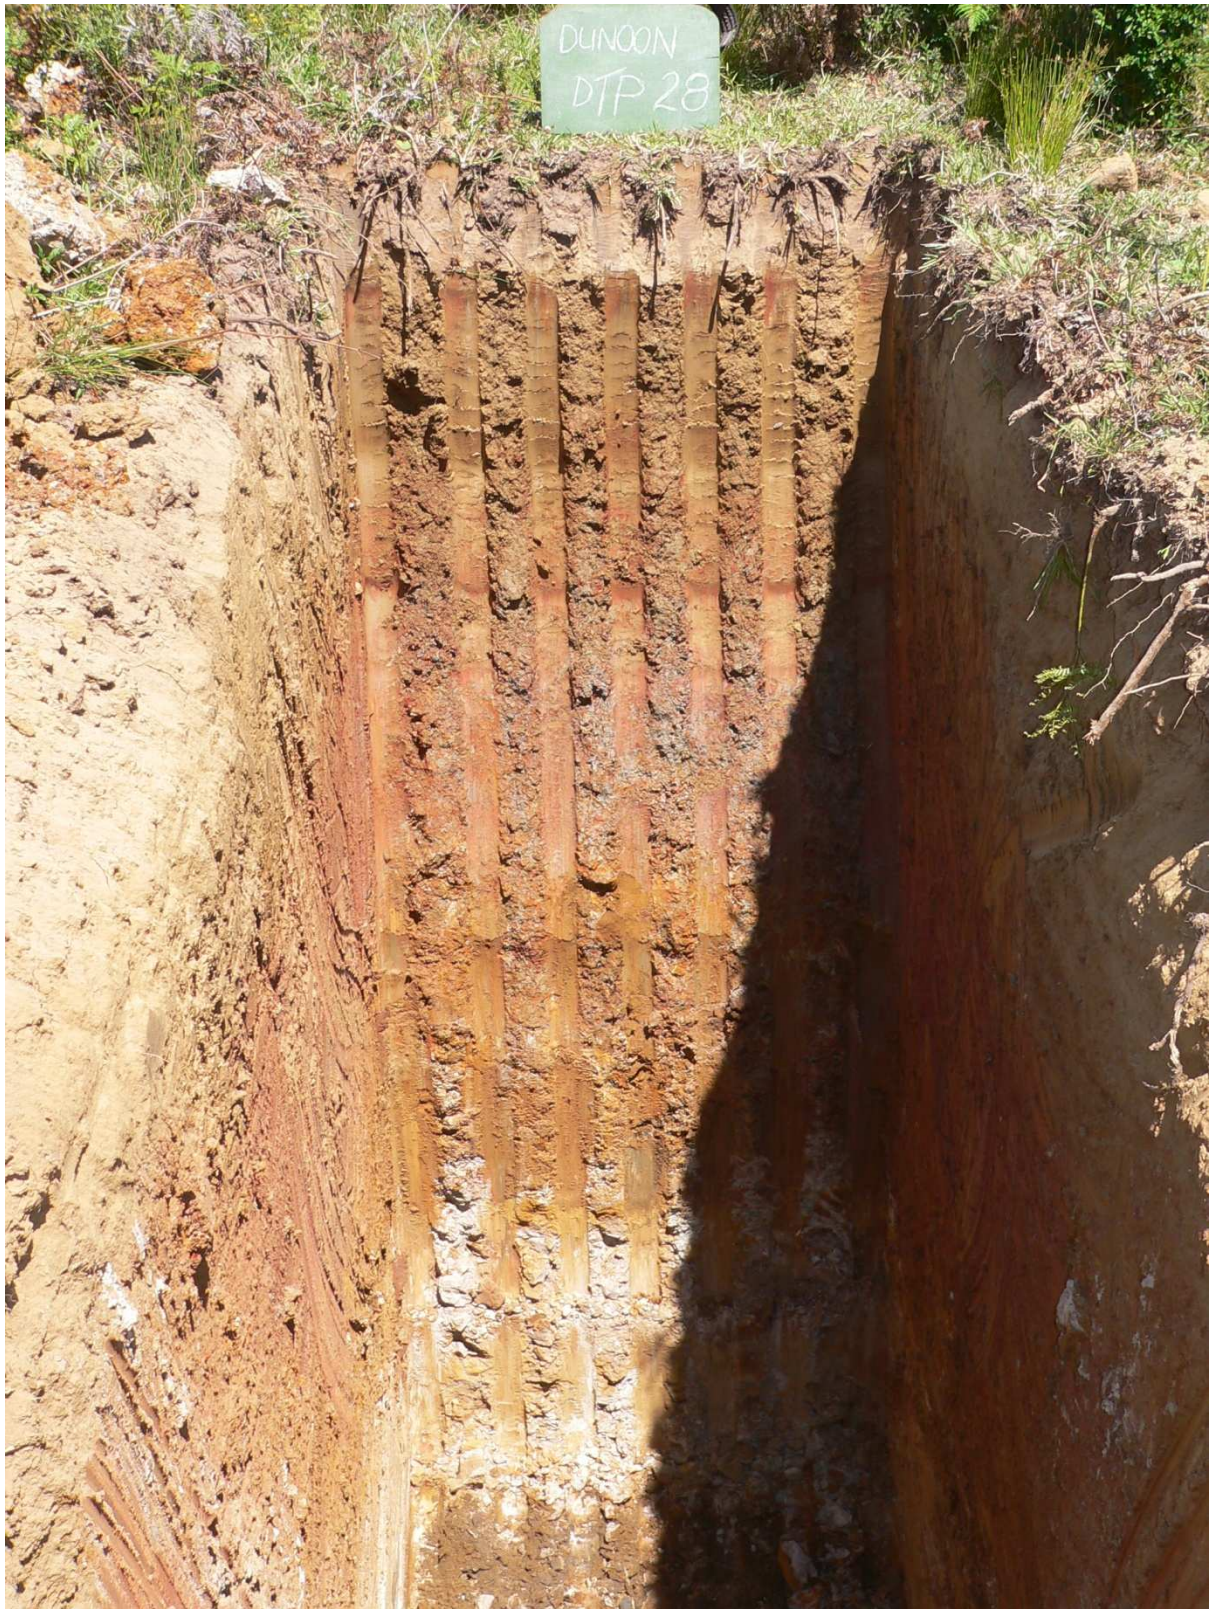
Test pit DTP 28

NSW GOVERNMENT		Public Works		DAMS & CIVIL		TEST PIT		DTP 28	
DUNOON DAM SITE						DATE		13.10.2012	
LOCATION		E 0529364		N 6828093		RL (m)		54	
CONTRACTOR J & M Bashforth				OPERATOR L McLeod		EQUIPMENT Caterpillar 320D L			
From	To	Sample	Class	Description					
0	0.4m		ML (Vis)	SANDY CLAYEY SILT (TOPSOIL); medium grained sand, trace ash, grey-brown, organic, trace grass roots, dry/just moist, firm.					
0.4	1.0	0.4 – 1.0	CH (Vis)	SILTY CLAY; trace fine sand, grey-brown & red-brown mottled, trace ash, moist, stiff.					
1.0	2.3m	1.0 – 1.5	CH (Vis)	SILTY CLAY; grey & red-brown mottled, trace ash, moist, stiff/very stiff.					
2.3	3.4m		MH & Rock (Vis)	SILTSTONE, CLAYSTONE & SANDSTONE; EW, behaves as MH, brown & grey, moist, firm to stiff.					
END OF PIT AT 3.4m IN HW SILTSTONE.									
LOGGED: M. J. Neville

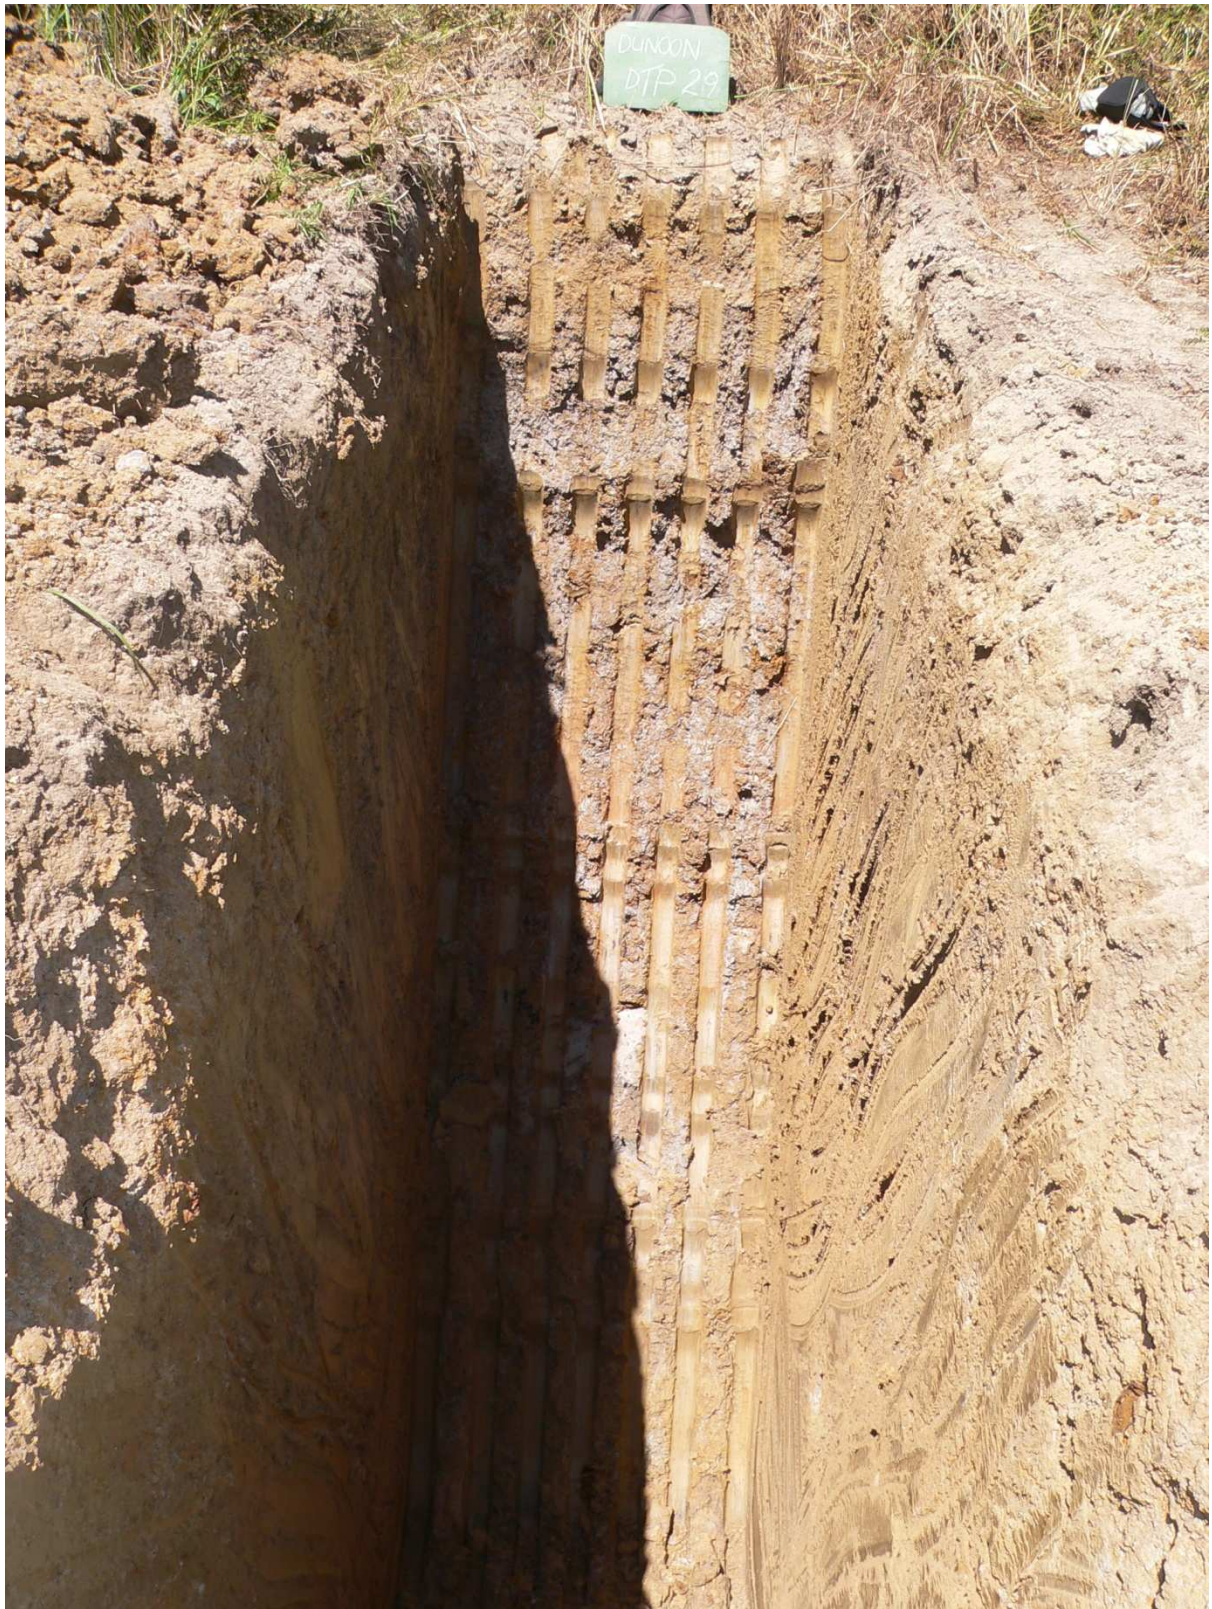
Test pit DTP 29

NSW GOVERNMENT		Public Works		DAMS & CIVIL		TEST PIT		DTP 29	
DUNOON DAM SITE						DATE		13.10.2012	
LOCATION		E 0529670		N 6828224		RL (m)		79	
CONTRACTOR J & M Bashforth				OPERATOR L McLeod		EQUIPMENT Caterpillar 320D L			
From	To	Sample	Class	Description					
0	0.2m		ML (Vis)	SANDY CLAYEY SILT (TOPSOIL); trace ash, grey-brown, organic, trace grass roots, dry/just moist, firm.					
0.2	4.9m	0.7 – 1.6	CH (Vis)	SANDY SILTY CLAY; trace pebbles (ironstone), trace ash, grey & brown mottled, possibly increasing clay content with depth, moist, stiff. 2.9 – 3.5m trace pebbles/cobbles.					
END OF PIT AT 4.9m – LIMIT OF REACH OF EXCAVATOR									
LOGGED: M. J. Neville
