# **Bora Creek Active Floodgate Management Plan**

**2019-2022**

## Management Plan operational summary

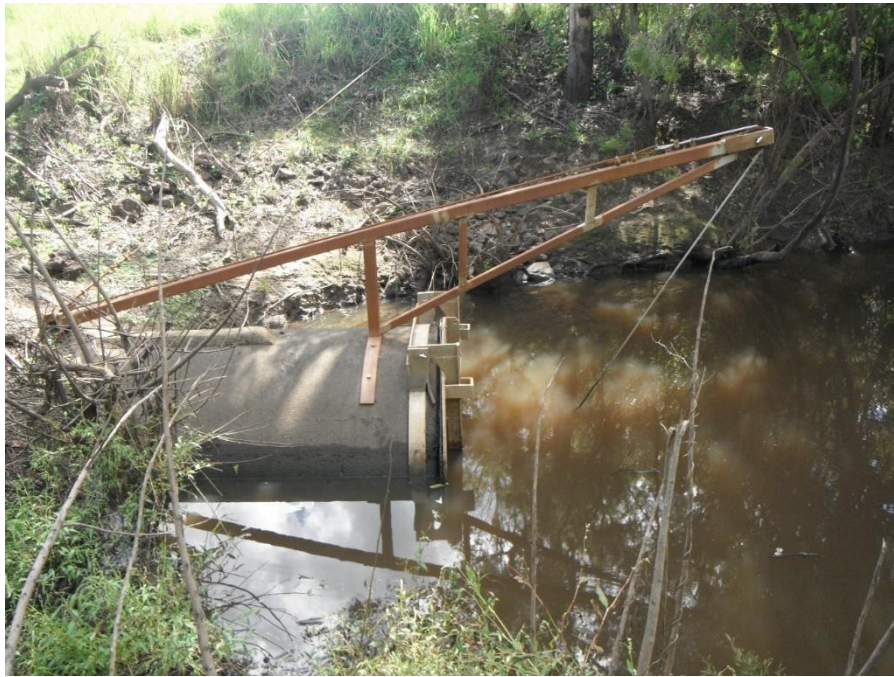
*2: Bora Creek floodgate and lifting gear in operational position.*

Currently, the floodgate is opened with a winch and fixed with a cable so it is horizontally out of the water. This allows for the floodgate to be opened fully for maximum tidal exchange. The floodgate is open all year, and only lowered into an operational position before flood events to protect upstream areas from riverine inundation. The operational position is when the floodgate hangs free to allow water from upstream to discharge on low tide or prevent river flooding from moving upstream, depending on water levels. This is the optimal strategy for the existing floodgate structure and no improvement can be suggested at this time for future management of it.

- One, 1800mm round style floodgate, operated with a horizontal lifting gear and winch

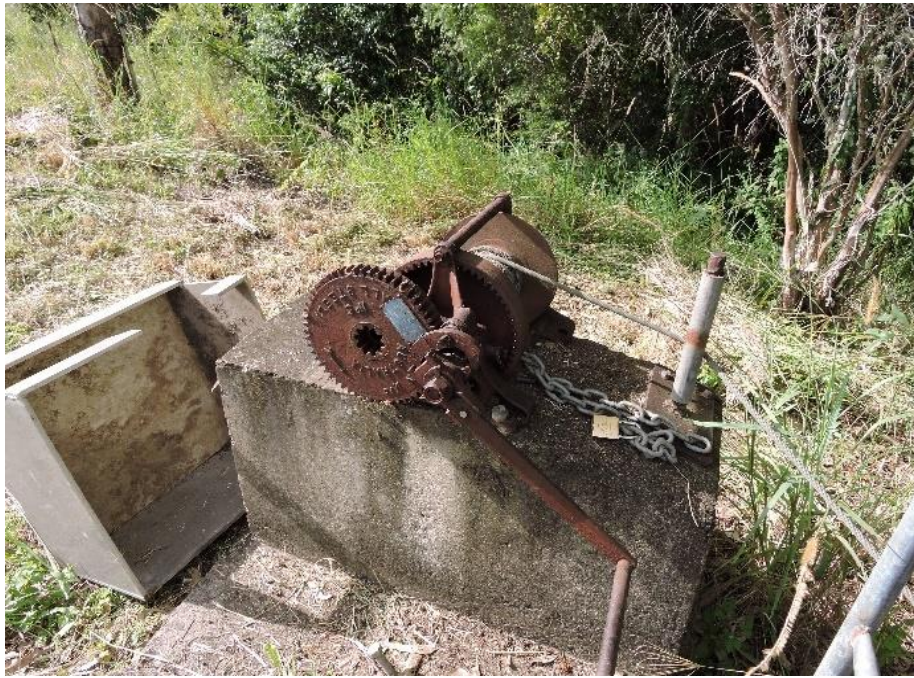
4: Bora Creek winch.

- The floodgate is fitted with a winch and large forces can be involved in winch and cable systems.
- The floodgate should only be opened on a low or falling tide. This will reduce the risk of the wire rope or chain breaking and the floodgate bowing.
- The floodgate is opened and lowered by nominated landowner volunteer or Council operator, who should consult and follow the approved Safe Work Procedure and Floodgate Fact Sheet relevant for the activity and undertake their own risk assessment before operating the floodgate.
- Operating the floodgate during and after heavy rain or flooding can require working in wet and slippery conditions. Safe access to the site should be assessed after events.
- The floodgate is only to be operated during daylight hours.

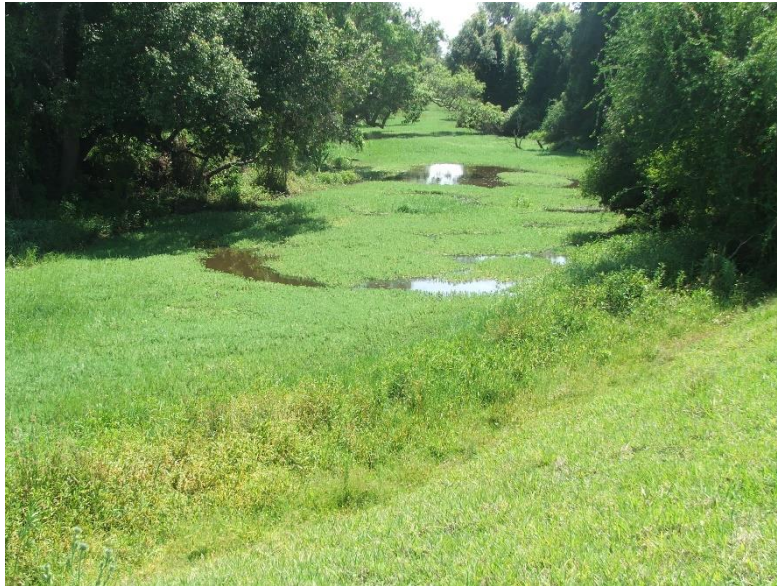
*5: Bora Creek almost completely covered with aquatic weeds in around 2006.*

Previous infestations of aquatic weeds have been so severe that they covered the majority of the waterway (see photos below). In around 2006, the former Richmond River County Council and Far North Coast Weeds (with financial assistance from Northern Rivers Catchment Management Authority) used a weed harvester to mechanically remove the weeds and open up the channel. Since then tidal flushing and Council's spraying program has managed aquatic weeds within the system.

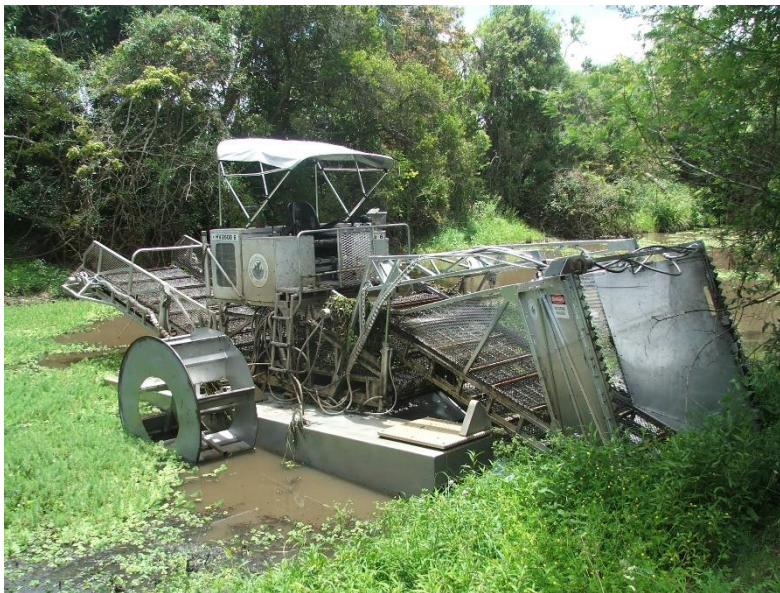
*6: The weed harvester used to mechanically remove the weeds and open the creek channel.*

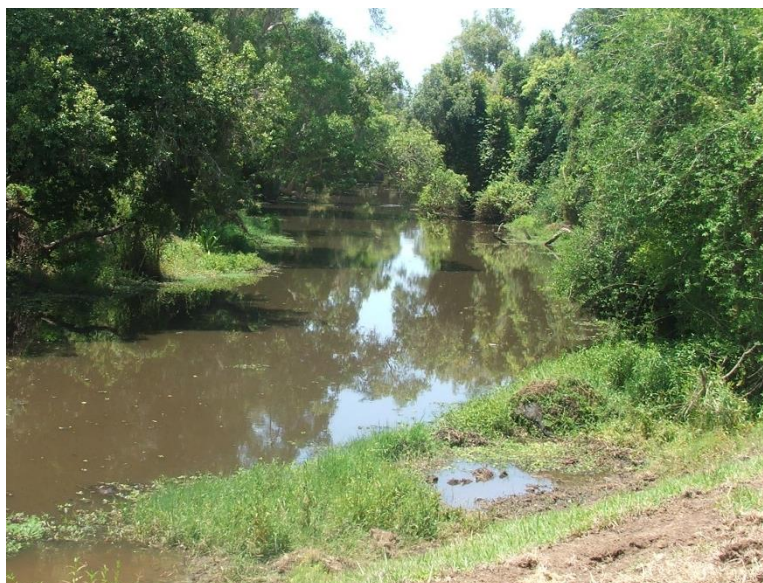
*7: Bora Creek after mechanical removal of weeds in 2006.*

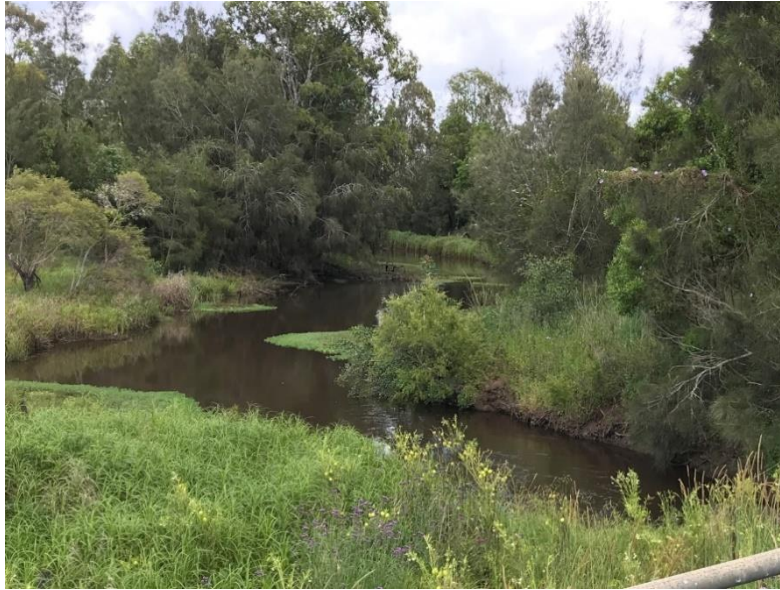
8: Bora Creek looking upstream from the floodgate 13 years on from mechanical cleaning (2018).

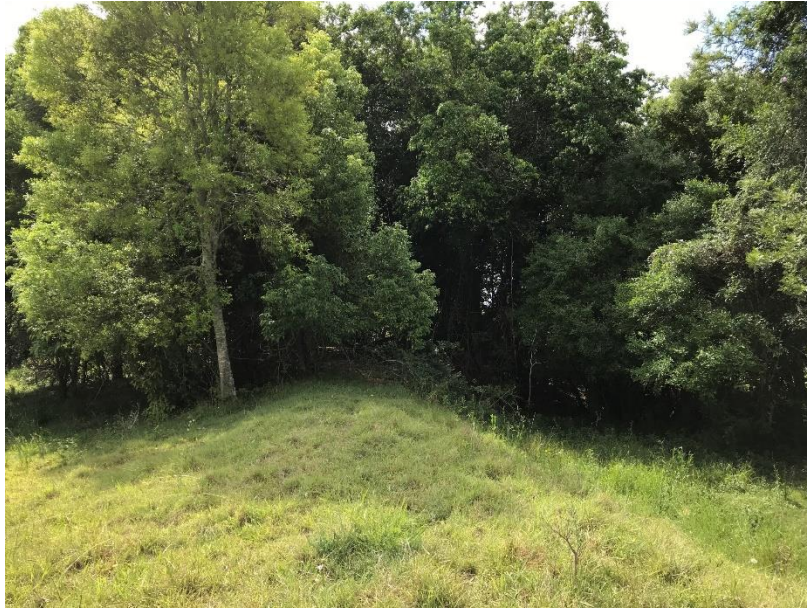
*10: Historical levee on north-west upper arm of creek.*

During the 1920s, a levee was constructed on the north-west arm approximately 1km from the creek's mouth to prevent flooding from the Haughwood area, inundating the upper Bora Creek catchment and to drain lands behind the levee. It is not known who constructed the levee.

To connect the upper and lower sections of the creek a 1500mm pipe with floodgate was installed in the levee where the creek intersected (RRCC, 2009). In 2009, Council recorded that the pipe had collapsed, and the floodgate dislodged, allowing only a minimal amount of flow through the pipe in either direction. The suggestion at the time was to replace the pipe and a modified floodgate be installed, to allow tidal flushing. During a site visit in 2018 the pipe could not be seen in the levee.

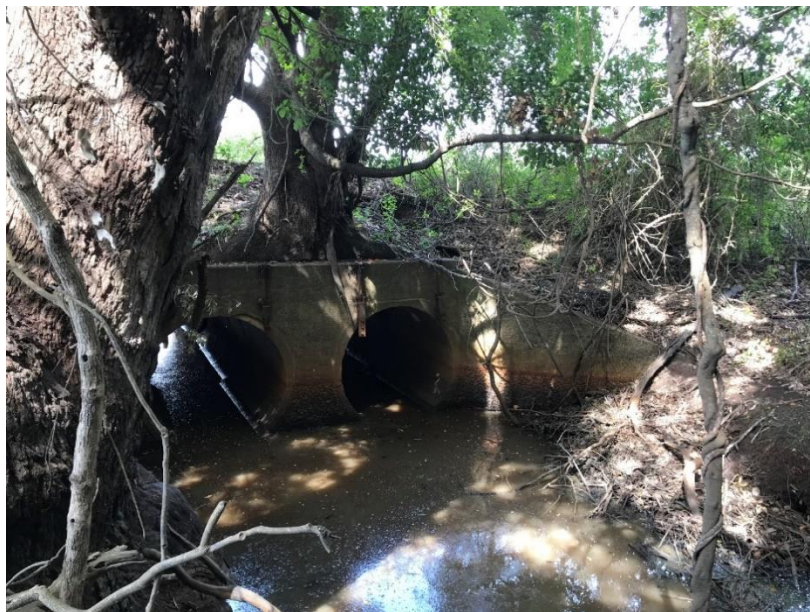
*11: Historic culvert and levee on south-west upper arm of creek, looking upstream.*

A second levee, with a two-pipe, concrete culvert, exists on the south-west arm approximately 1.5km from the creek's mouth. It is not known who constructed the levee and installed the structure, or when that occurred. Previously, two floodgates, possibly wooden, were located on the downstream face, seemingly facilitating drainage from the Haughwood Road area and preventing ingress of waters from the creek further upstream. These floodgates no longer exist, and two floodgates that Council manages are located upstream.

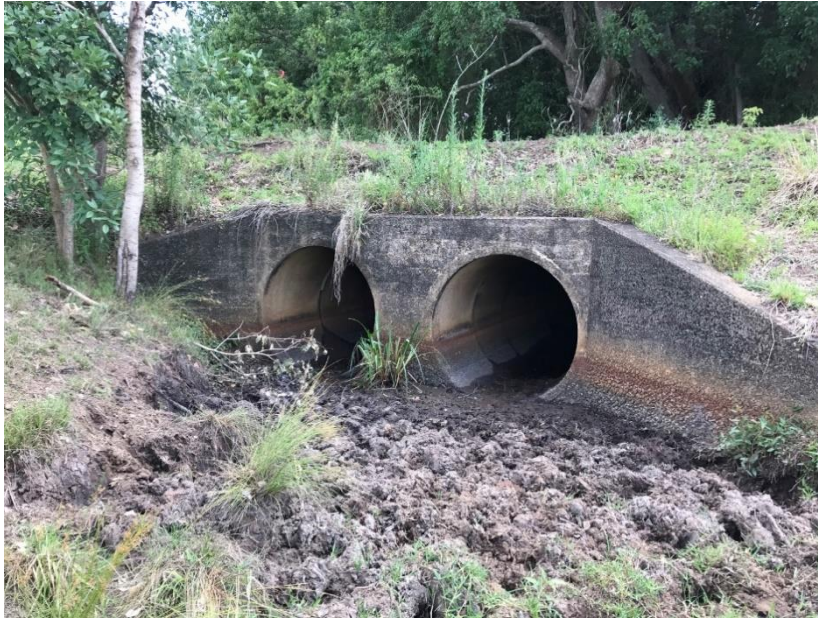
12: Historic culvert and levee on south-west upper arm of creek, looking downstream.

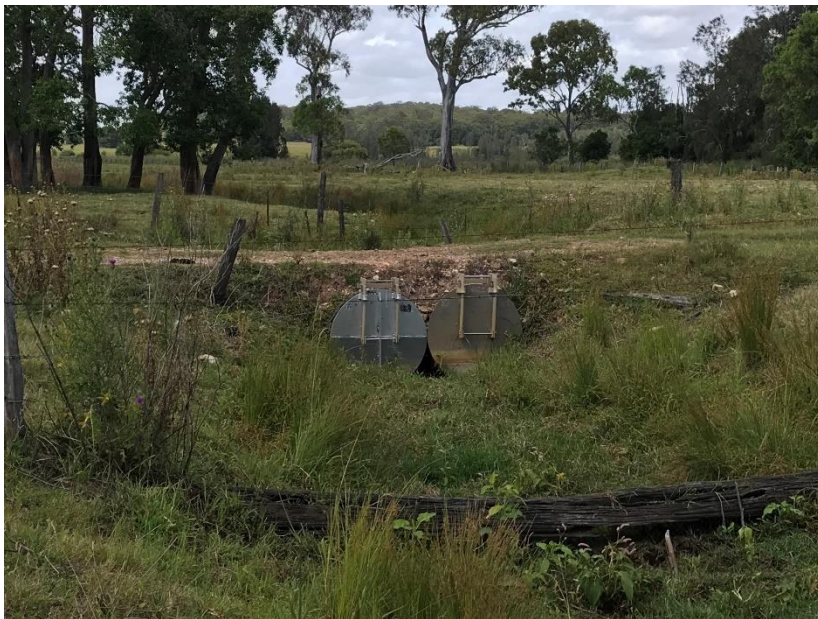
13: Council managed floodgates (asset number 1975) on upper south-west arm of Bora Creek.

- Two, 900mm round style floodgates

When the first Active Floodgate Management Plan was developed in 2001, two 900mm floodgates were installed by Council above the historic culvert on the south-west arm to address landowner concerns. These floodgates were installed instead of the historic culvert floodgates being replaced. These new floodgates prevent flood water from Bora Creek moving upstream into low-lying areas and facilitates drainage of water off surrounding paddocks.
