Keith Hall Drainage System Active Floodgate Management Plan

2020-2023

Management Plan operational summary

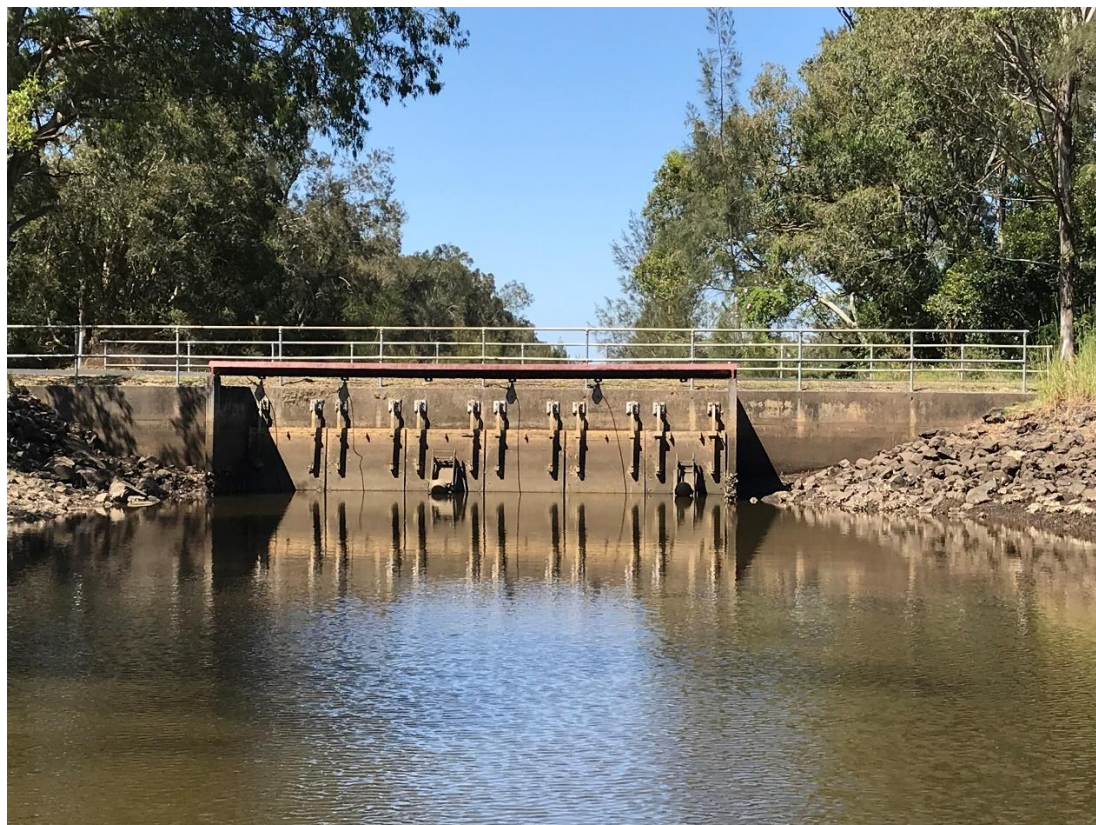
2: KHDS floodgates, showing two previously installed automatic tidal float mechanisms.

- Six square 1,800mm floodgates, one with a sluice window operated with a winch, another with an automatic, tidal float mechanism.

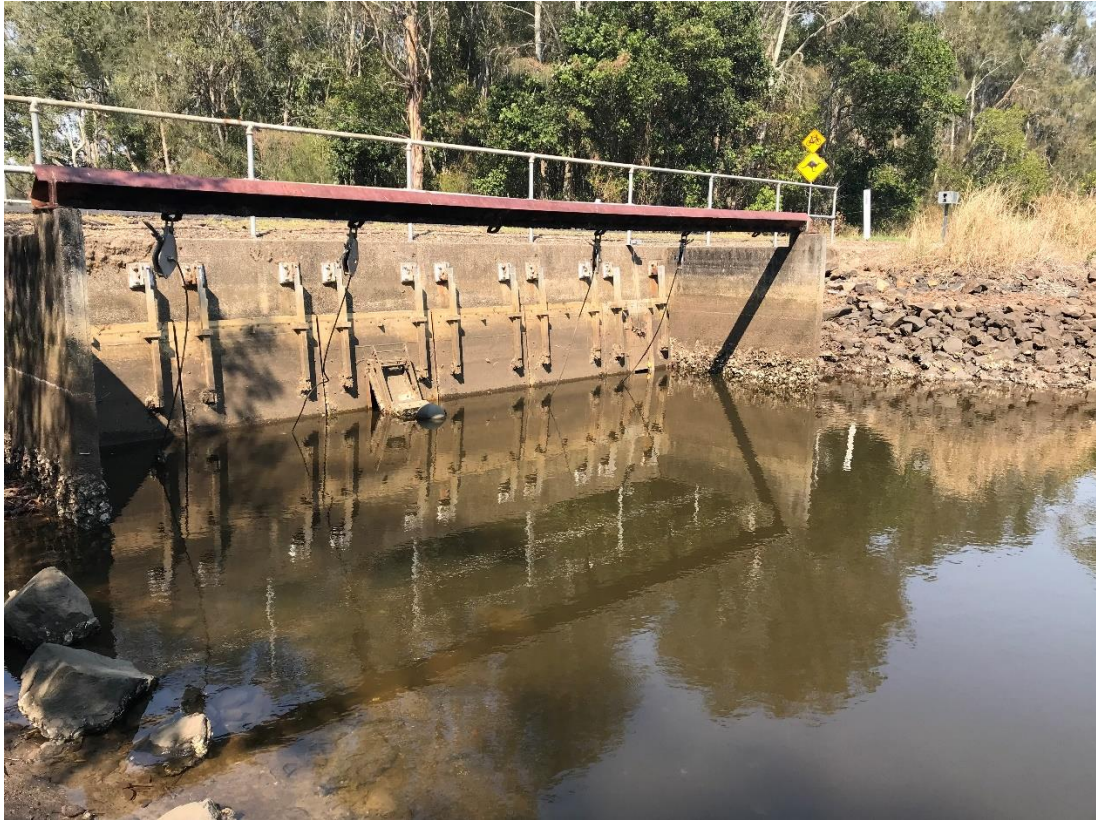
3: KHDS floodgates, showing the automatic tidal float mechanism and new sluice window on the far right floodgate.

A sluice window was installed as part of the trial, replacing one of the two existing automatic tidal float mechanisms. The Keith Hall floodgates are currently fitted with both a sluice window (controlled by a winch) and an automatic tidal float mechanism.

In 2019, Rous County Council replaced one of the automatic tidal float mechanisms with a sluice window to allow more tidal exchange.

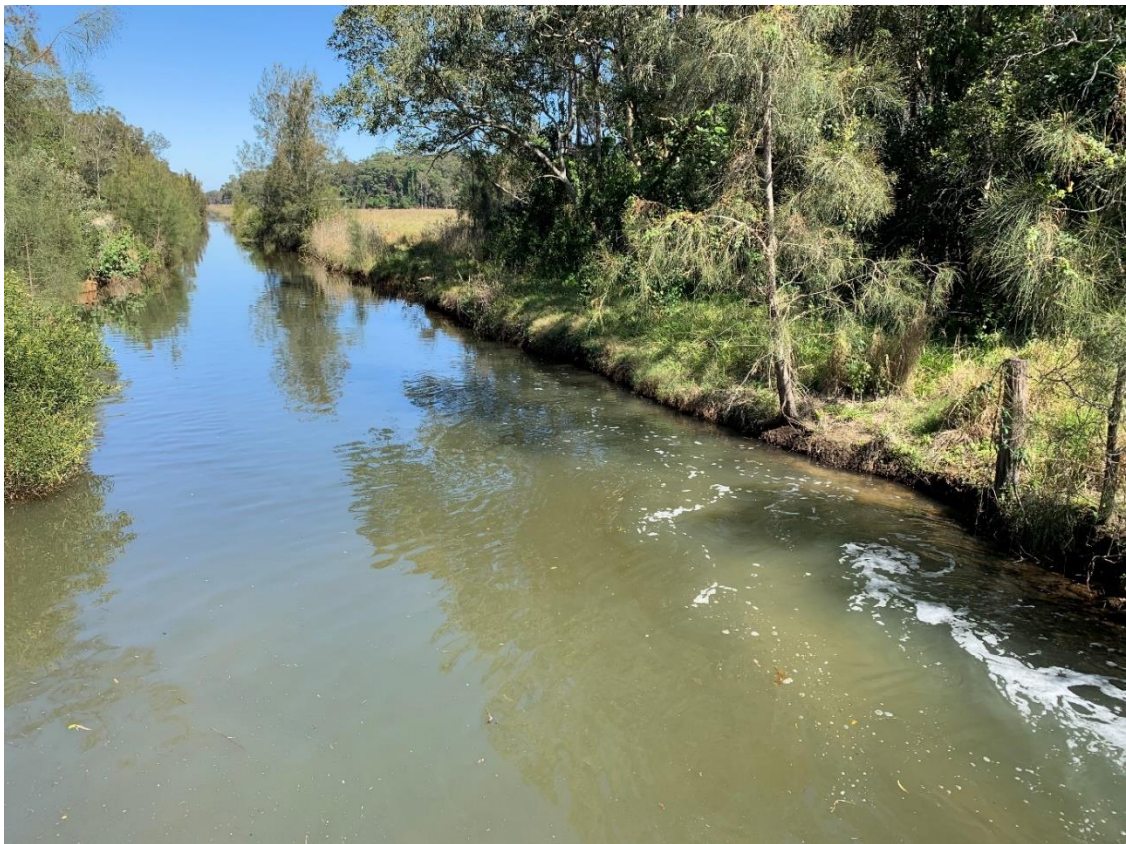
4: Keith Hall No.1 flood mitigation drain looking immediately upstream of the floodgates at Mobbs Bay. Note incoming tidal water through the sluice window.

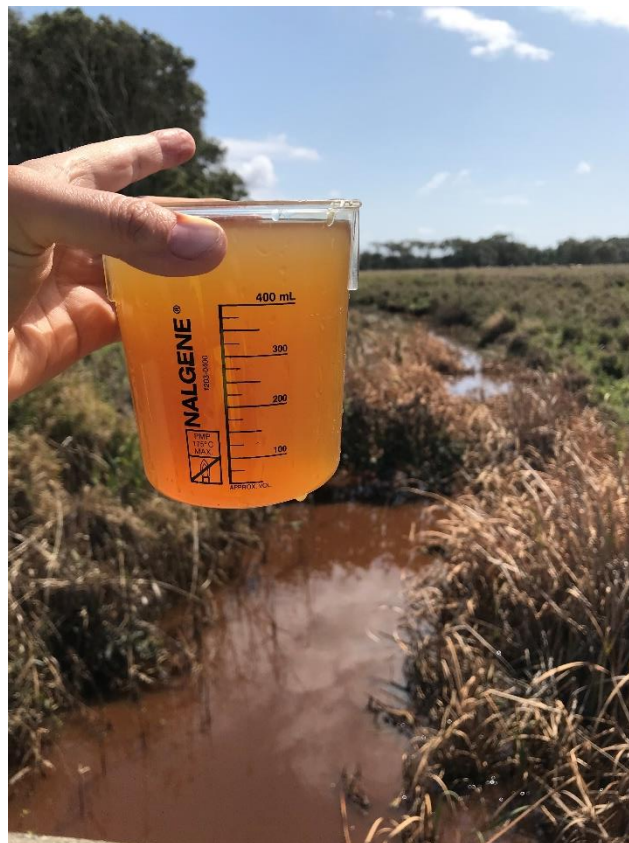
5: Mid-point of the No.1 flood mitigation drain in October 2019 when the drain was dominated by naturally occurring iron-rich groundwater.

Rous County Council also observed that the No. 1 flood mitigation drain can at times be dominated with iron-rich groundwater (see figure 5). This was observed during a prolonged hot and dry spring in October 2019 when drain water levels were low. Samples of drain water were analysed at a laboratory and the results showed the iron-rich water was not associated with acid sulfate soils and is likely to be naturally occurring. Very high levels of dissolved iron (27mg/L) were recorded at the mid-point of the No.1 drain, however tidal exchange buffered levels before water was discharged into Mobbs Bay. Anecdotally, iron-rich groundwater is considered common from South Ballina to Empire Vale and has been intercepted frequently by bores for many decades. Although naturally occurring, drainage now transports this iron-rich water downstream into the estuary with unknown consequences.

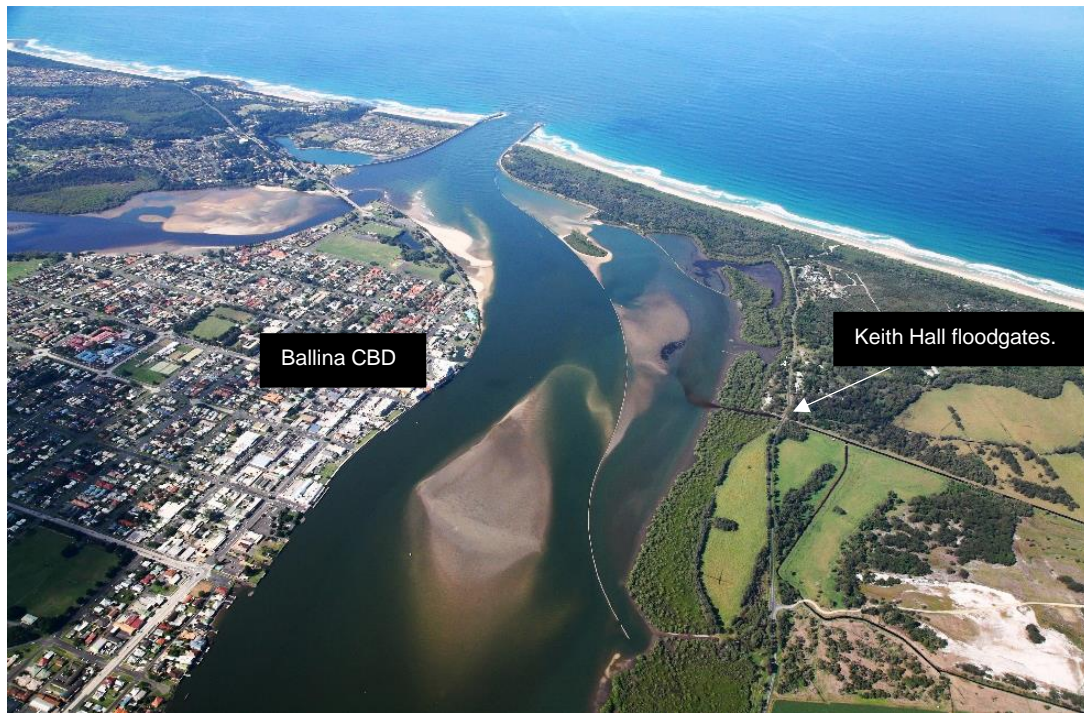
6: Aerial of KHDS discharging discoloured water into Mobbs Bay.

The system is known to regularly discharge discoloured water; however little is known about its chemistry or impact. Before tidal flushing was increased in late 2019, the system would almost continuously discharge discoloured water. Discharge plumes from Keith Hall drains are visible in past aerial images (see figure 6).

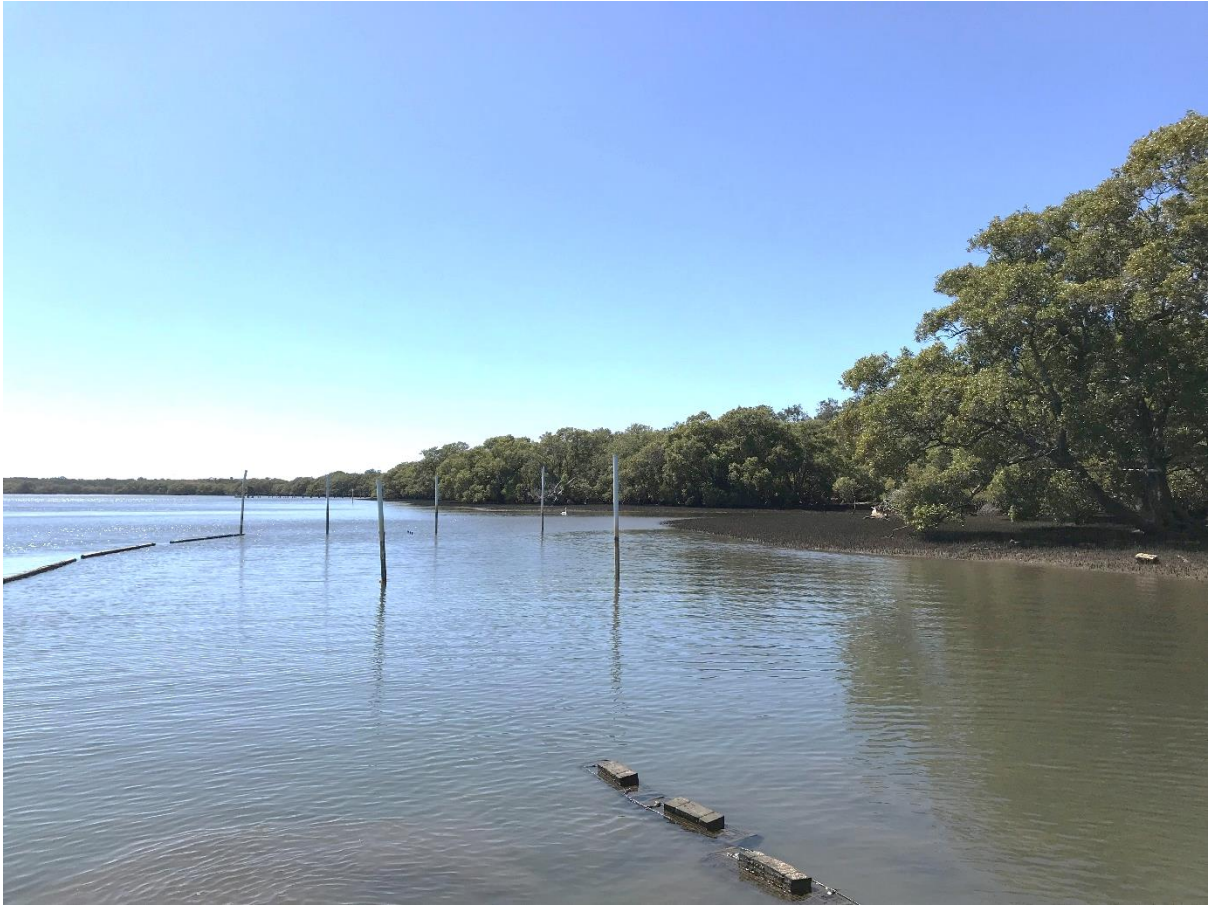
7: Oyster growing area immediately downstream of the KHDS floodgates.

Mobbs Bay is a significant area in the lower Richmond River estuary due to its environmental and recreational value and proximity to Ballina. Mobbs Bay is an important habitat for migratory birds and aquatic fauna and flora. Fishing is a popular recreational activity, and the Bay also represents significant oyster habitat in the lower Richmond River estuary.

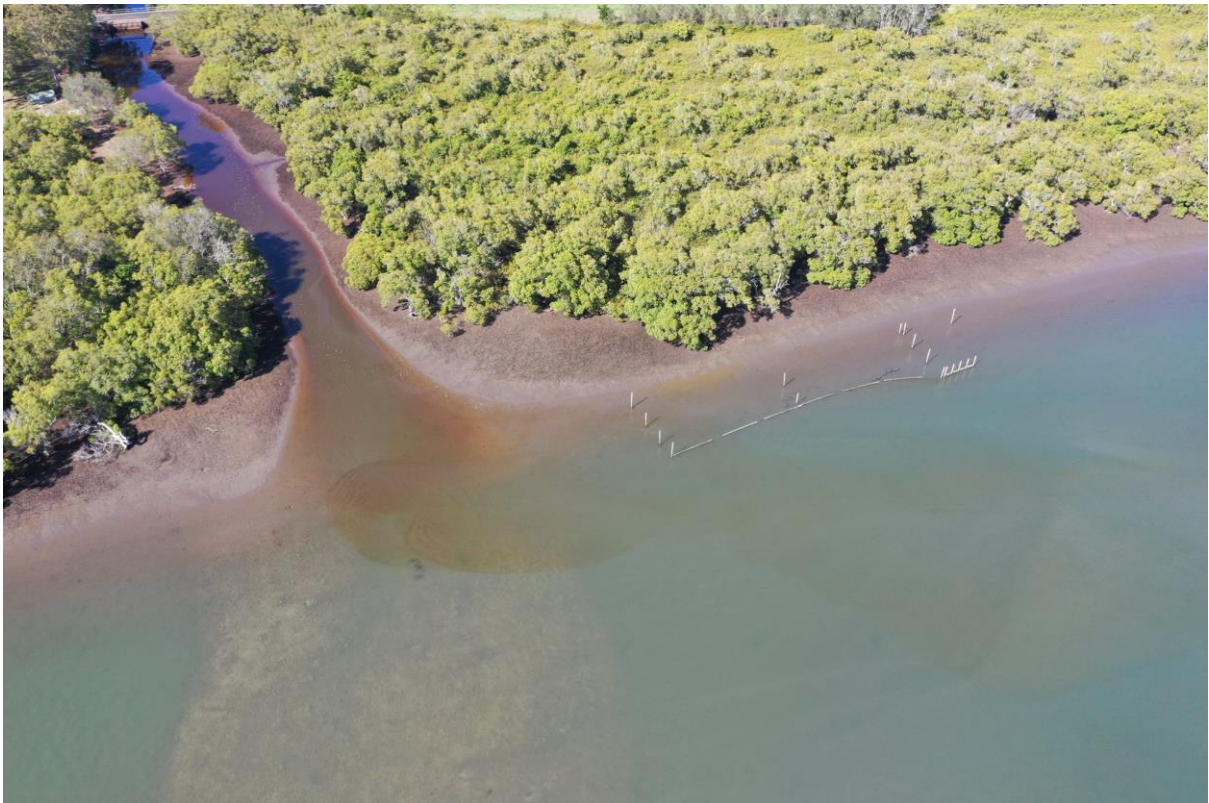
8: Aerial photographs showing discoloured discharge from the KHDS and the proximity of oyster growing areas.

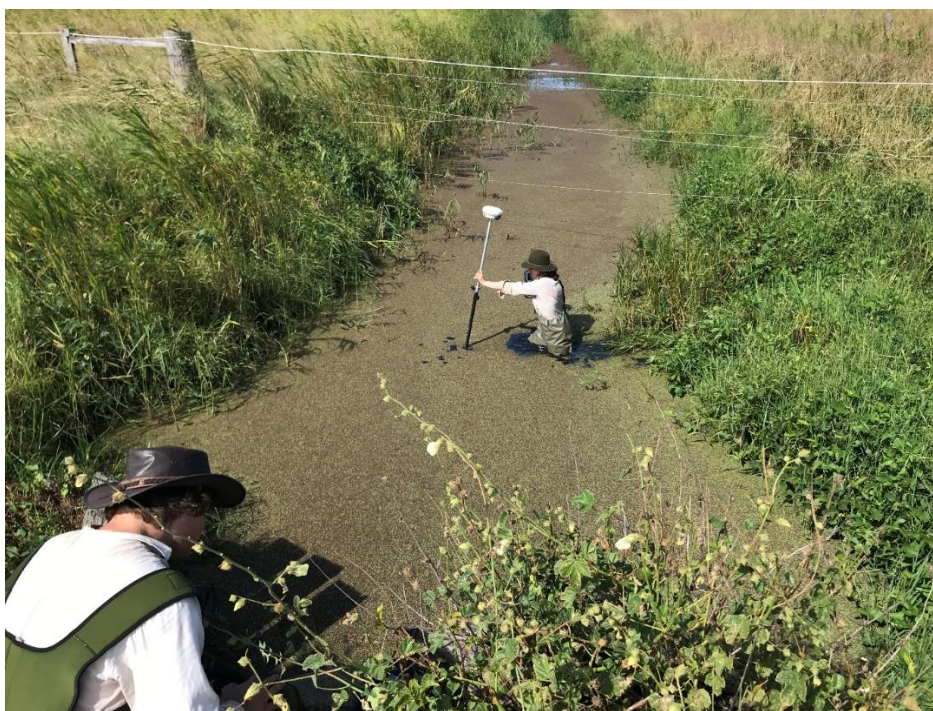
10: University of New South Wales staff surveying the invert of the Keith Hall No.1 flood mitigation drain.
