WILSONS RIVER REACH AUDIT AND PLANNING: ELTHAM TO BOATHARBOUR

PART B: REACH SCALE ASSESSMENT OF CONDITION AND
REACH PRIORITISATION

MARCH 2023

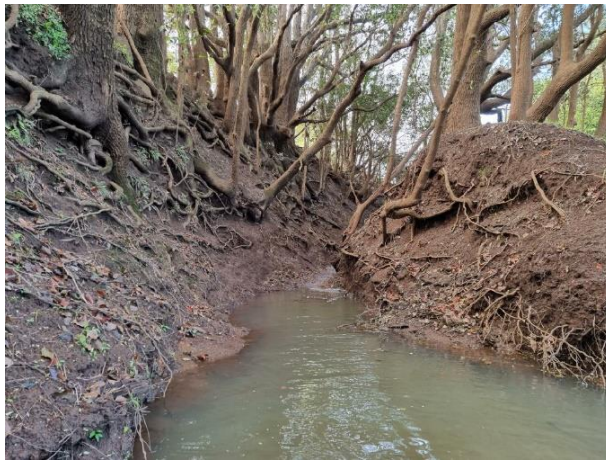
SUB-REACH 1

This photo shows a developing gully, with headward erosive processes, incising with head cuts.

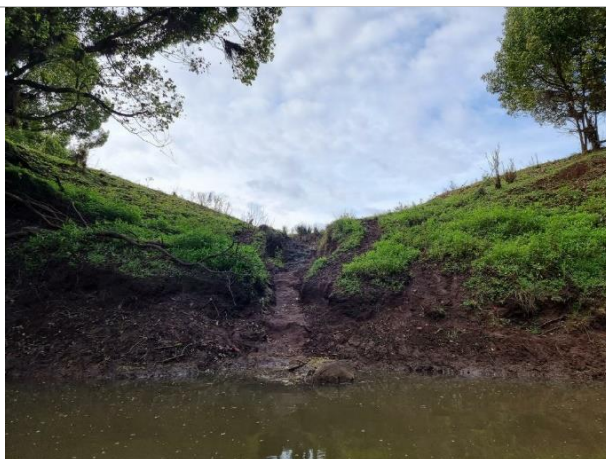
A gully is seen here, with headward erosion, avulsion linkup point, and evidence of grazing.

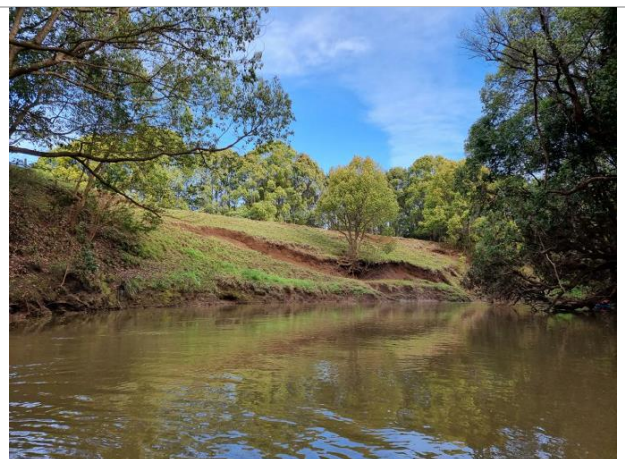
This photo illustrates bank erosion, slumping. Potential livestock trail.

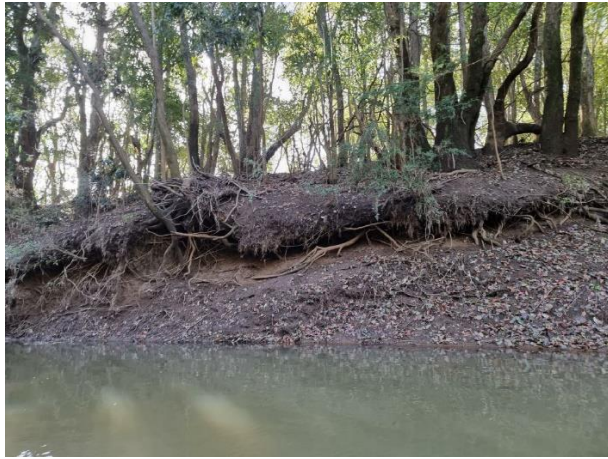
SUB-REACH 2

This photo shows bank toe erosion and slumping.

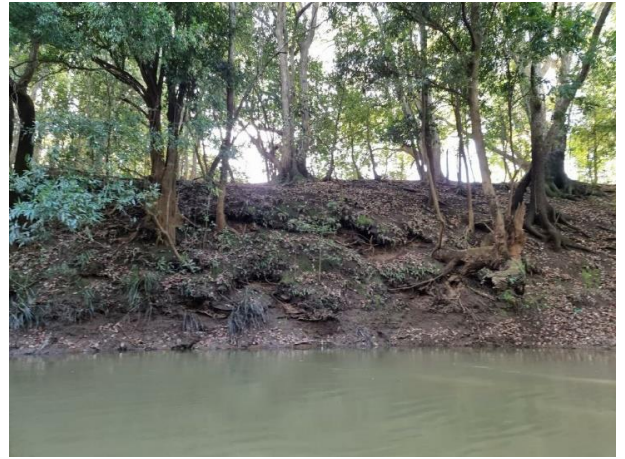
Bank slumping prevalent in this photo.

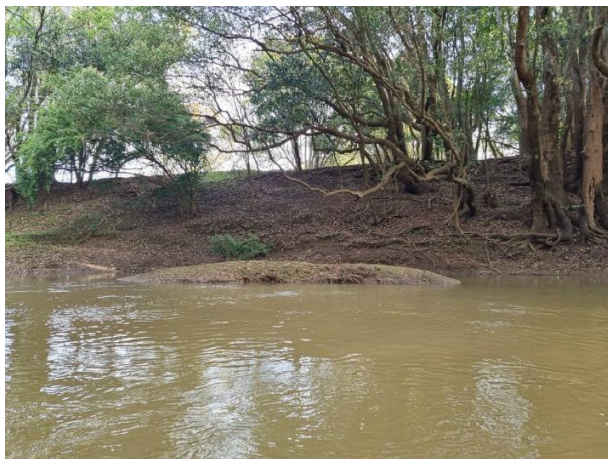
Island establishment seen here, as well as, toe scour, notches with potential gully development, and channel widening.

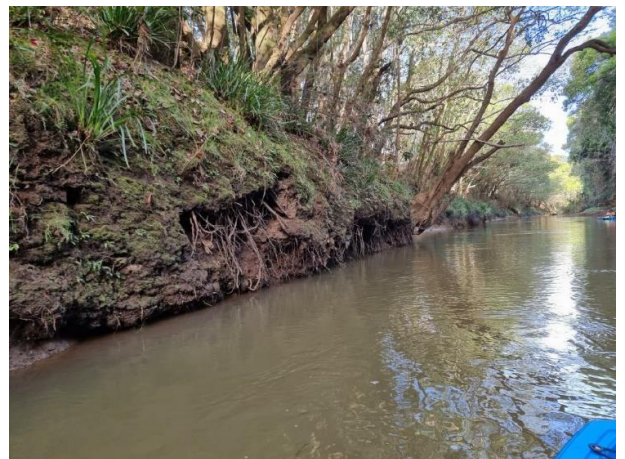
The channel is seen to widen here with toe scour exposing tree roots. Potential slumping.

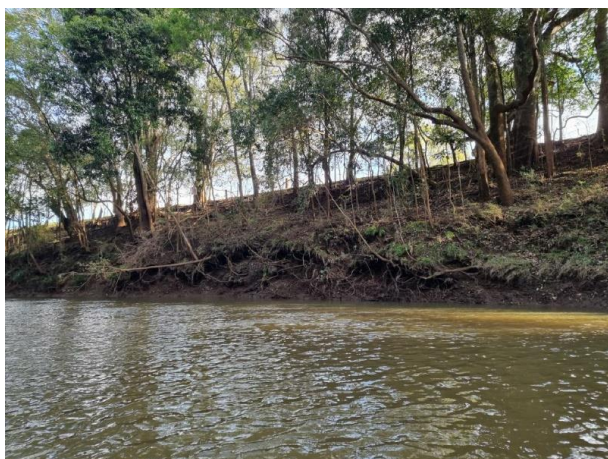
This photo shows the bank has collapsed over time subjected to scour processes.

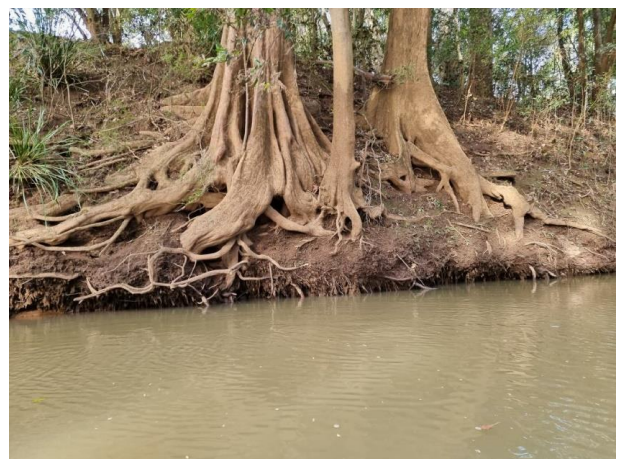
Undercutting of the banks and bank scour are some of the erosive processes seen here.

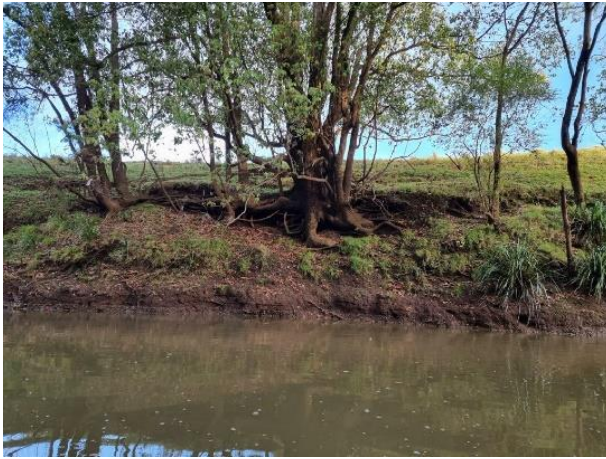
This photo shows the slumping bank and mass tree root exposure leading to tree collapse.

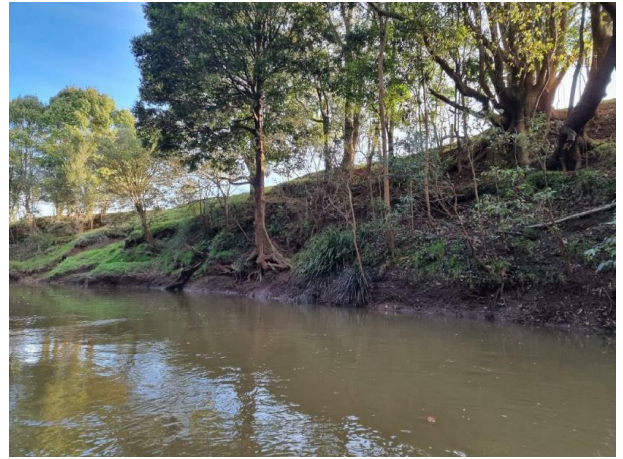
This shows potential livestock trail, leading to ground cover removal in restricted areas, and bank scour.

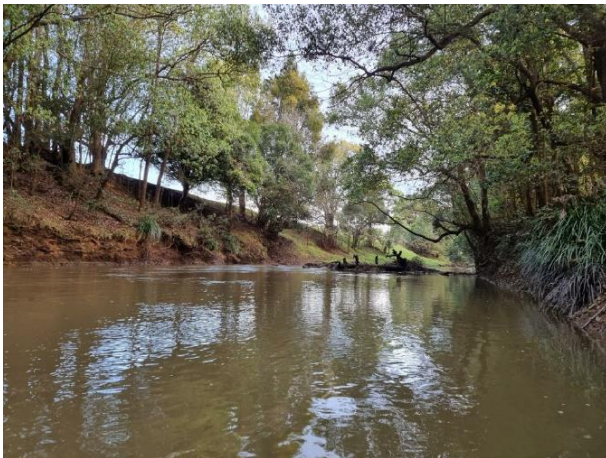
This photo shows increased in-stream diversity; log jams, run and riffles. Toe scour also seen in the mid to left-handed side of the photo.

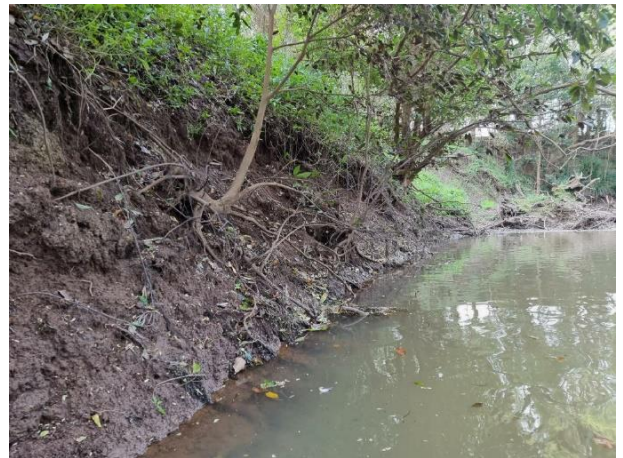
This photo shows increased in-stream diversity; log jams, run and riffles. Toe scour also seen.

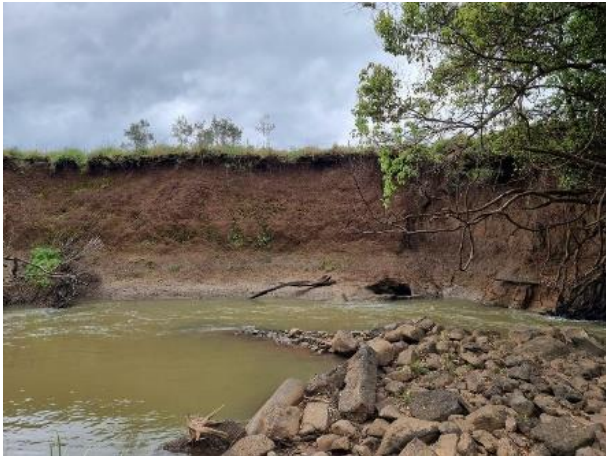
This photo illustrates major bank erosion, exposure bank wall and potential avulsion.

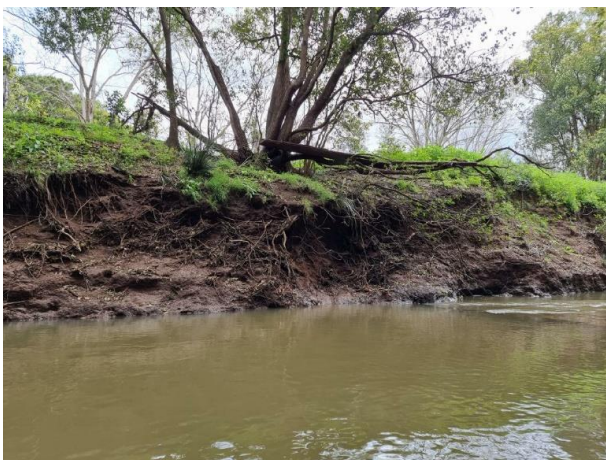
Bank scour and collapse is seen here.

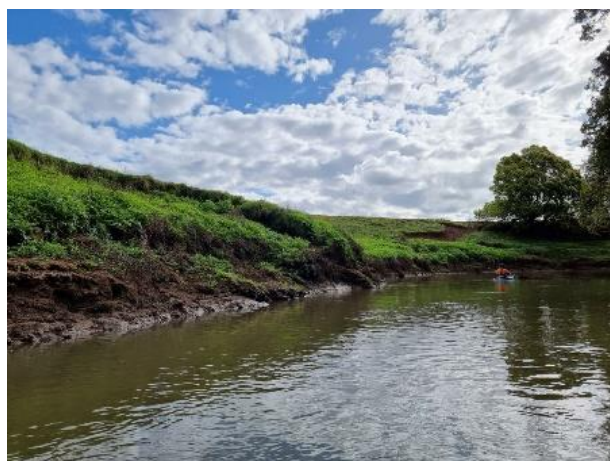
Reduced riparian vegetation and bank slumping is seen here.

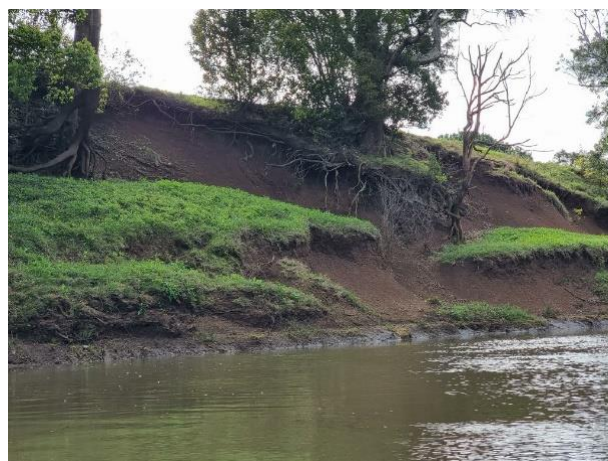
Evidence of historical bank collapse and currently bank exposed, resulting in vulnerability to current erosive processes.

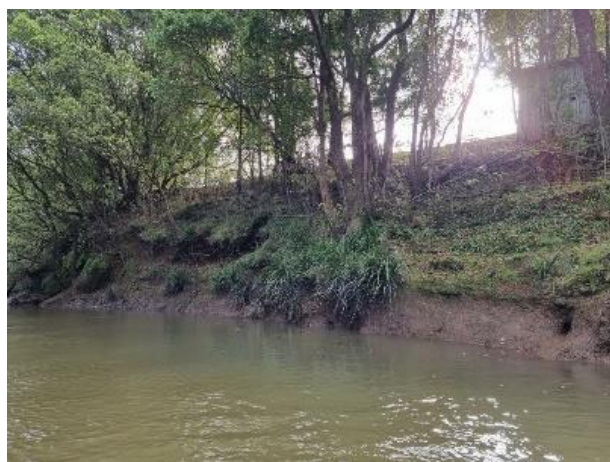
Bank slumping and undercutting is seen here.

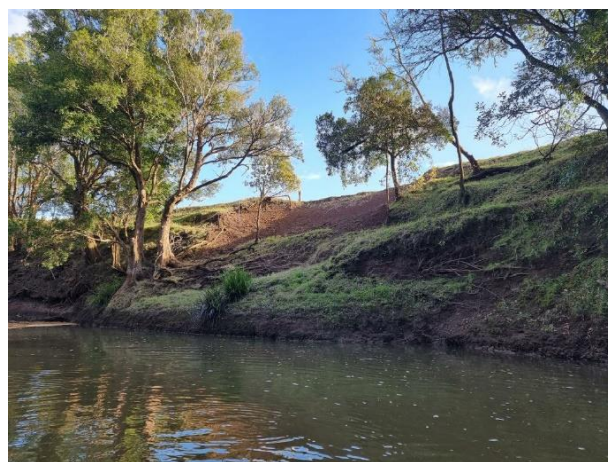
Bank erosion is seen here. Evidence of grazing and well-used livestock/quad/4WD trail.

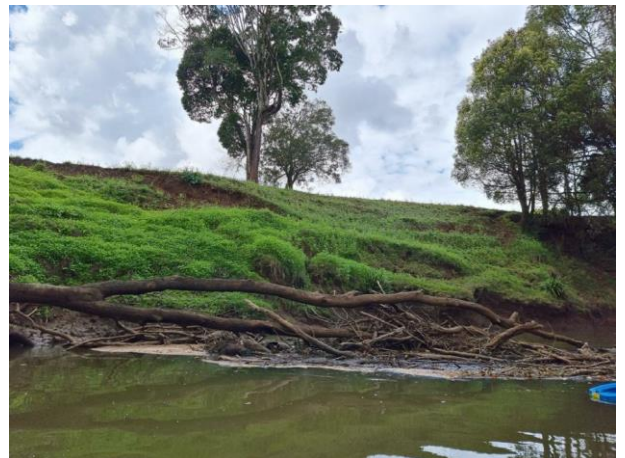
Reduced riparian vegetation and some bank slumping is seen here. Less slumping comparatively to the photo on the left.

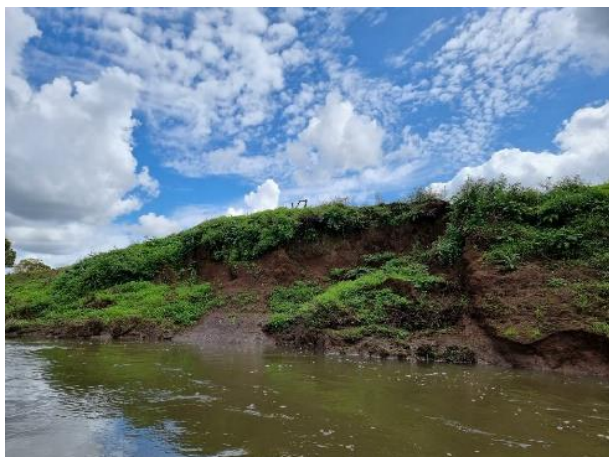
Reduced riparian vegetation and bank slumping is seen here.

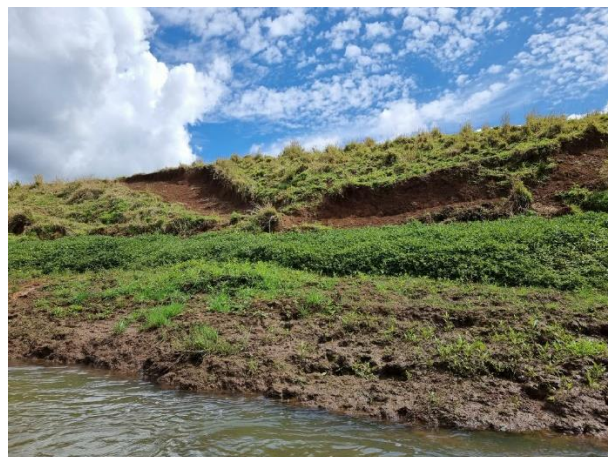
Reduced riparian vegetation and bank slumping and bench is seen here. Potential livestock/quad bike trail.

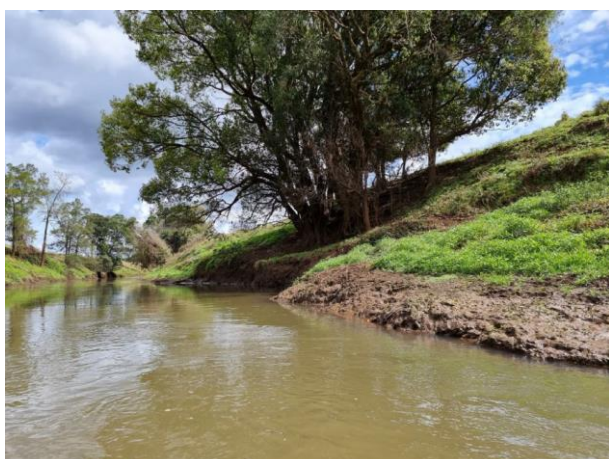
Reduced riparian vegetation and predominate tow scour.

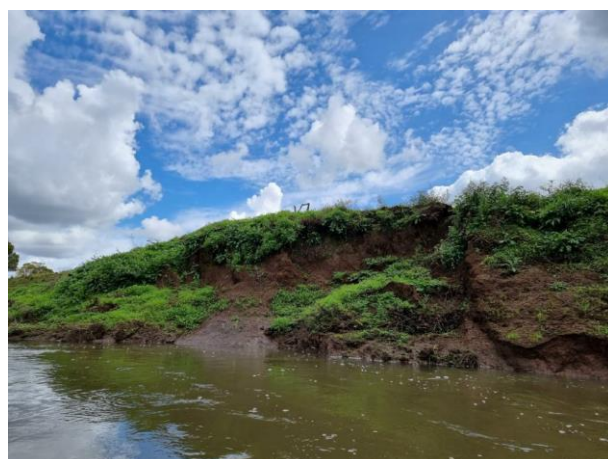
Reduced riparian vegetation and bank slumping is seen here.

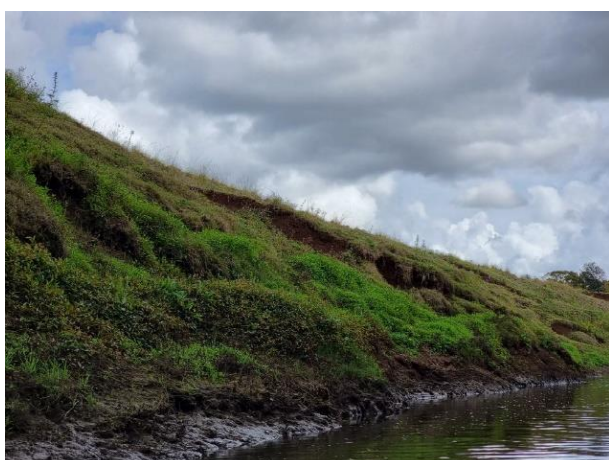
This photo shows bank slumping.

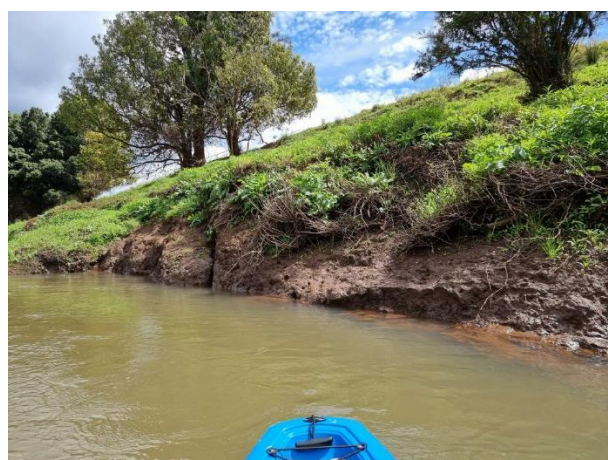
Strong toe scour is seen here.

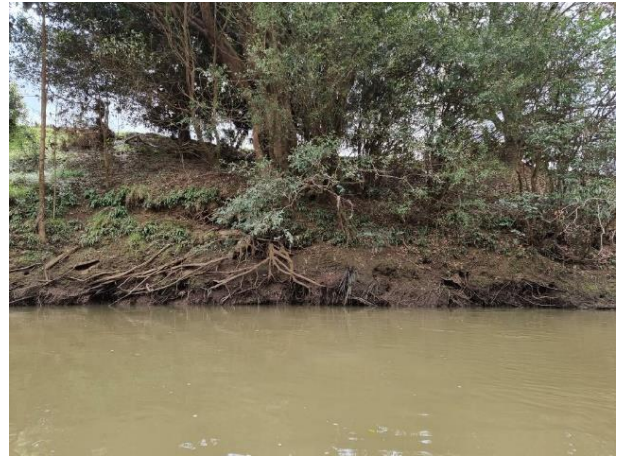
This photo shows toe and bank scour.

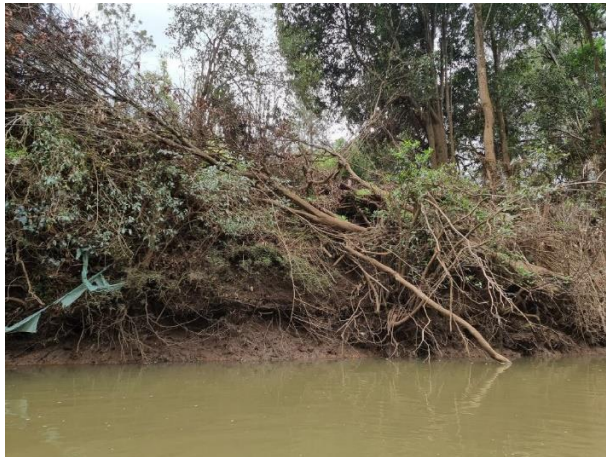
Flood debris is seen here. Potentially exposed underneath debris.

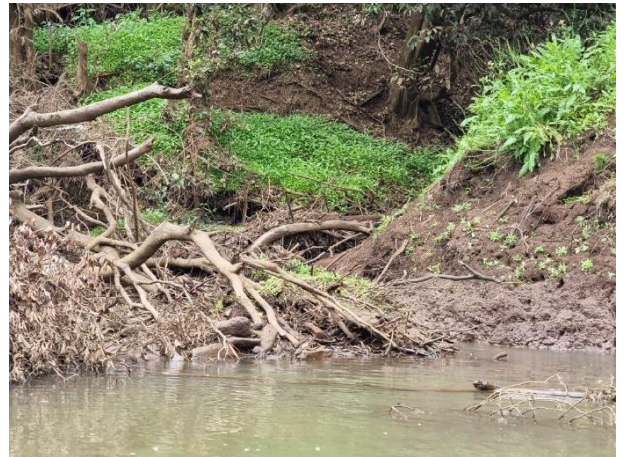
This photo shows a perched tributary, flow blocked by large woody debris.

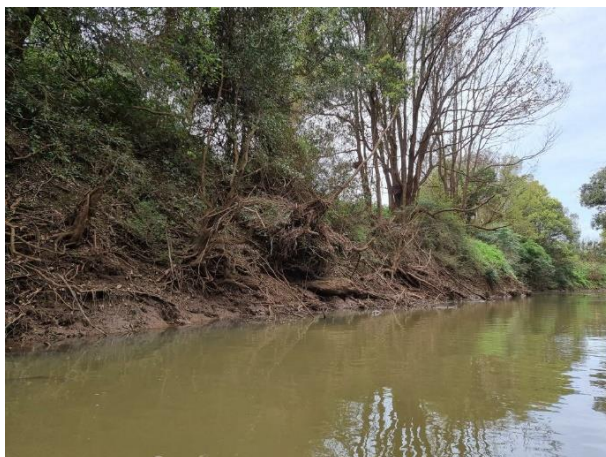
Flood debris is seen here, along with bank scour.

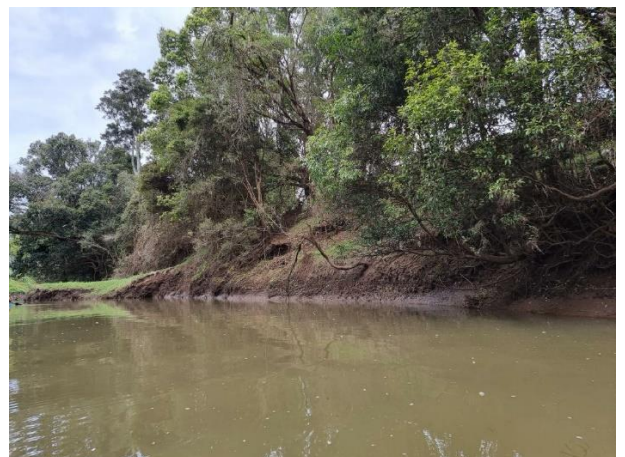
Flood debris is seen here, along with bank scour.

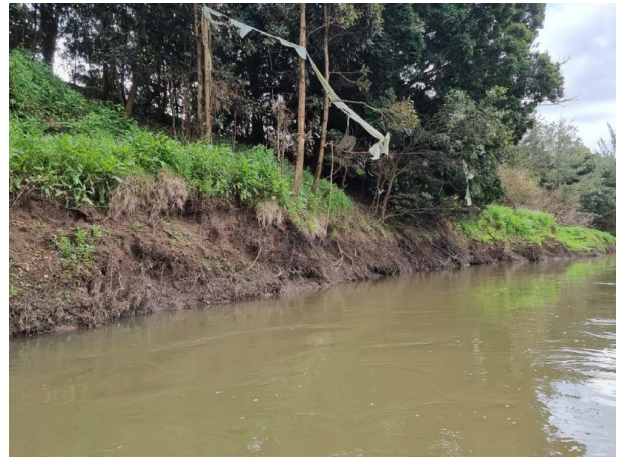
Bank scour is seen here.

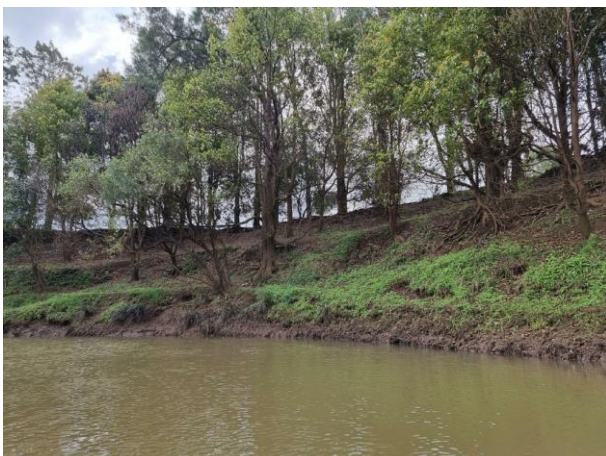
Scour throughout bend is seen here.

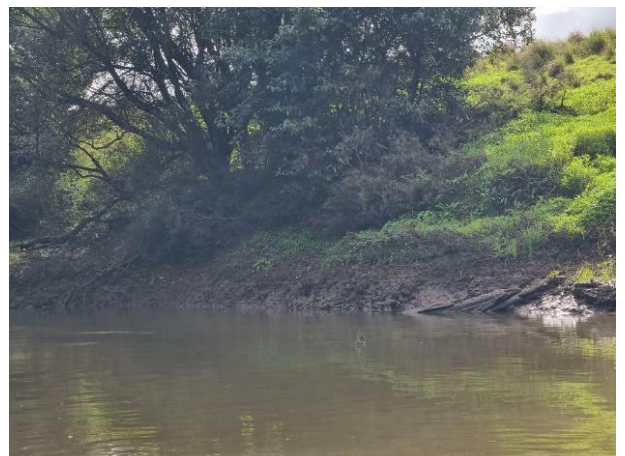
This photo shows bank scour.

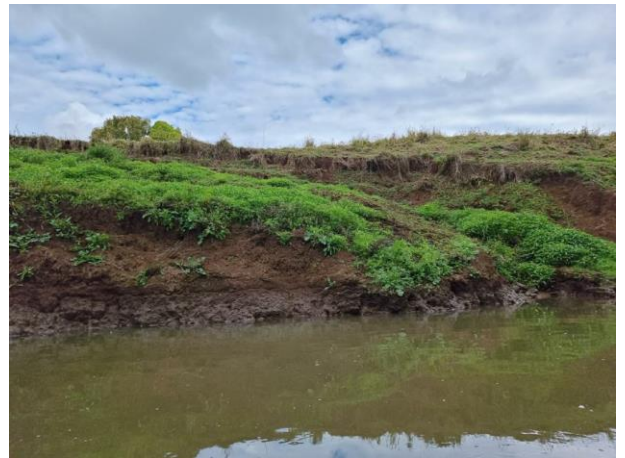
Reduced riparian vegetation and some bank slumping is seen here.

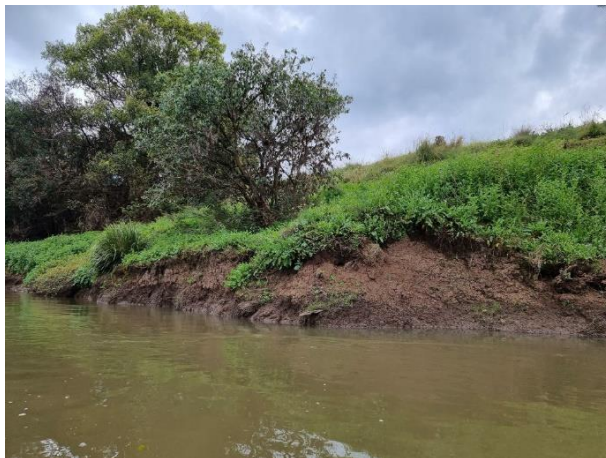
This photo shows some scour and evidence of replanting.

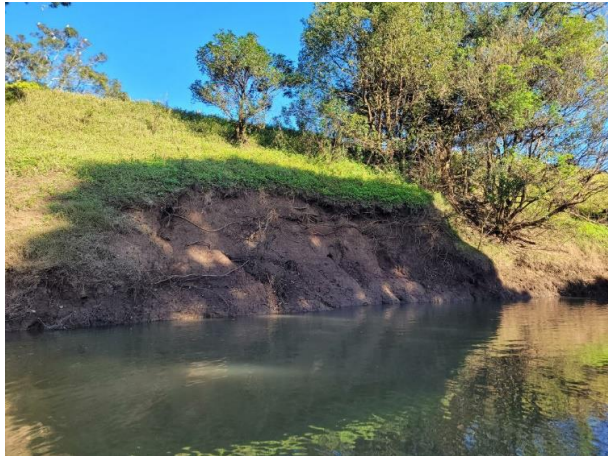
This photo illustrates bank slump and reduced riparian zone vegetation.

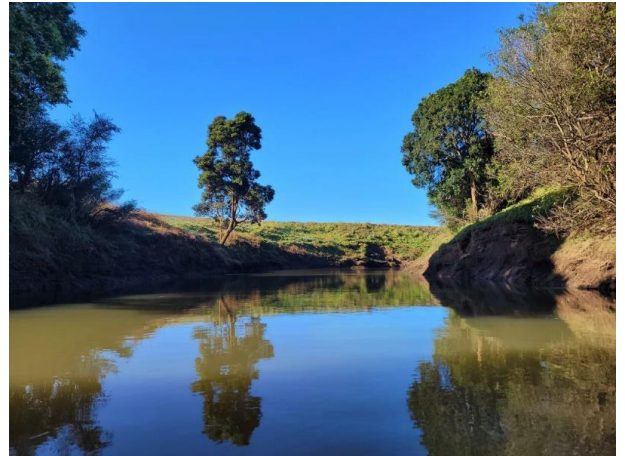
This photo illustrates bank slump and reduced riparian zone vegetation.

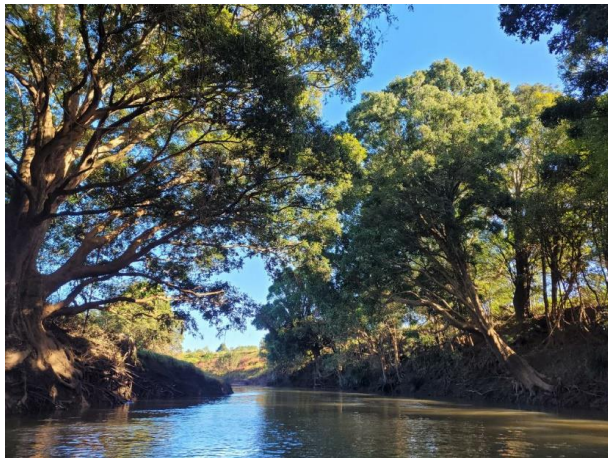
Stronger fringing zone comparatively to other sections of the reach. Increased presence of native vegetation on fringing zones. Bank scour and slump is seen.

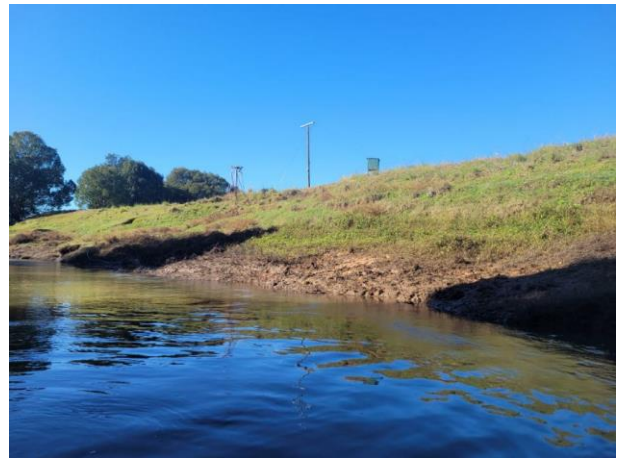
No trees present on riparian zones, some bank slumping is seen here. Strong evidence of grazing.

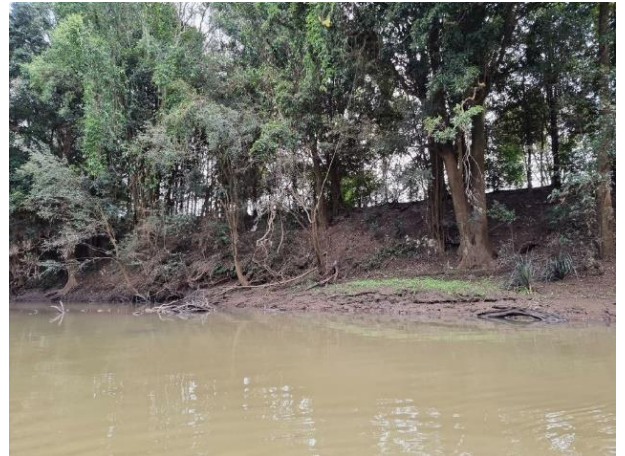
Bank scour is seen here, with potential bank undercutting in parts.

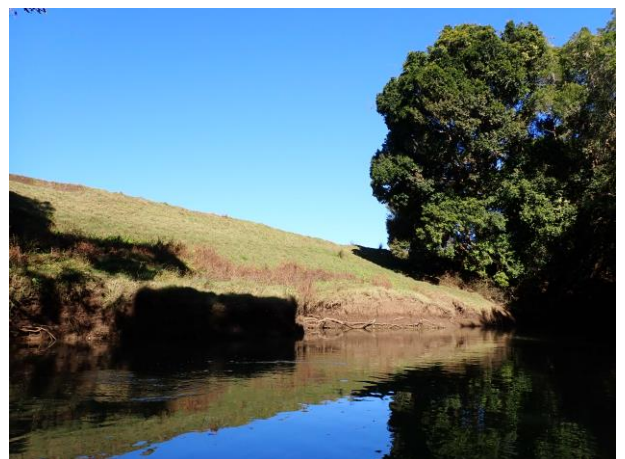
Reduced riparian vegetation and bank slumping is seen here. Evidence of grazing

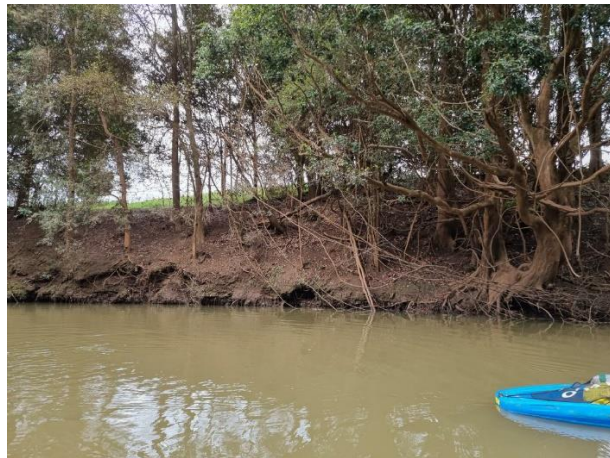
Undercut banks is seen here.

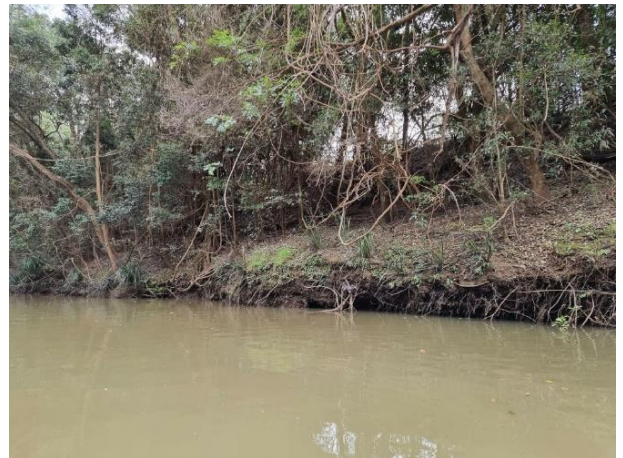
This photo shows toe erosion and some loss of tree stability.

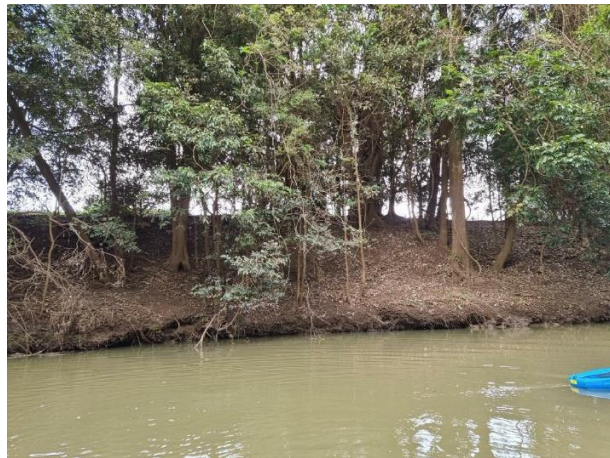
Undercut banks is seen here.

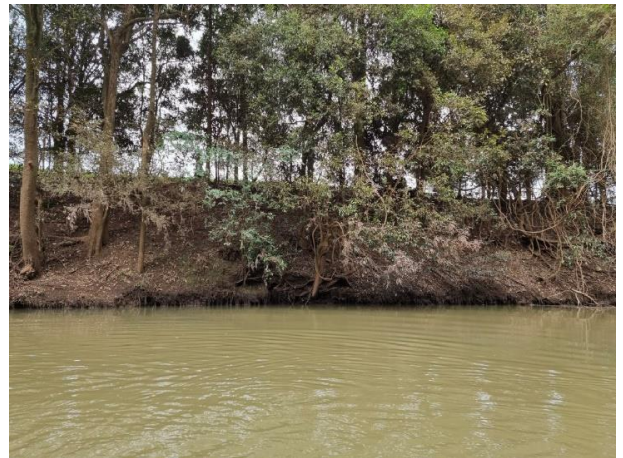
Undercut banks is seen here.

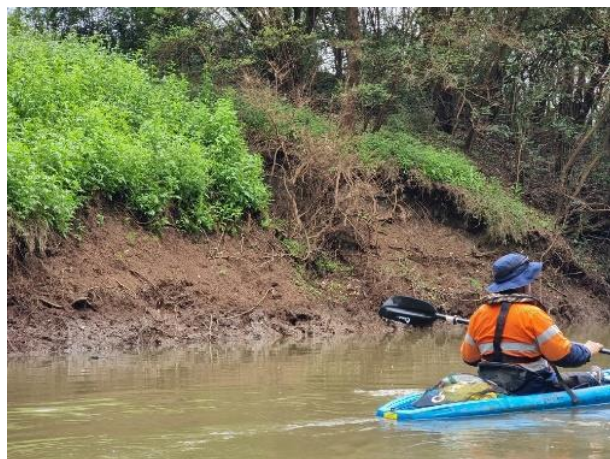
This photo shows the bank has already collapsed where there is no vegetation.

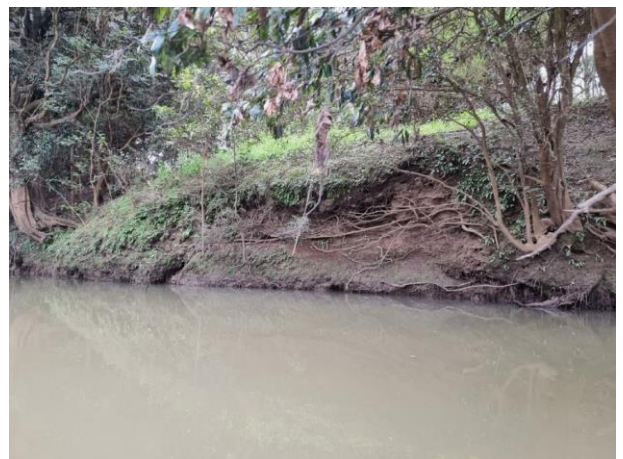
Some scour is seen here, with presence of some large trees on riparian zone.

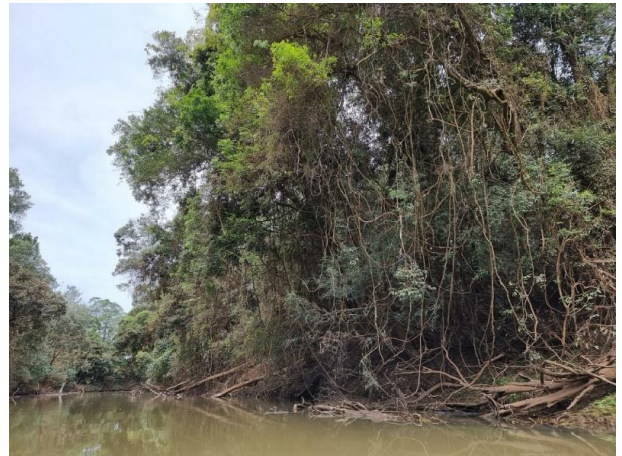
Some overhanging vegetation is seen on fringing zone, with undercut banks.

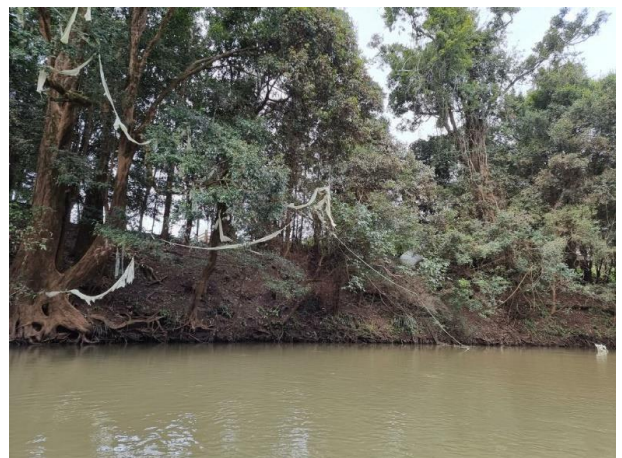
This photo shows increased vegetation comparatively to other sections of the reach. Strong presence of undercut banks reducing tree stability in some parts.

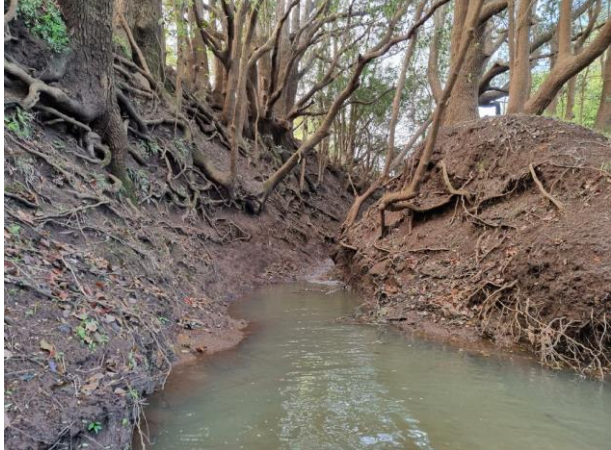
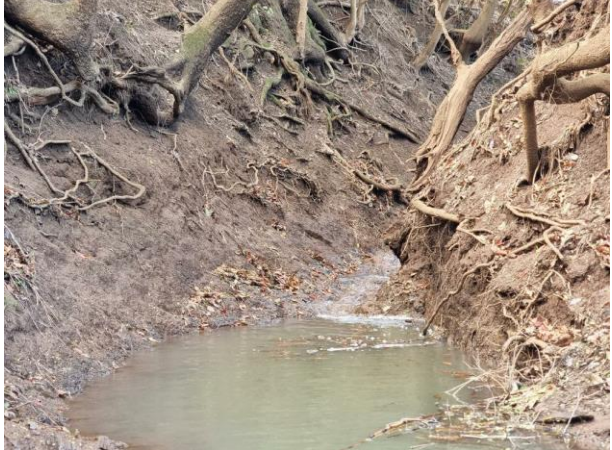
<p>1 – Reach 1, Gully headward eroding, incising with headcuts. Severity – Moderate.</p>	<p>1</p>

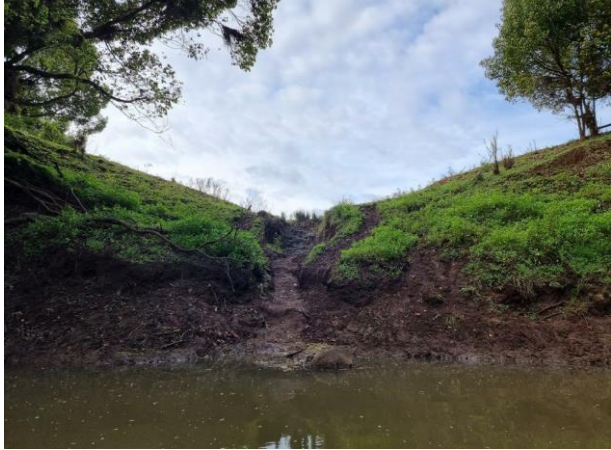
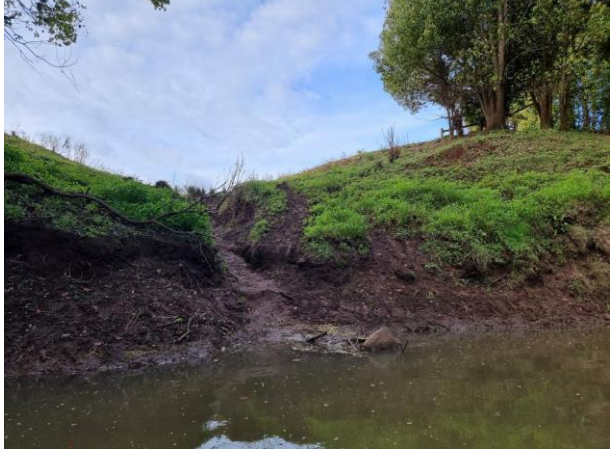
<p>2 – Reach 1, gully, headward erosion, avulsion linkup point. Severity – Low.</p>	<p>2–</p>

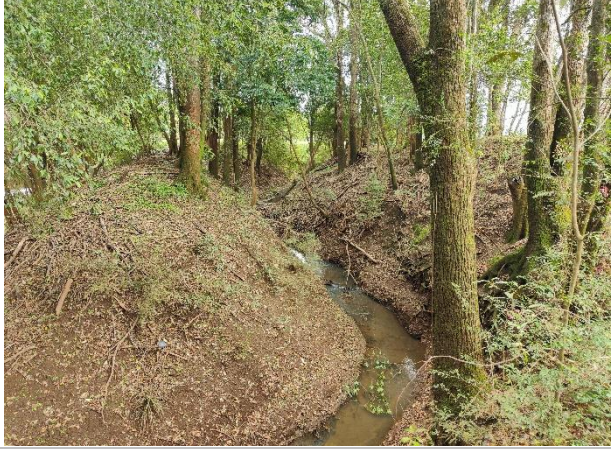
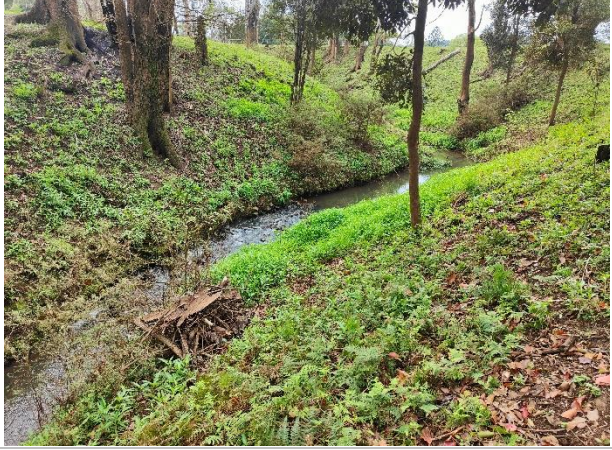
<p>3 – Reach 1, gully, headward erosion, well vegetated at confluence, Severity - Moderate</p>	<p>3</p>

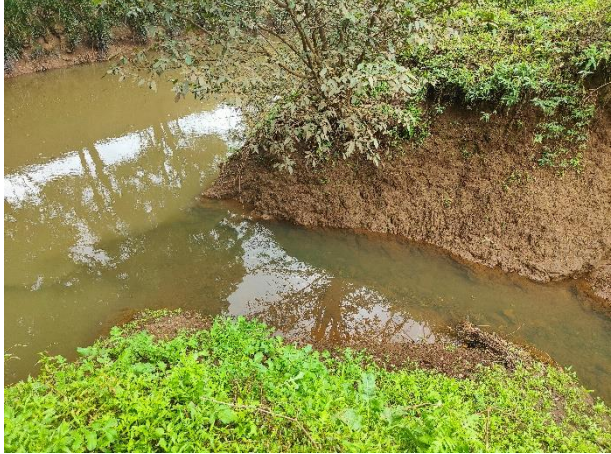
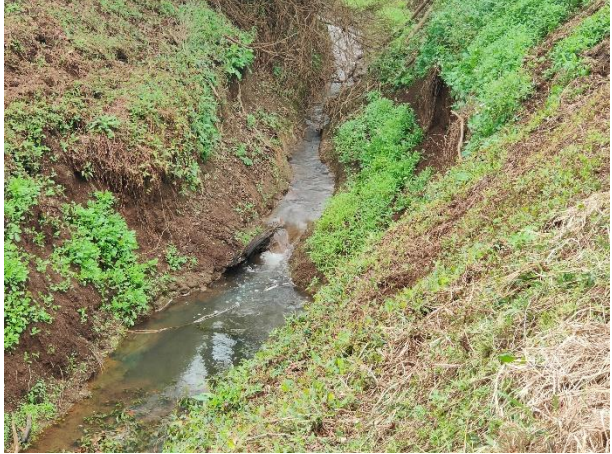
<p>4 – Reach 3, headward erosion, moderate catchment, sediment deposition, Severity - High</p>	<p>4 – Reach 3, gully headcuts</p>

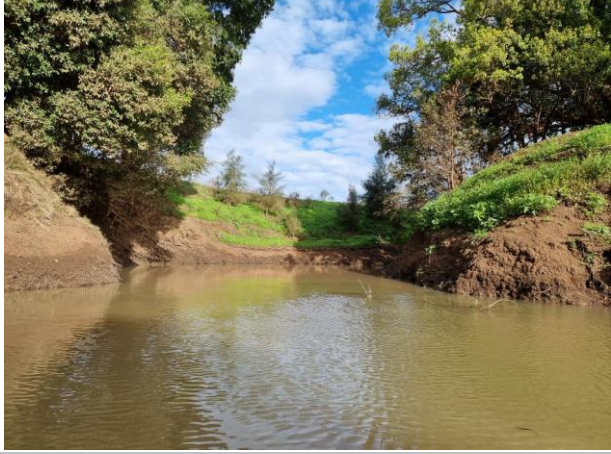
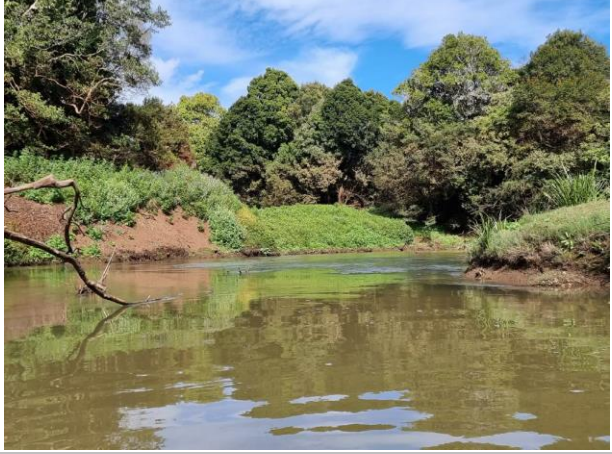
<p>5 – Reach 7, Large Trib/Gully input, landowner Gary said it has high flow during big events, possible large sediment source. Severity - High</p>	<p>7 – Reach 7, Meander cut-off and gully. Lots of headcuts in channel. Erosion. Severity – Moderate.</p>

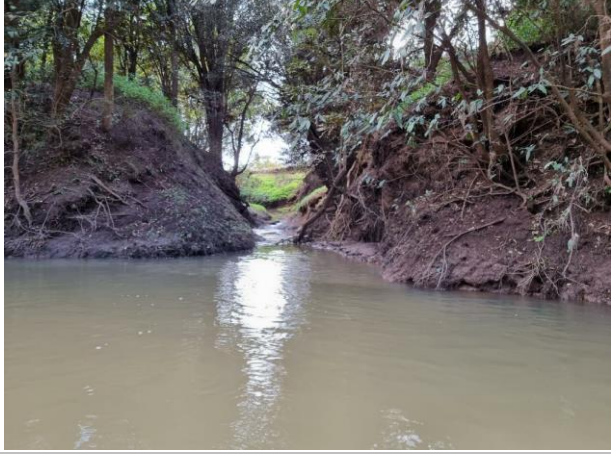
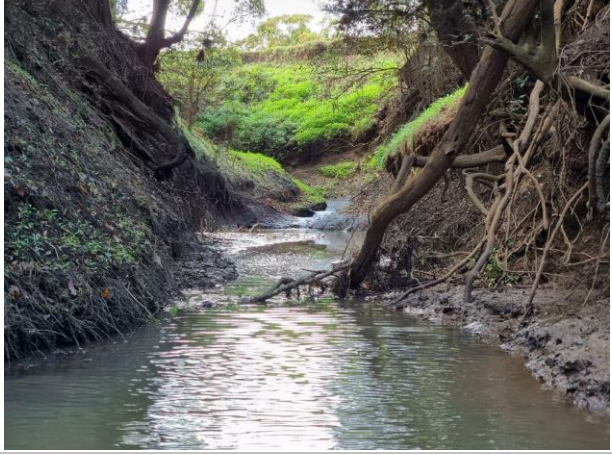
<p>8 – Reach 8, Gully tributarys, headward eroding with headcuts, sediment input. Severity - High</p>	<p>8</p>

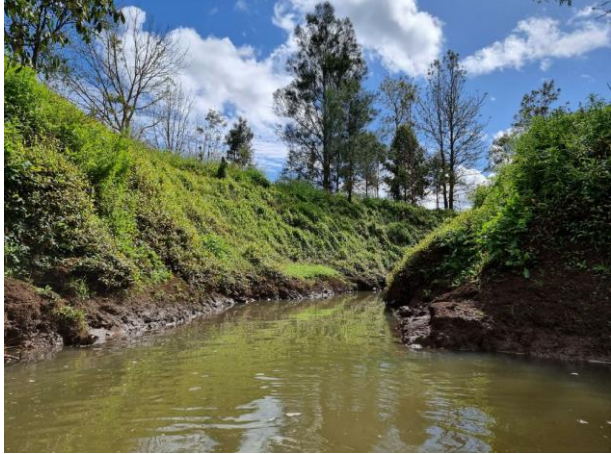
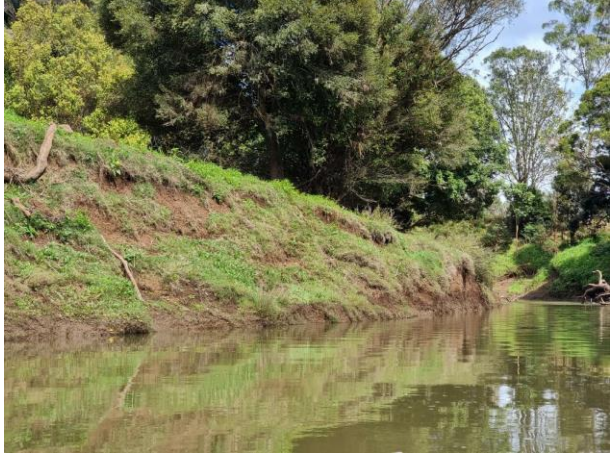
<p>9 – Reach 8, Incised Tributary, sediment source. Severity – High.</p>	<p>9</p>

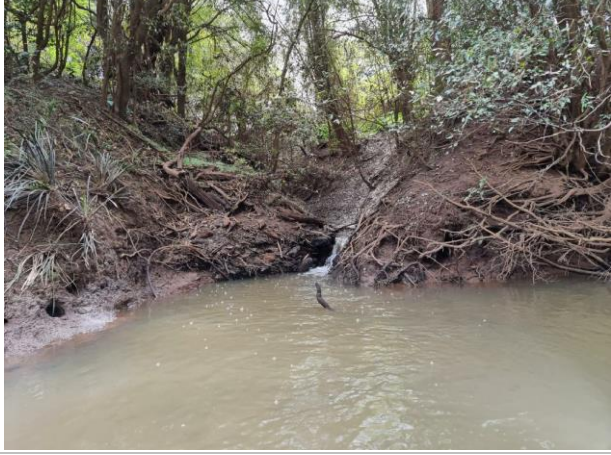
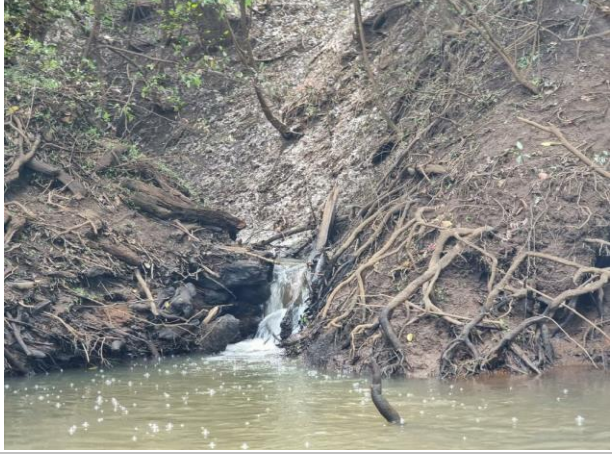
<p>10 - Reach 9, Tributary with headcuts. Severity – Moderate.</p>	<p>10</p>

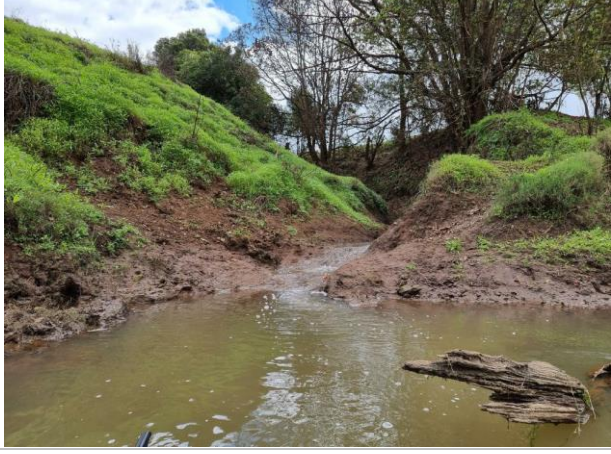
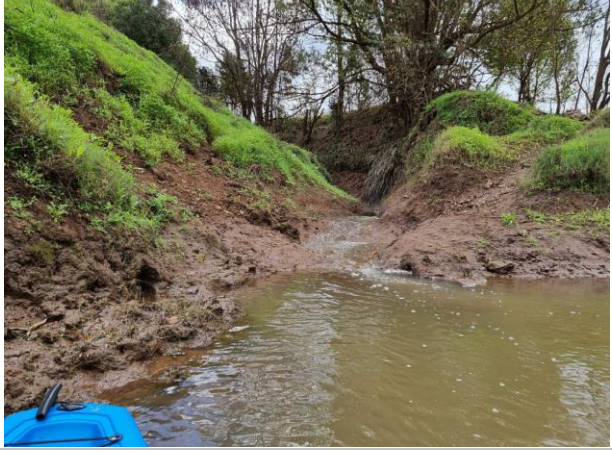
<p>12 - Reach 10, tributary with headcuts, incising/headward eroding. Severity - High</p>	<p>12</p>

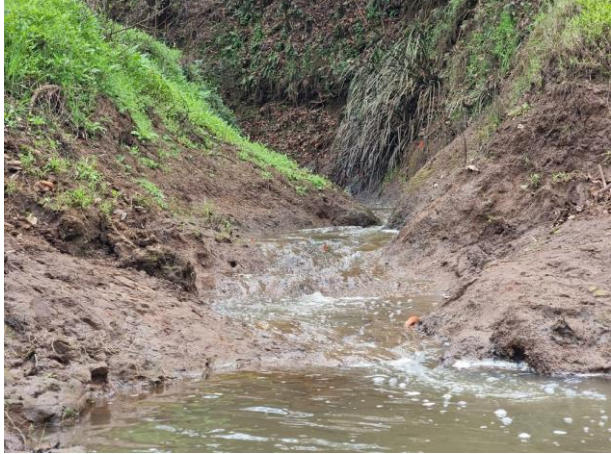
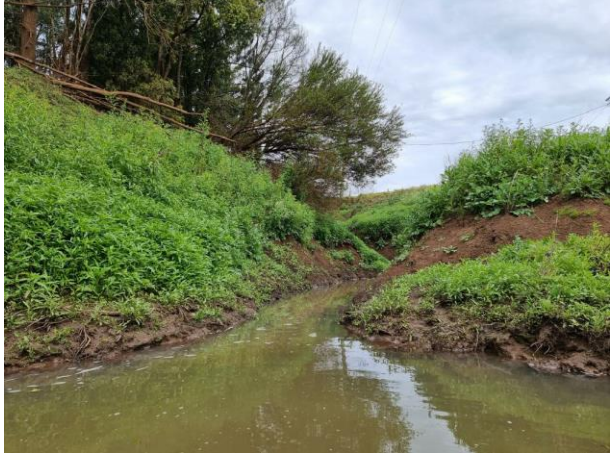
<p>12</p>	<p>13 – Reach 12, eroding trib. Severity - High</p>

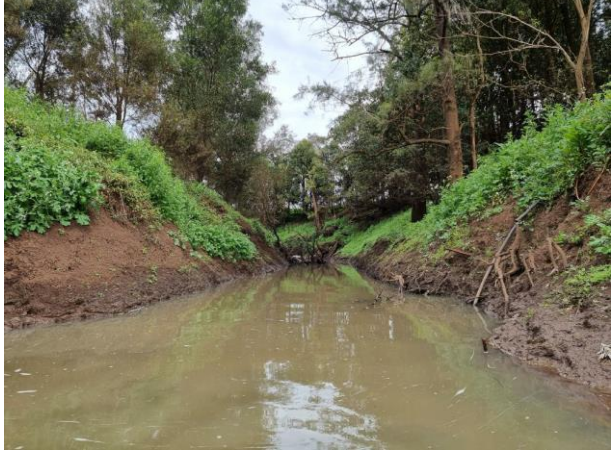
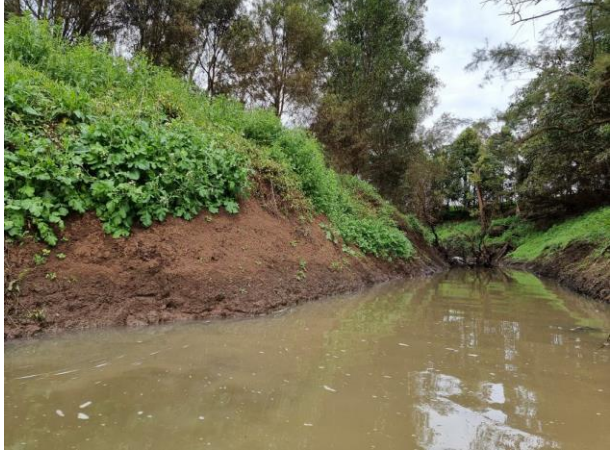
<p>14 - Reach 12, headward eroding trib with toe scour. Severity - High</p>	<p>14</p>

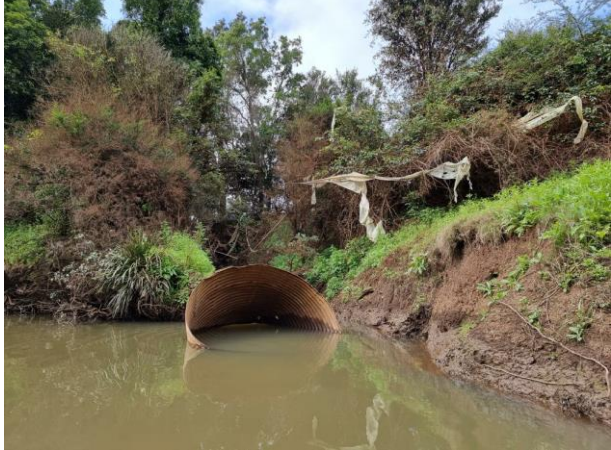
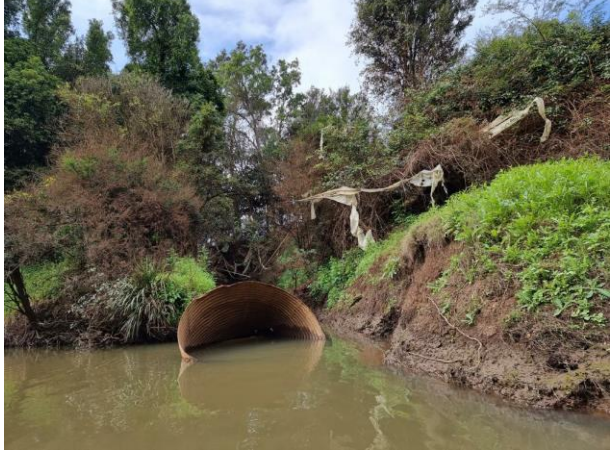
<p>16 - Reach 18, eroding trib with flood debris. Severity - Low</p>	<p>16</p>

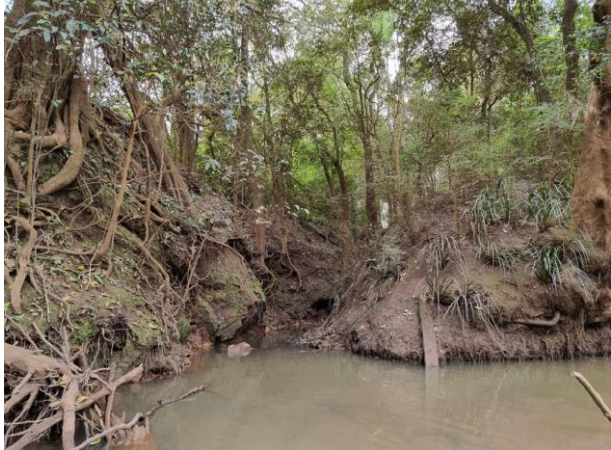
<p>17- Reach 19, headward eroding trib with exposed bedrock</p>
